**Partners for Water and Sanitation (PAWS)
Wastewater Treatment Works Assessments
Gauteng Province, South Africa**

March 2009

Report prepared by Tom Wayling and Rob Smith of Anglian Water (UK), in collaboration with Department of Water and Environmental Affairs (SA) and Partners for Water and Sanitation.

Executive Summary

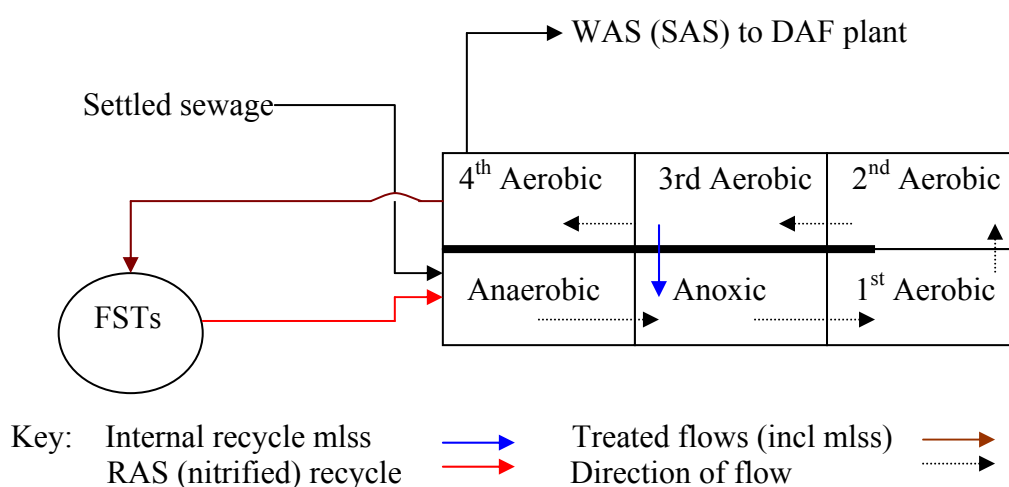
Figure 21: The diagram below illustrates what was found to be present in reactor 3.

It was observed that there was an internal recycle from 3rd stage aerobic into the anoxic zone, providing a substrate feed for this zone. RAS flows from the FSTs were being pumped directly into the front end of the anaerobic zones.

Closer inspection found that the original pipe and channel construction actually fed these flows into the front of the anoxic zones. However, the RAS screws had been taken out of action (fig 22) and replaced by pumps closer to the FSTs. These pumps passed the RAS flows along long, above ground pipelines (fig 23), depositing it into a channel close to the incoming settled sewage flows and thus directly into the front end of the anaerobic zones. Site staff were not able to confirm when or why this action was taken. The net result of this action was to provide a feed of nitrate bearing RAS into the anaerobic zone, thus hindering the P removal process. This is of course, assuming that the aerobic process was converting the ammonia to nitrates in the main bulk of the reactor.

It should be noted that this arrangement has been effected for reactor three only. For reactors one and two the RAS screws were still in use. However, no detailed information was obtained as to the reasons or effectiveness of these different set-ups.

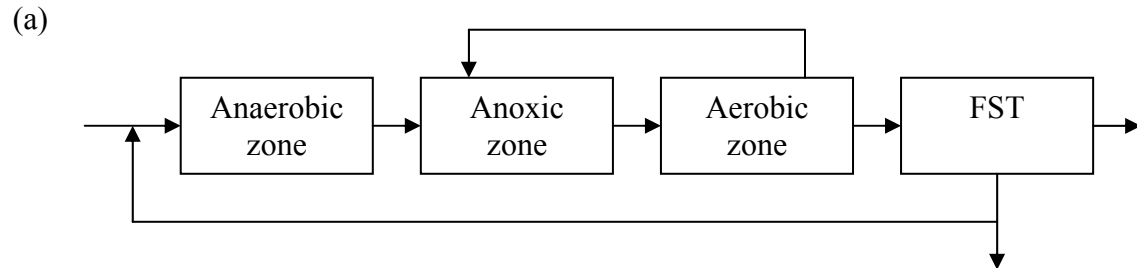
The basic configuration found on site was as fig 90 (a) and (b) below.

We were told initially that the north works was being run in a Phoredox configuration. However, site inspection did contradict this. Combined removal of both nitrogen and phosphorus biologically can be achieved by a number of ways, but all are based on modifications of the original Bardenpho system.

Rooiwal North works has three separate BNR reactors. Figure 90 (a) above was found to be only on reactor three. Reactors one and two retained their original configuration. (i.e. (b) above). This may have reduced the concentration of nitrates entering the anaerobic zones for these reactors. However, it is likely that some nitrates were still present due to higher climatic temperatures (Wastewater Handbook).

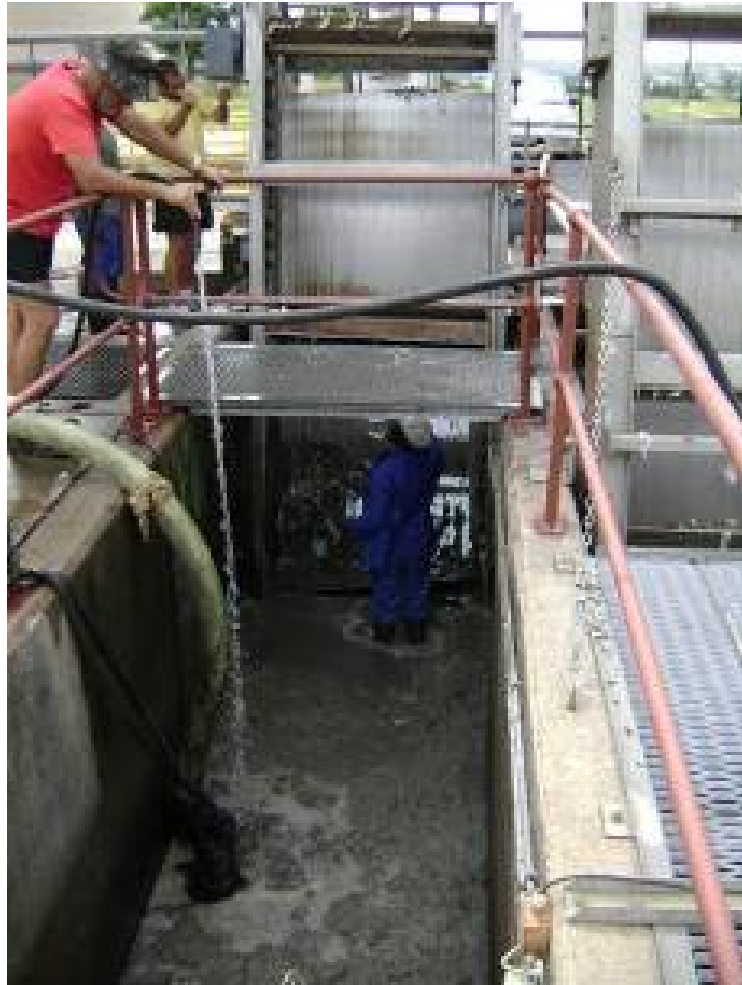
Fig 1: Mechanical Screen out of use and under repair. Also shows limited ppe

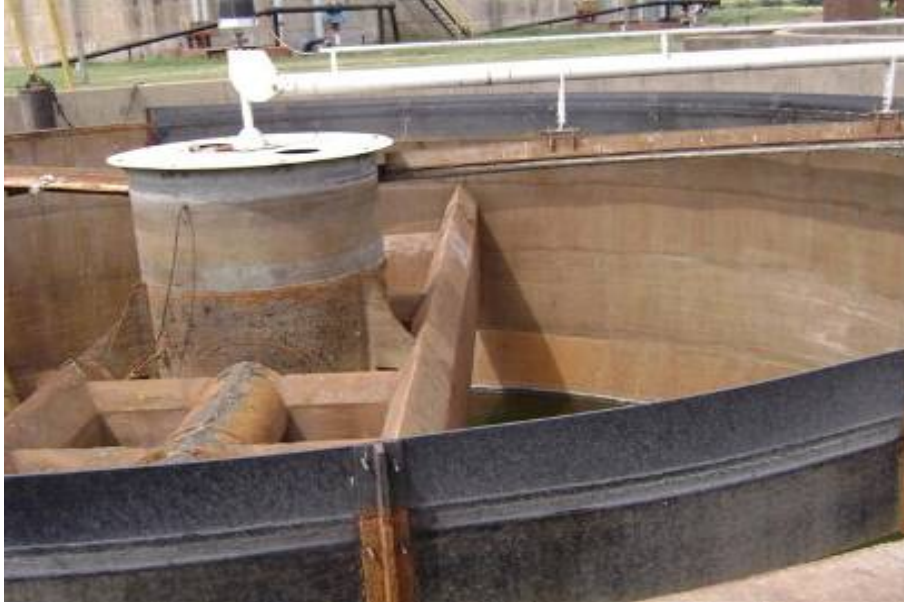
Fig.2 East Works PSTs out of use – mechanical failures

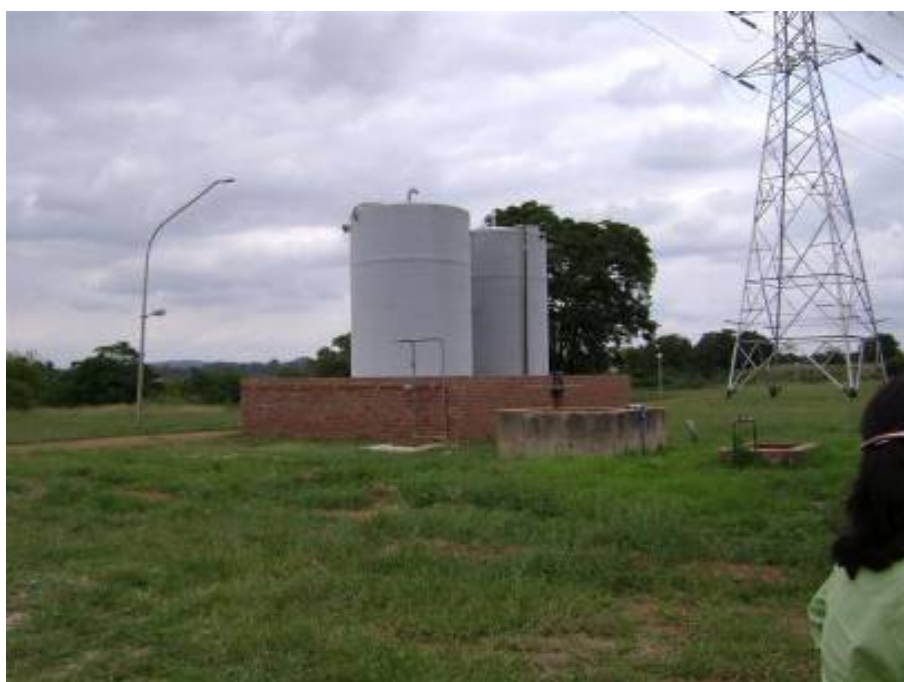
Fig. 7: Ferrous chemical dosing plant out of use.

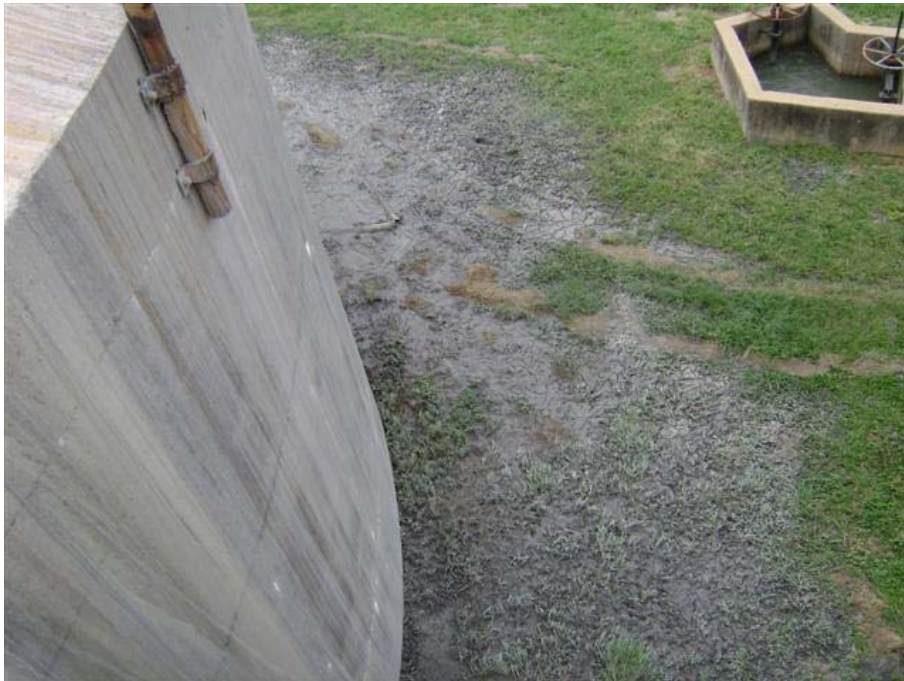
All of these were seen to be in a relatively poor condition, and some showing signs of leaking sludge (fig 8). The methane gas generated should be collected in a nearby gas holder, but this was seen to be empty (fig 9). There was also a boiler (fig.10) intended for burning the gas to provide steam injection heating and mixing of the digesters. This too, was out of action, due to the lack of gas. Site staff informed us that the digesters were not separately heated, and so the digestion was being carried-out at ambient temperatures. Air temperature on the day was approximately 25°C. This temperature is below a more ideal 37°C required for effective mesophilic digestion (and assumes that no heat loss occurred through the concrete walls of the structures). No information was available as to the feed rates of the digesters. The nearby psts were also only desludged manually, so digester feed would have been erratic, irrespective of actual volumes and rates.

Fig. 8: Leaking digesters east works

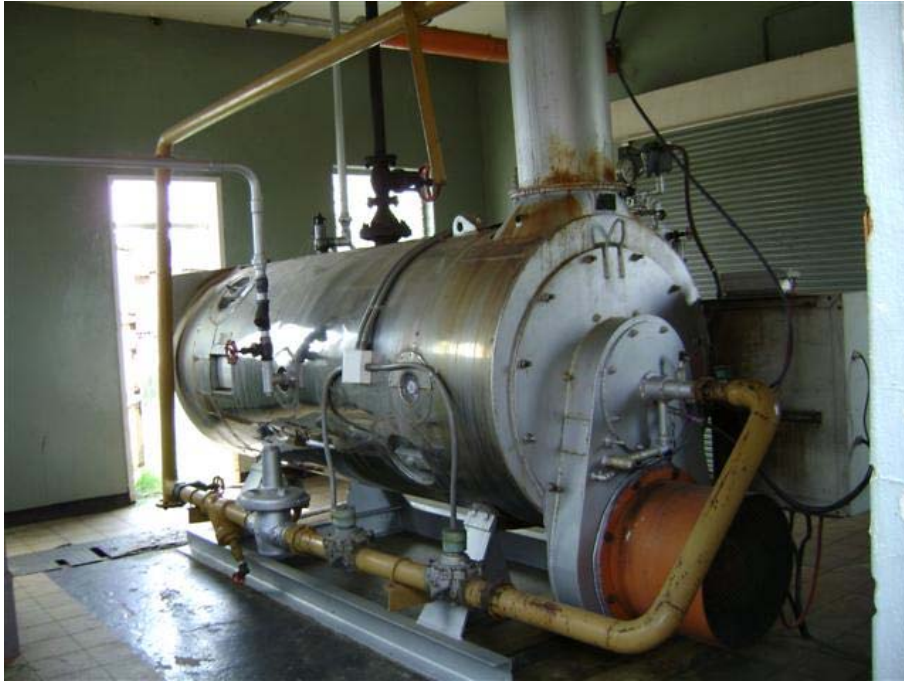
Fig. 10: Boiler out of use due to lack of gas.

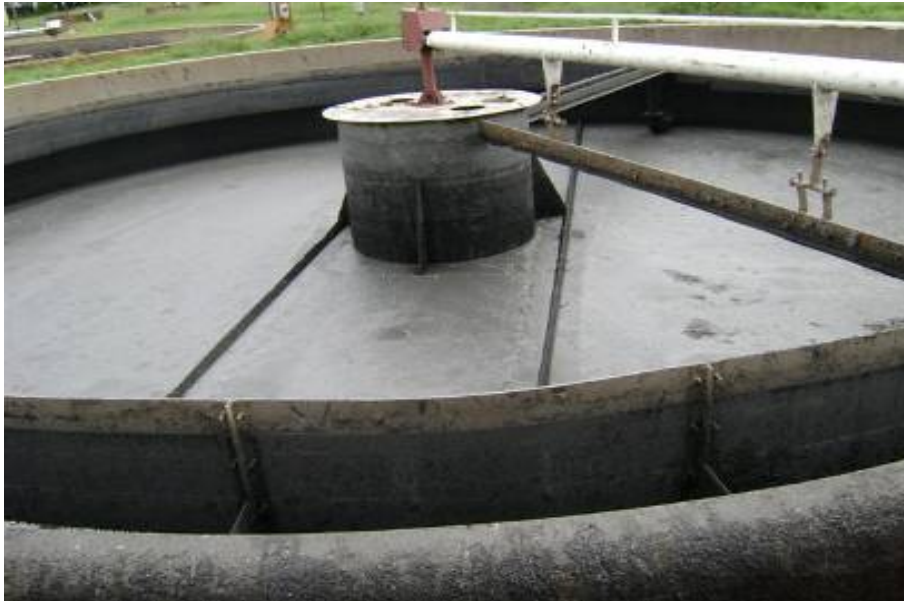
However, in this case, the situation was far worse, the works effectively being out of use. The only exceptions to this were the psts and the digesters, but even these were not being operated very effectively. The psts were being used to re-settle the primary sludge from the North works, and the condition and operation of the digesters was certainly in doubt.

Fig. 13: PSTs being used to re-settle sludge from north works

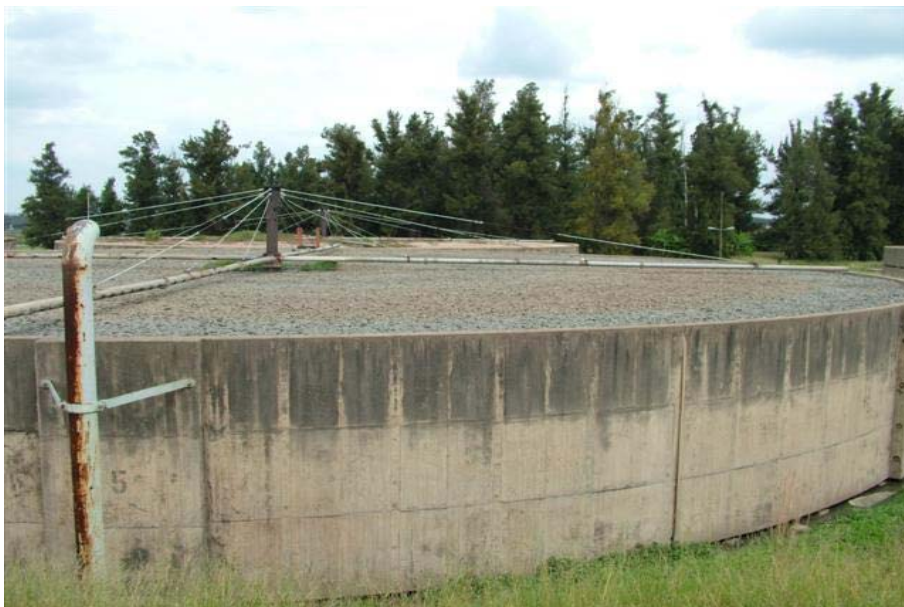
Fig.14: Biofilters totally out of use, mechanical plant missing

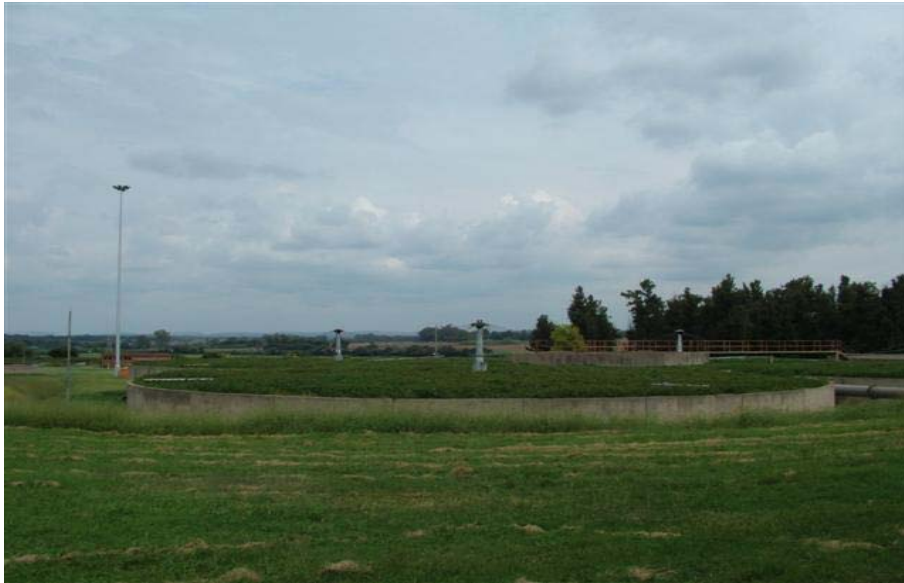
Fig. 15: Biofilters out of action due to mechanical issues, excessive vegetative growth.

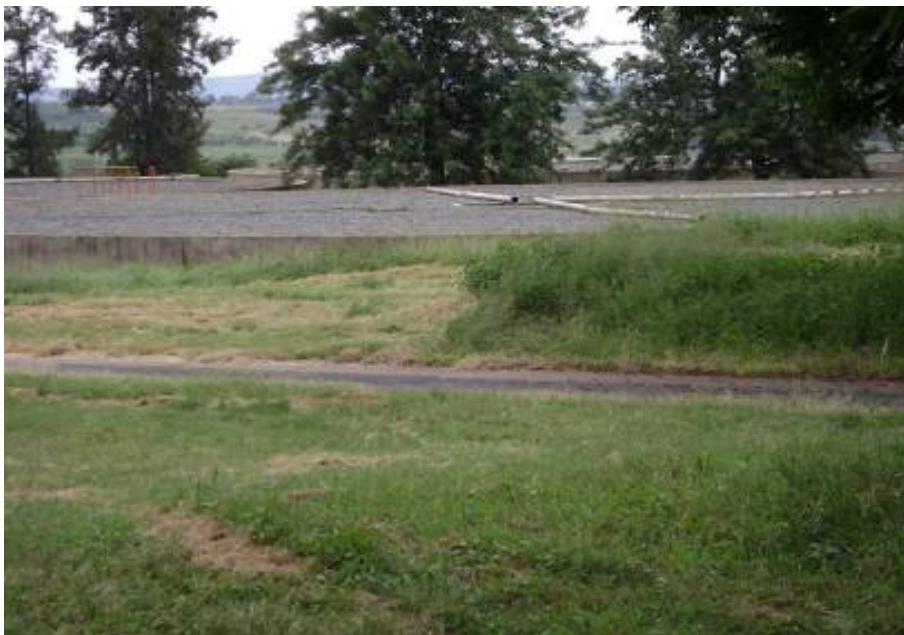
Fig. 15: Biofilters out of action, missing mechanical plant.

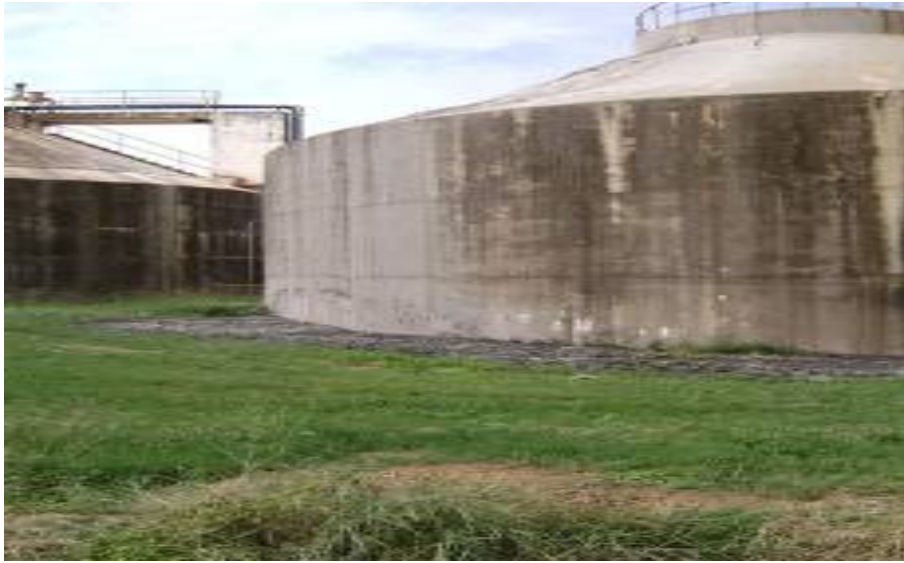
There are seven anaerobic digesters and two gas holders. Observed condition was very similar to that at the east works. In this case the extent of leakage was much worse (fig 16), sludge being observed around the base of structures and down along a nearby access road. Considering the extent of the spills, it would seem that this sludge had been leaking for some time.

Fig.16: West works leaking digesters

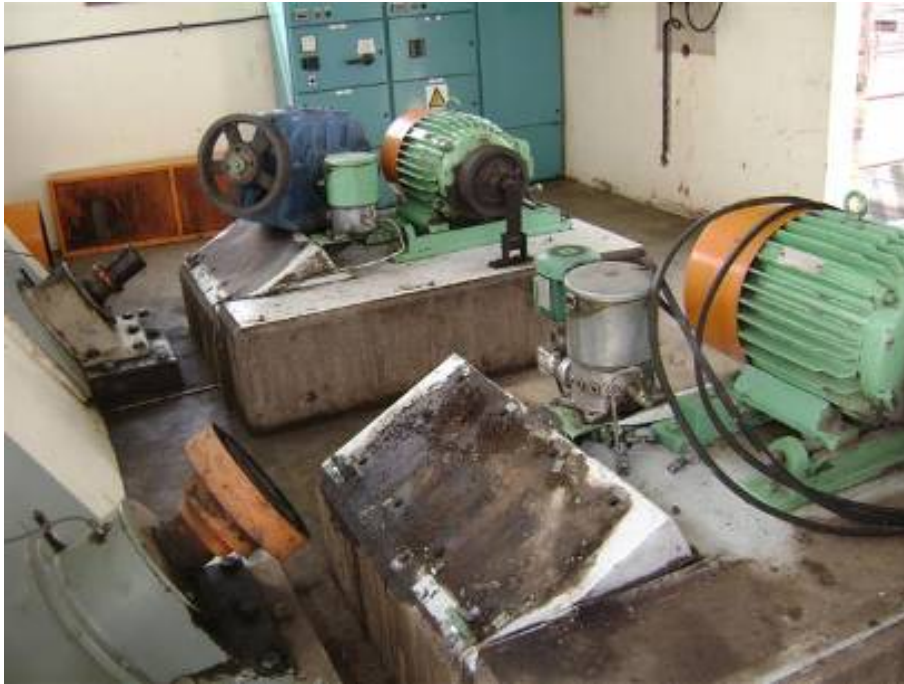
Fig.22: RAS screws taken out of action, pumps partially dismantled.

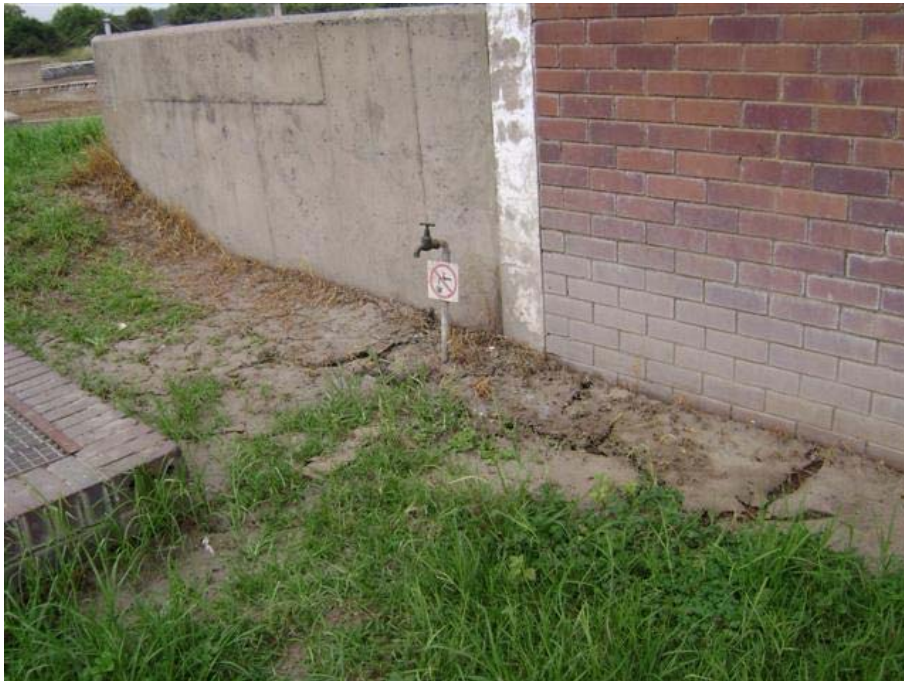
Fig. 24: Overflows from sludge transfer ps, around water (non potable) tap

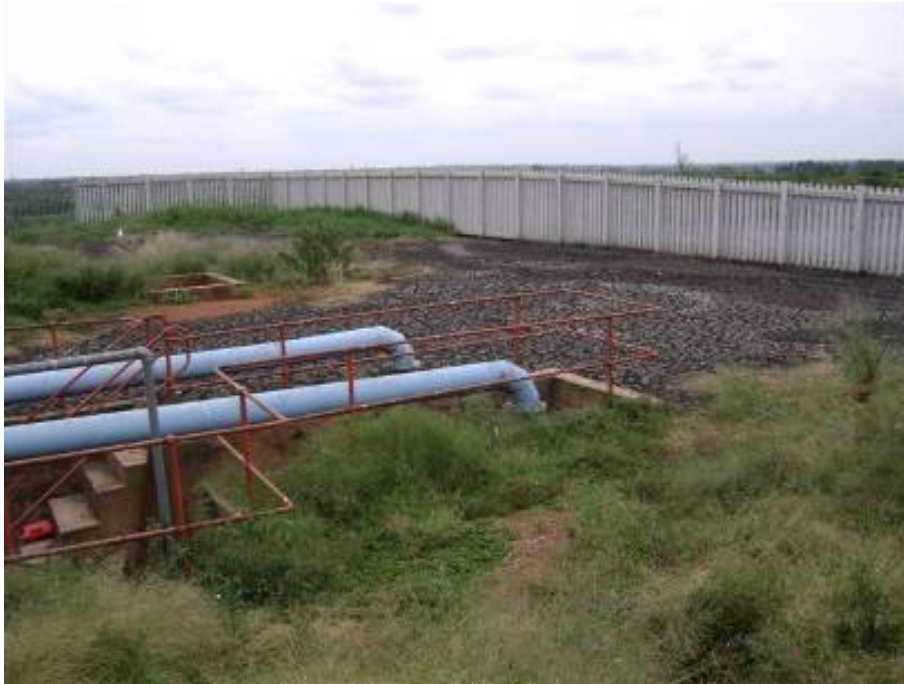
Fig. 30: Sludge overflows from holding dam.

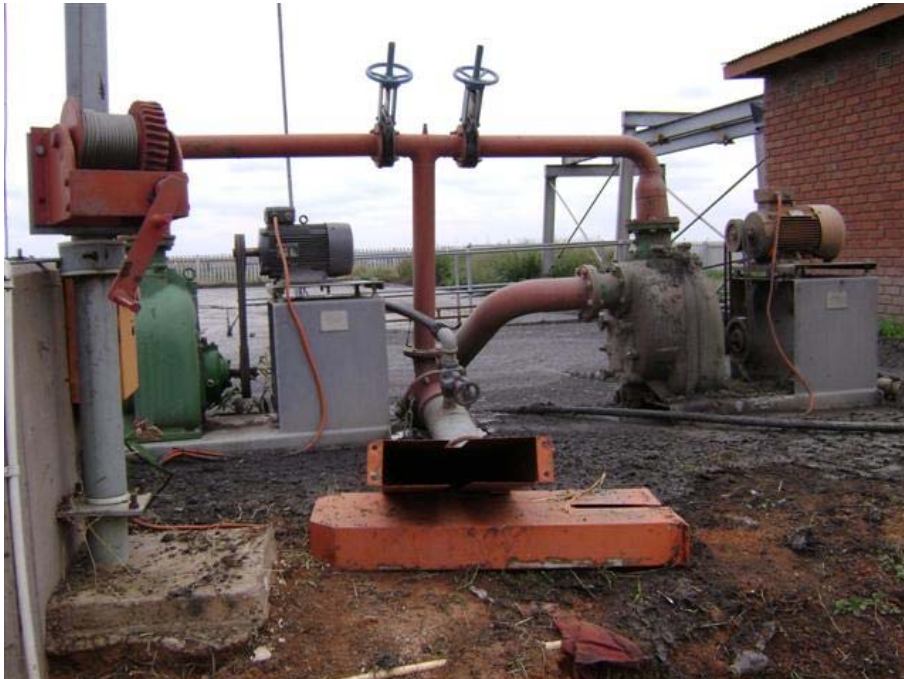
Fig. 31: Lack of maintenance sludge dam plant.

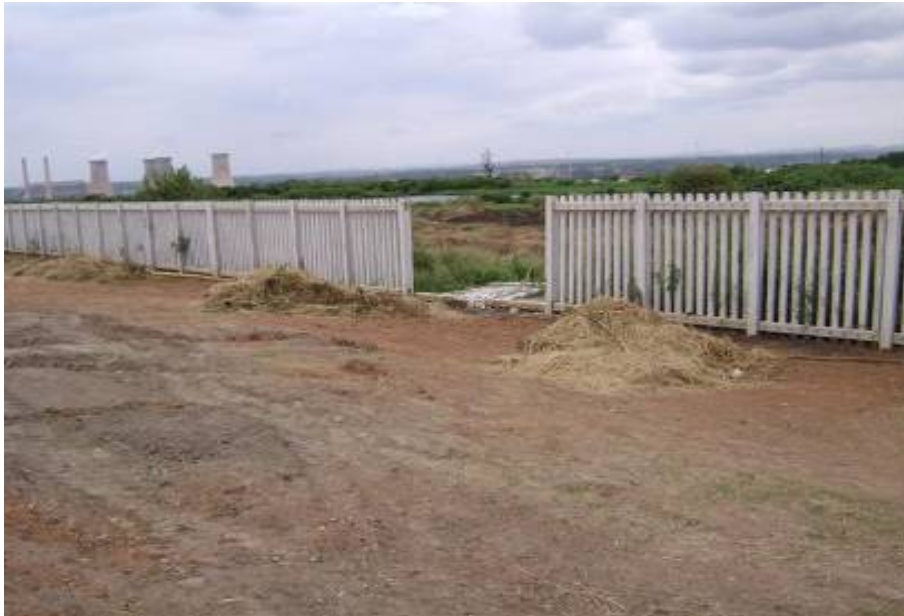
Fig. 32: Security issues with damaged fence left un-repaired at sludge dam.

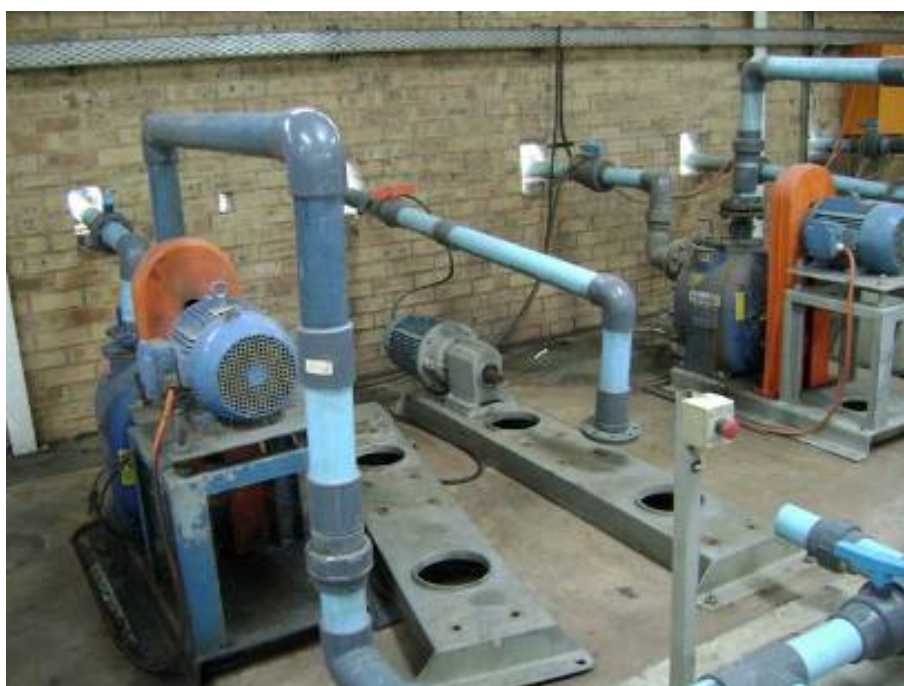
Fig. 35: Redundant polymer dosing equipment.

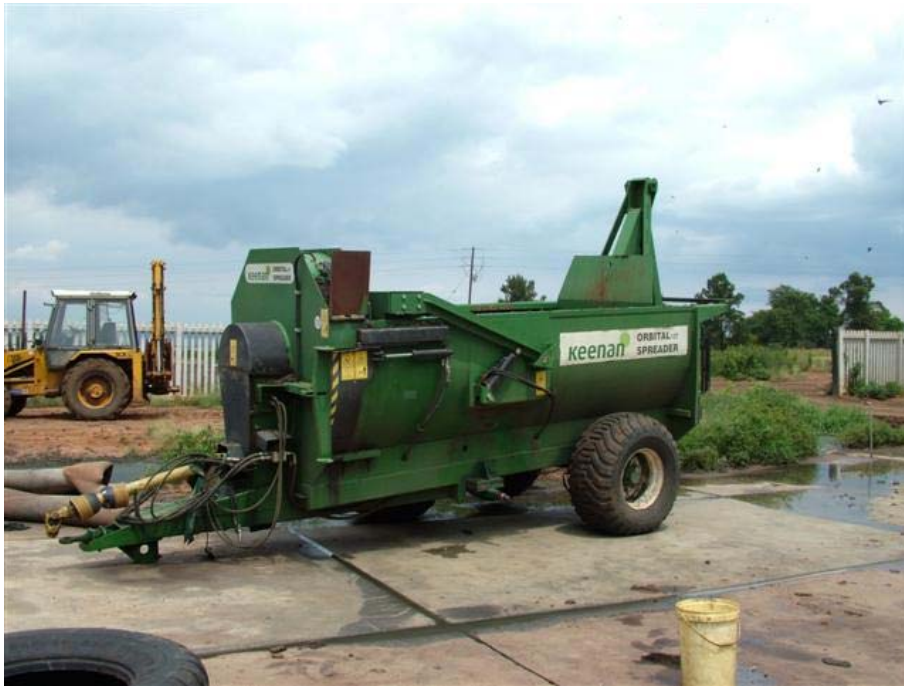
It was reported that the sludge spreaders were only three years old, having been sourced from Ireland. Their condition was seen to be poor, and one was missing a wheel, but was still being used (fig.38). Using this equipment in this condition would have accelerating its eventual breakdown.

Fig. 38: Cake spreader, re-used silage spreader with wheel missing.

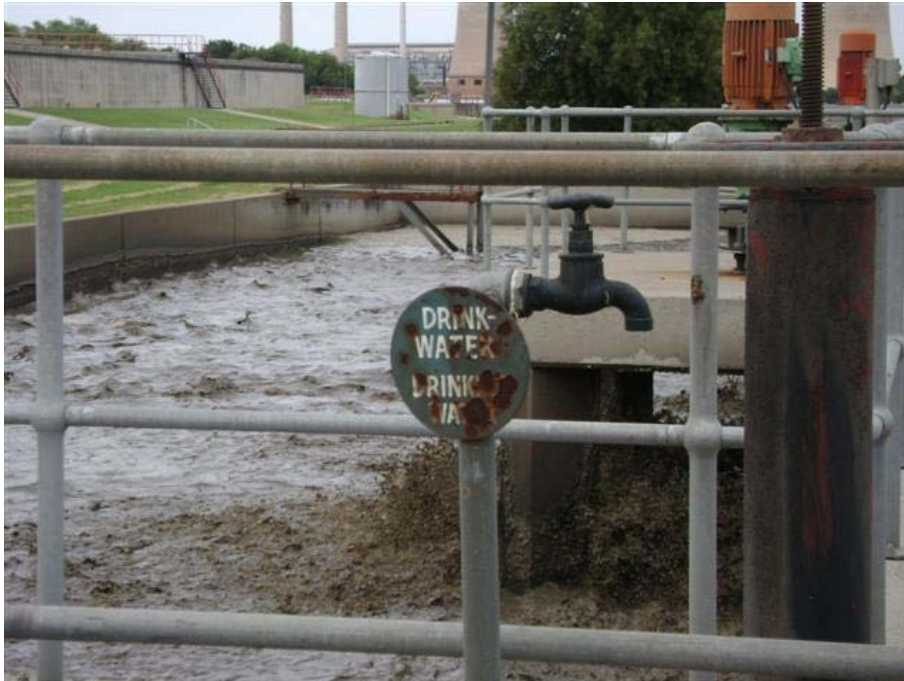
Fig. 40: Potable water tap, labelled but in very vulnerable position.

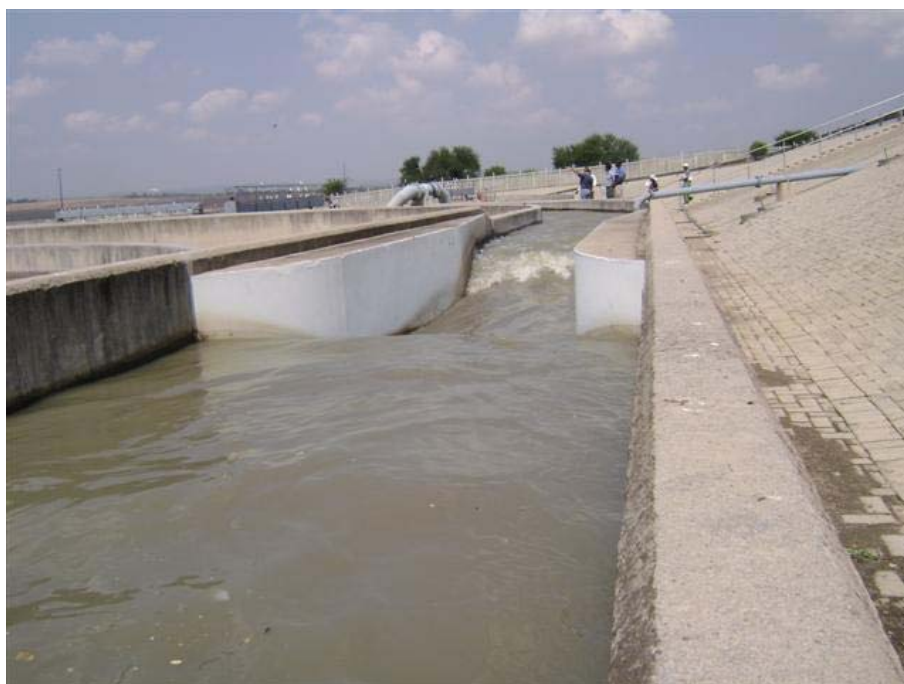
Fig. 44: Inlet channel very close to overflowing

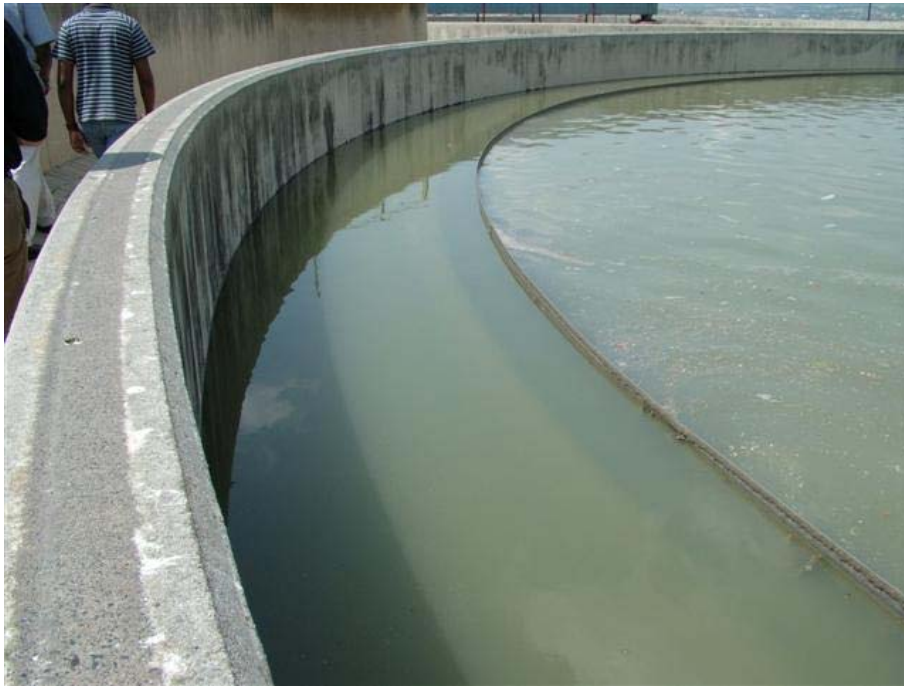
Fig. 45: PST Launder channel flooded due to hydraulic overloading

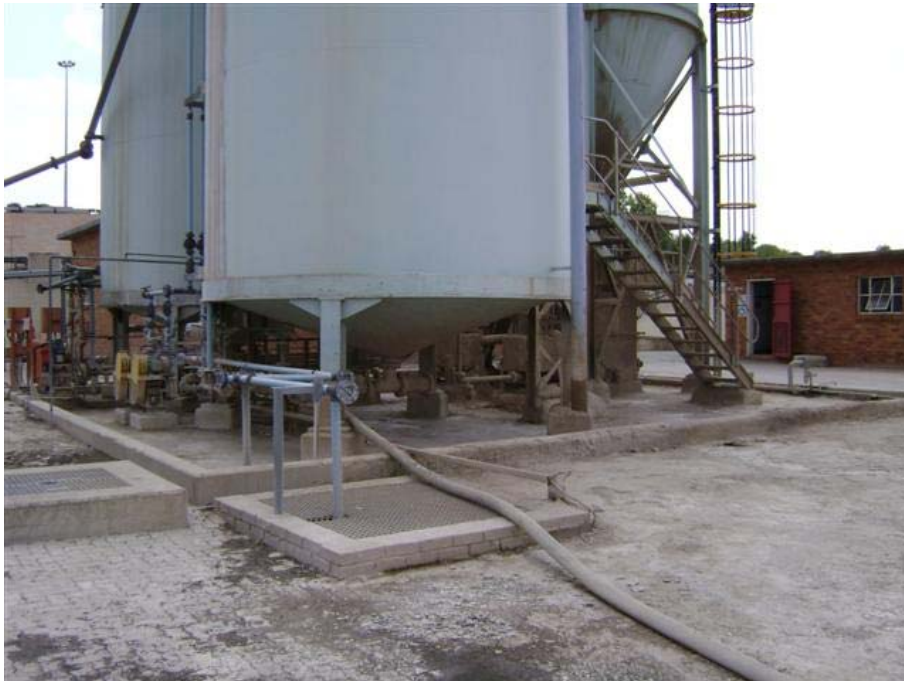
Fig. 51: Spillages around lime dosing plant not cleaned-up.

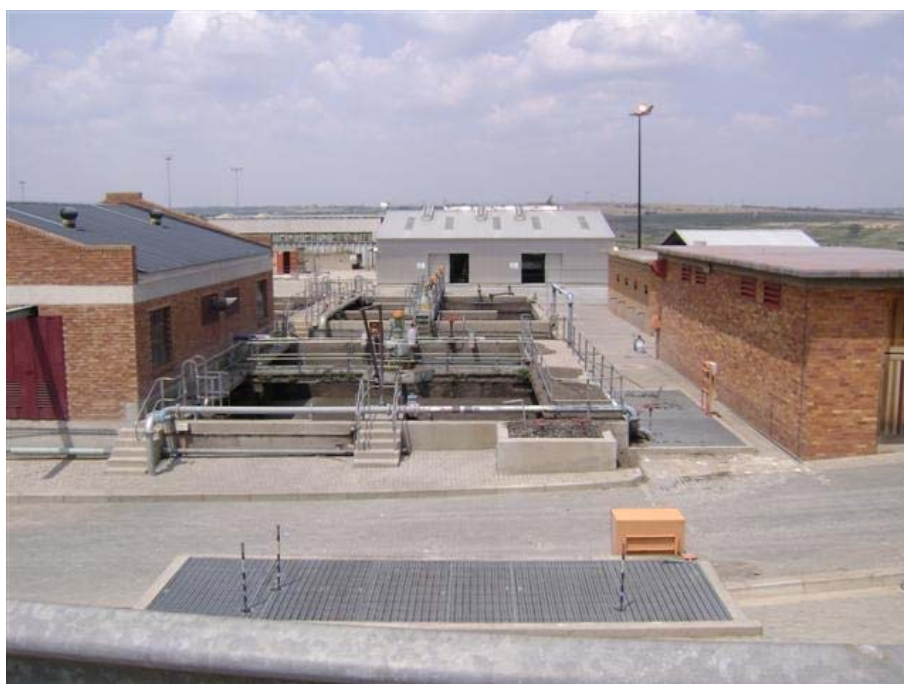
Fig. 53: Sludge spills following power cut, not yet cleared-up.

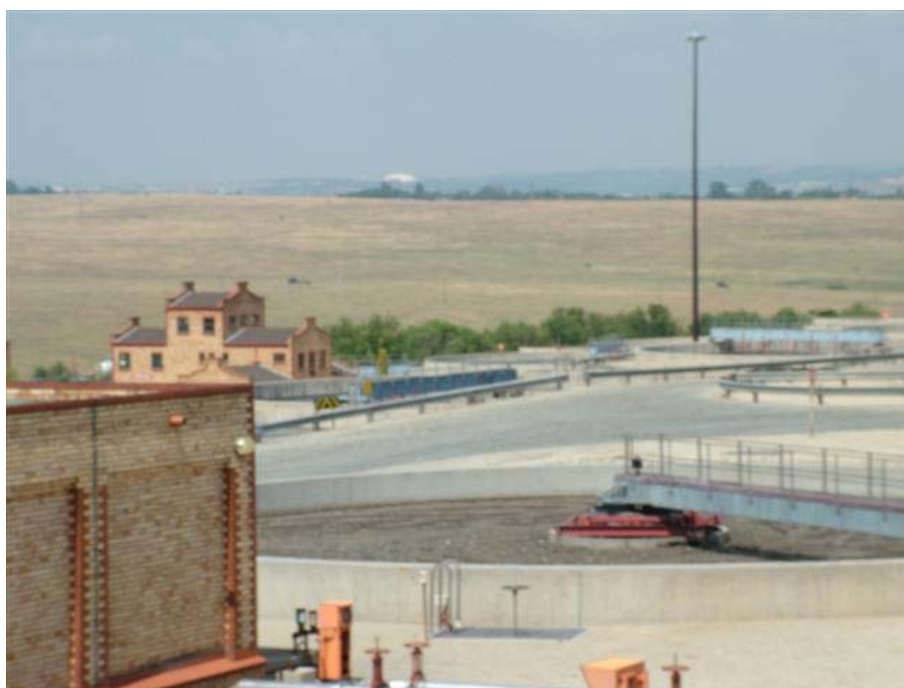
Fig. 54: PST out of action, showing crust formation, awaiting repairs.

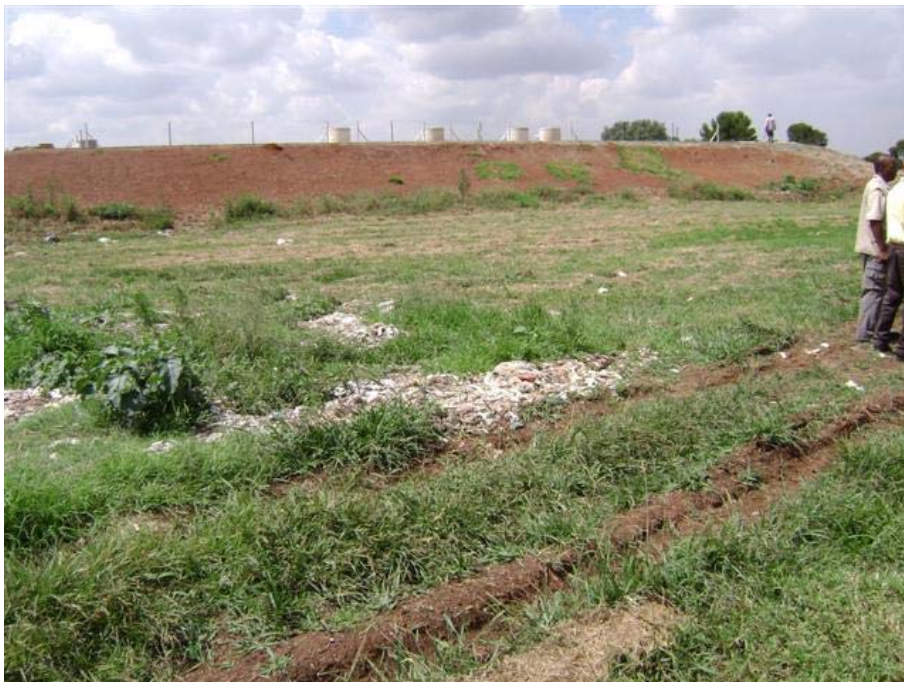
Fig. 60: Rough and uneven ground around inlet works, also shows rag being dumped.

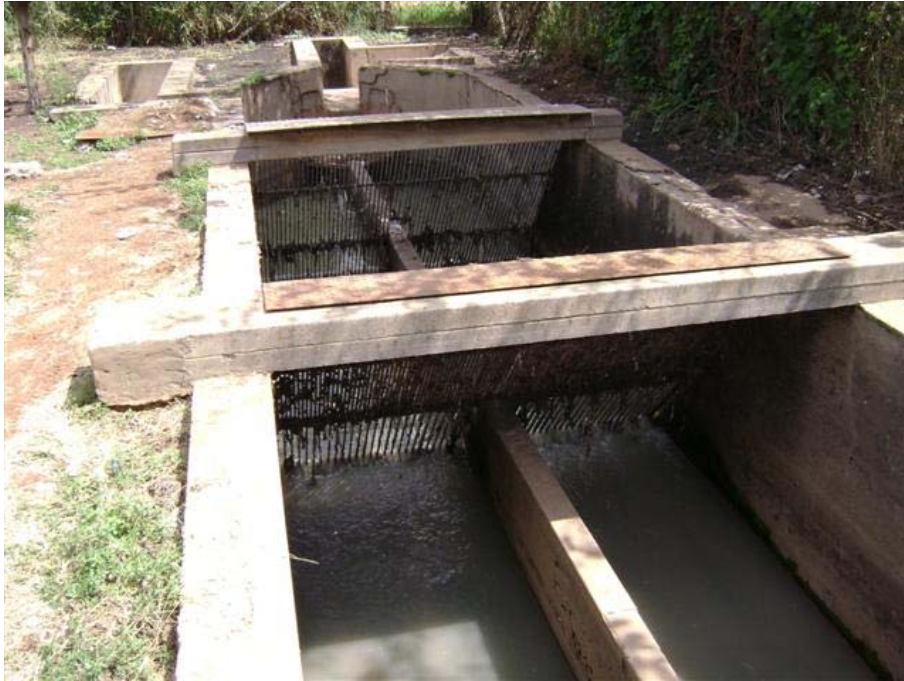
Fig. 61: Inlet screens channels with no fall protection provided.

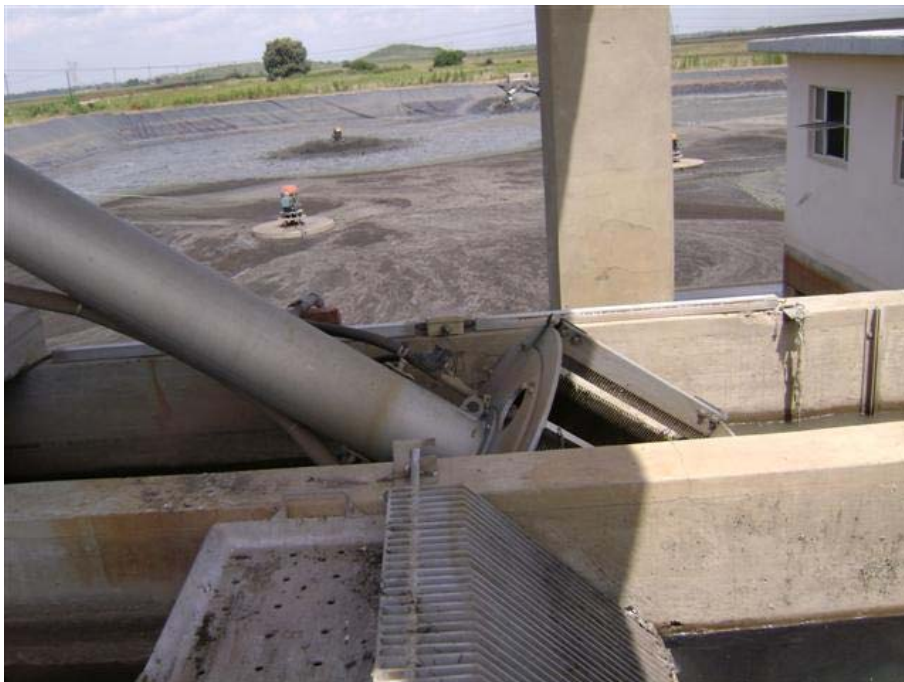
Fig. 62: Mechanical and hand rake screens, also with no fall protection provided.

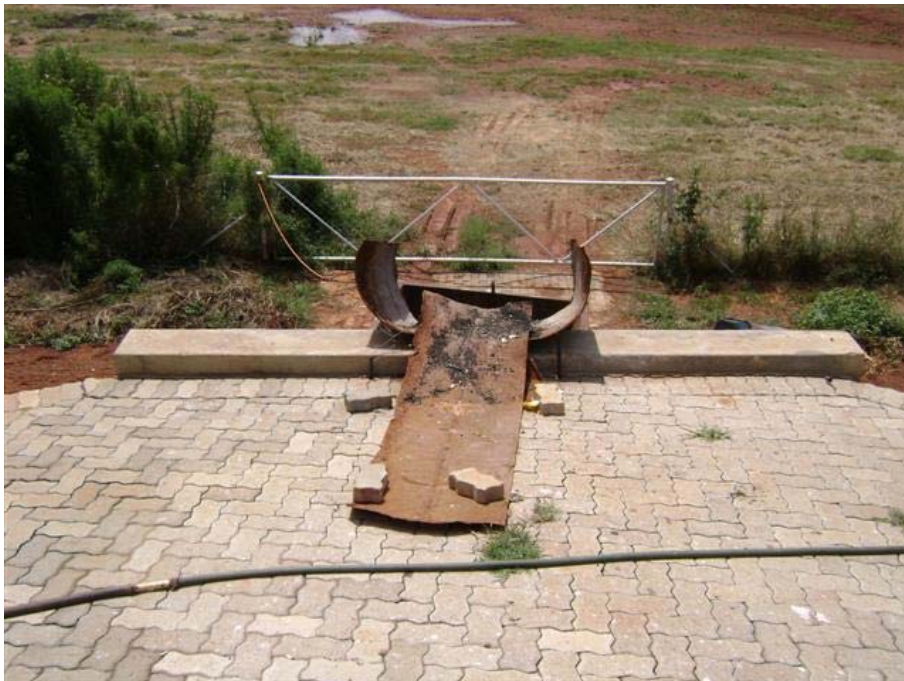
Fig. 64: Unsafe access to skip for rag and grit disposal.

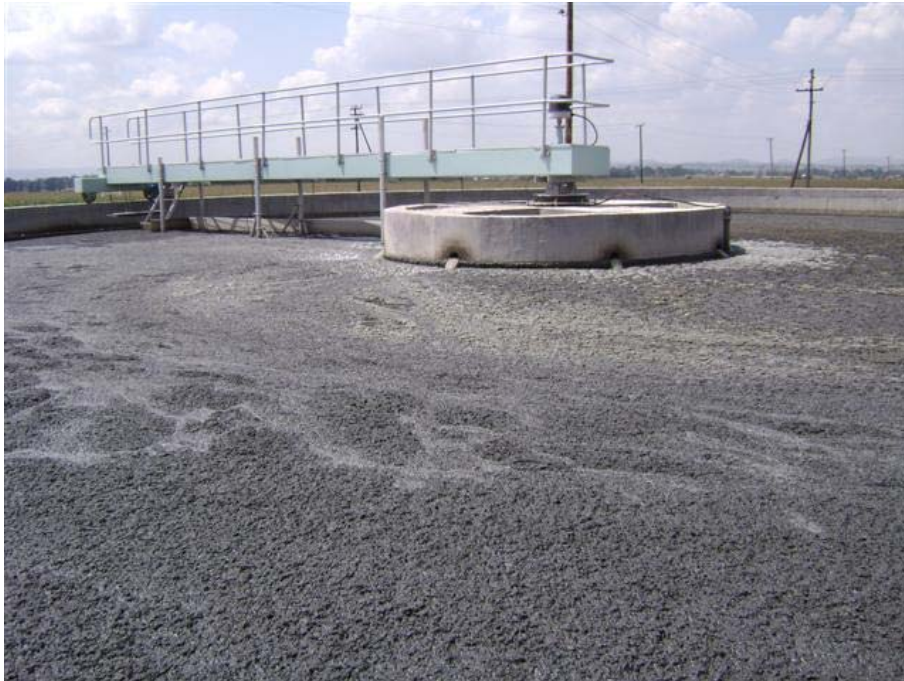
Fig. 65: New PST heavily overloaded, with thick scum of solids on surface.

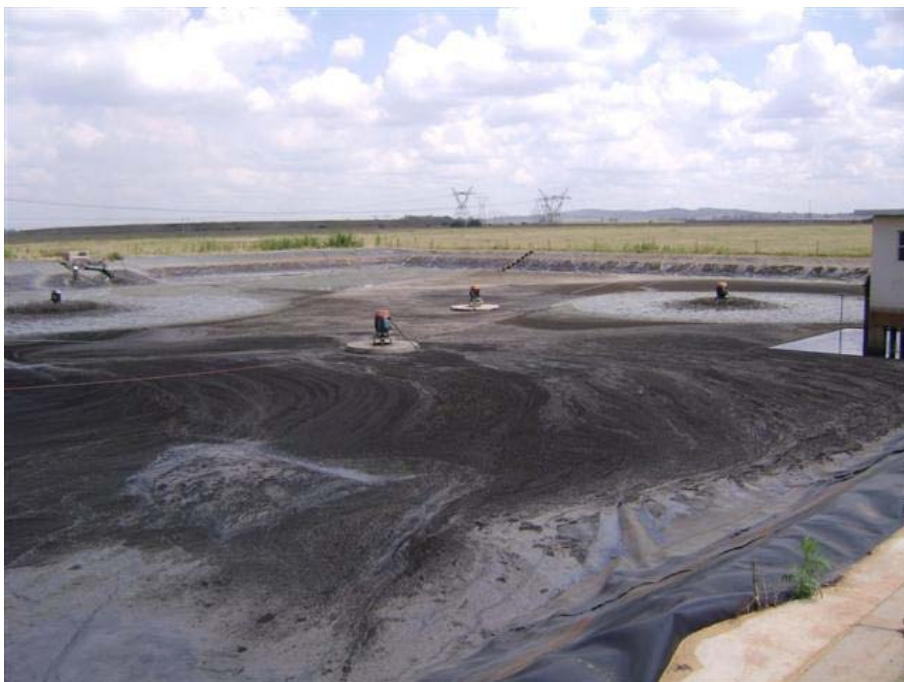
Fig. 66: New aerated balance pond with highly septic contents, showing aerators out of use

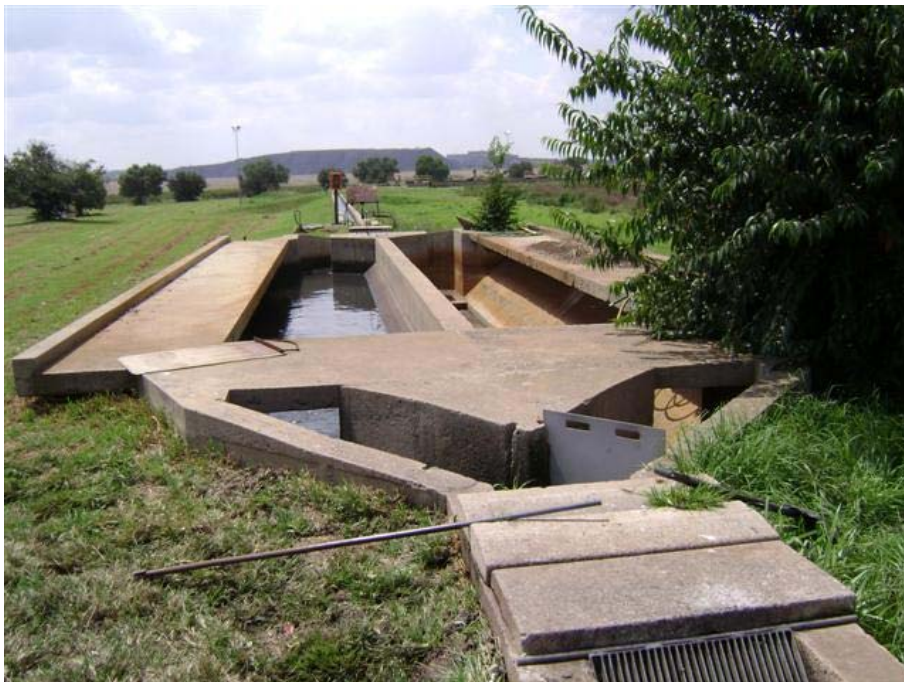
Fig. 68: Disused parallel grit removal channels.

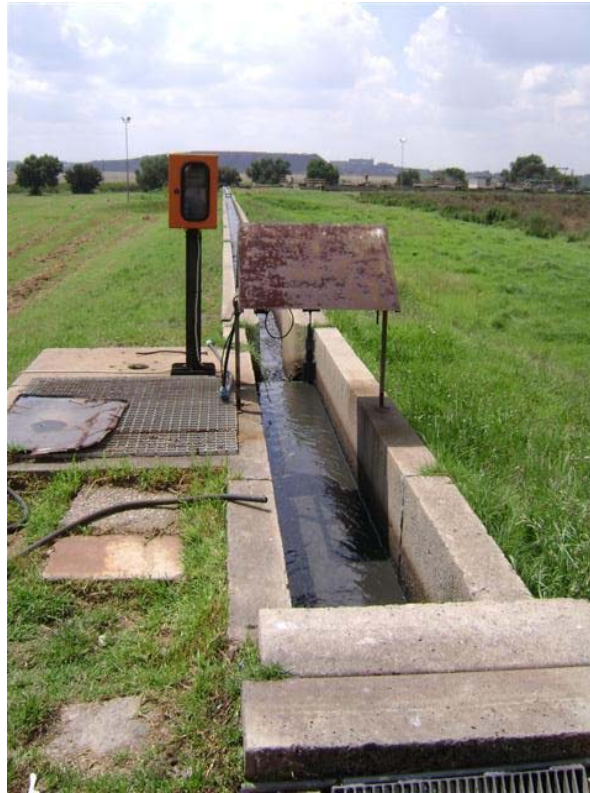
Fig. 69: Flow meter flume and instrument – not set-up or calibrated.

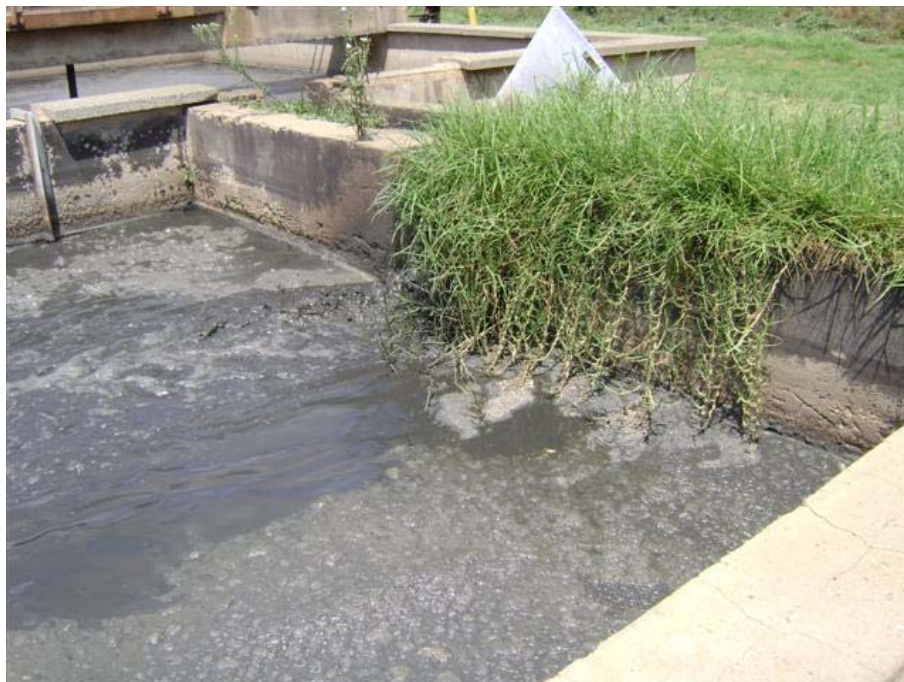
Fig. 70: Poor condition of BNR inlet zones.

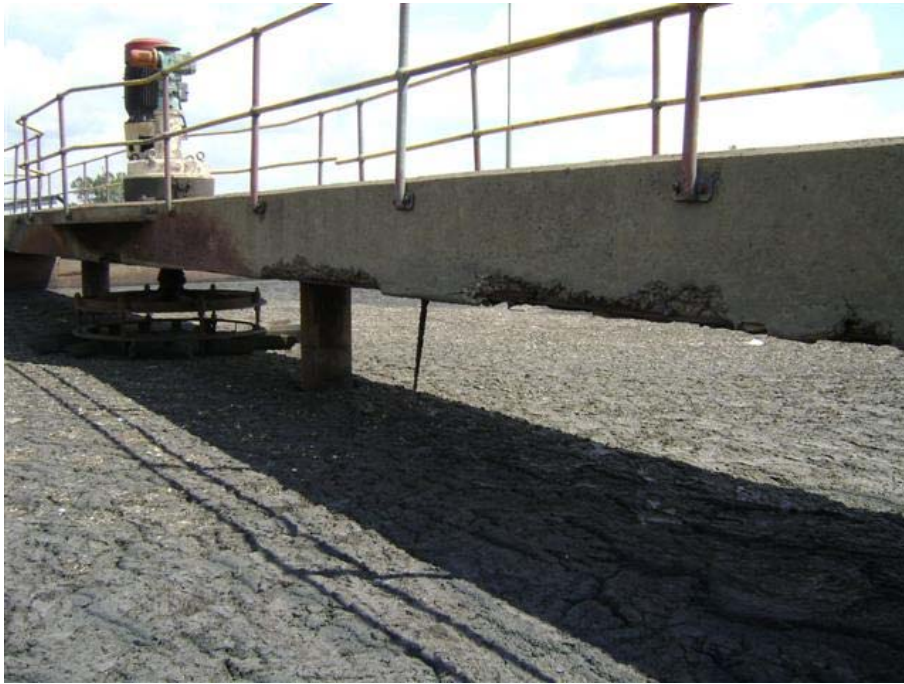
Fig. 71: Poor condition of BNR zone 2 shows septicity attack on bridge.

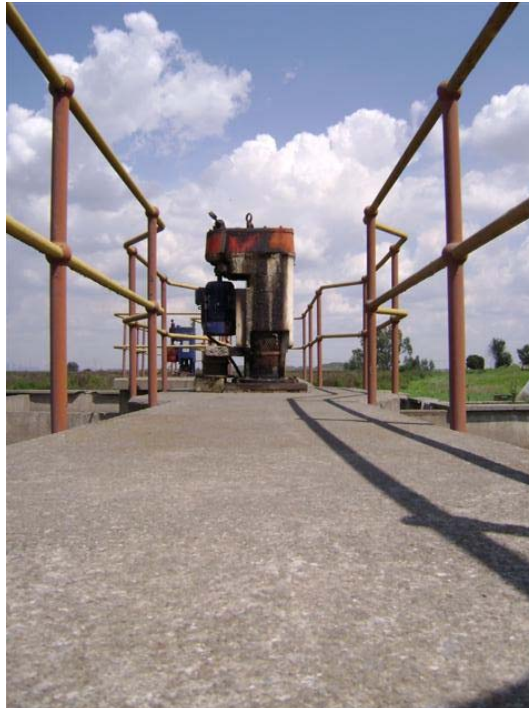
Fig. 72: Mixer leaking oil.
