**Partners for Water and Sanitation (PAWS)
Wastewater Treatment Works Assessments
Gauteng Province, South Africa**

March 2009

Report prepared by Tom Wayling and Rob Smith of Anglian Water (UK), in collaboration with Department of Water and Environmental Affairs (SA) and Partners for Water and Sanitation.

Executive Summary

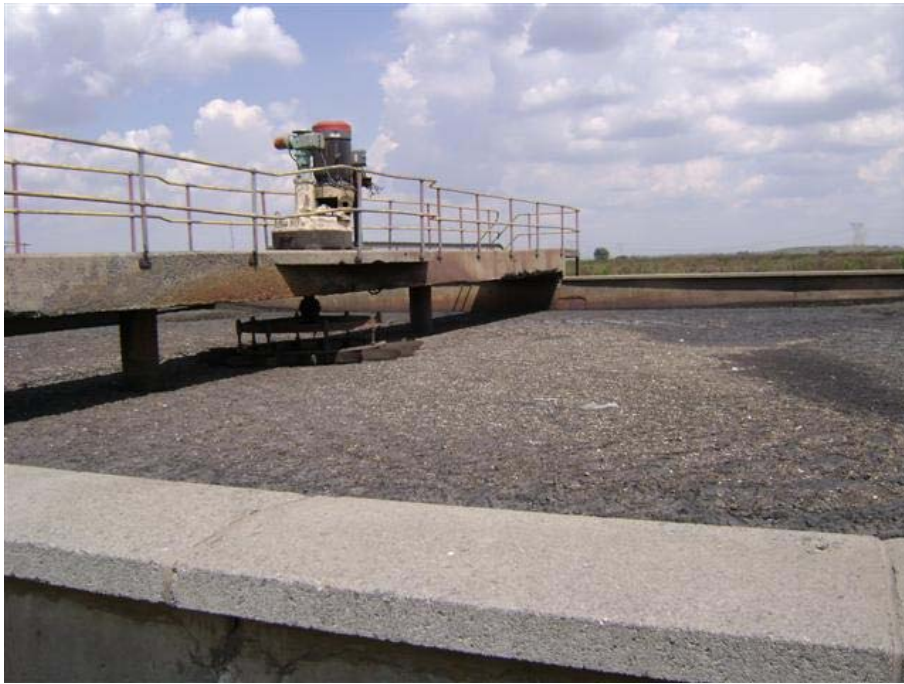
Fig. 73: BNR Zone 2 aerator out of action and heavy crust forming.

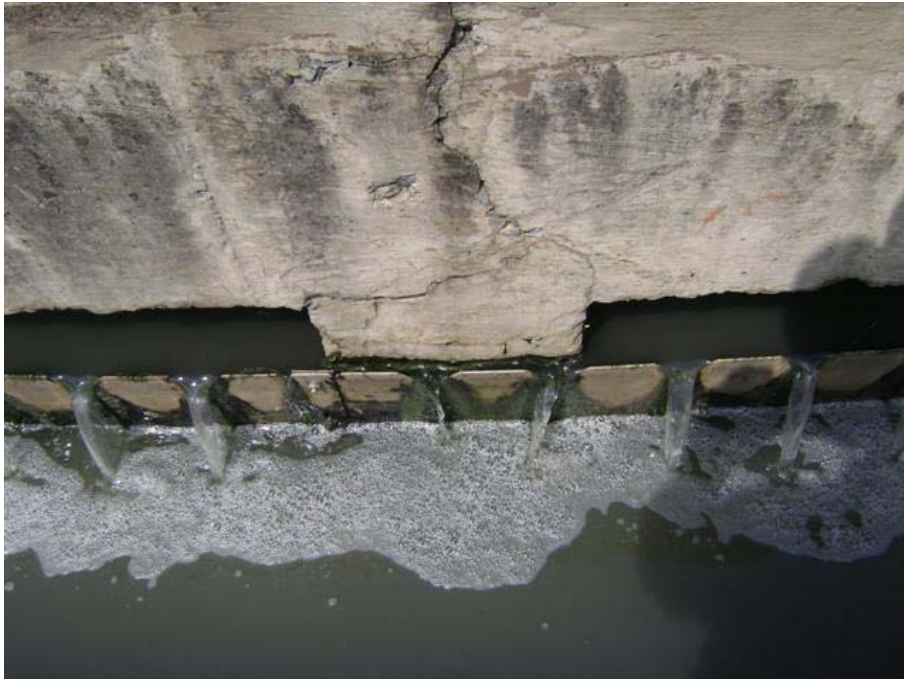
Fig. 74: FST Structure cracked and damaged.

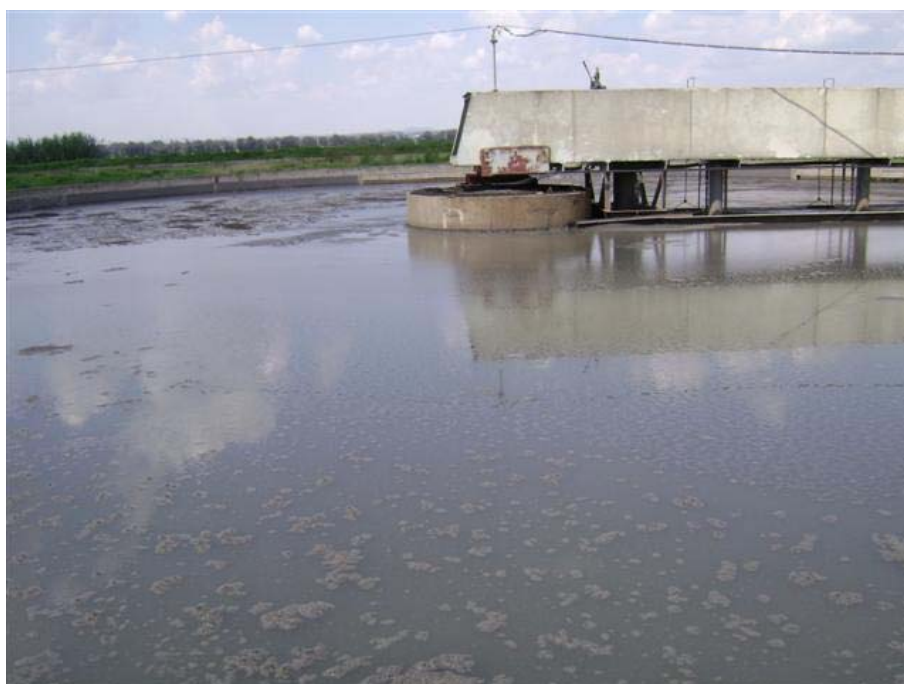
Fig. 75: FST Surface showing grey-black poor quality contents.

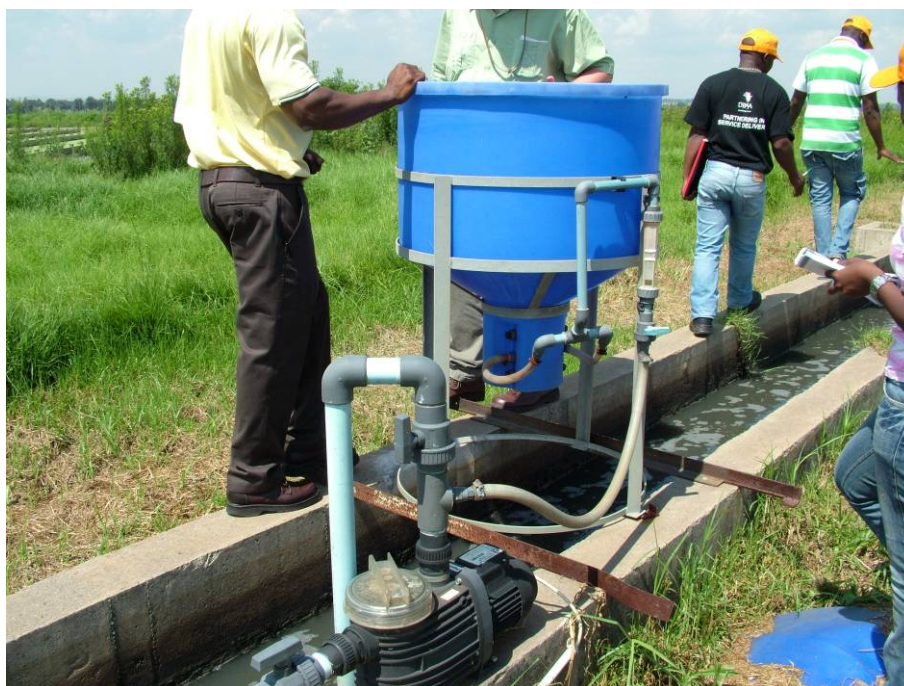
Fig. 76: Temporary Fix Chlorination unit, fixed but not functioning.

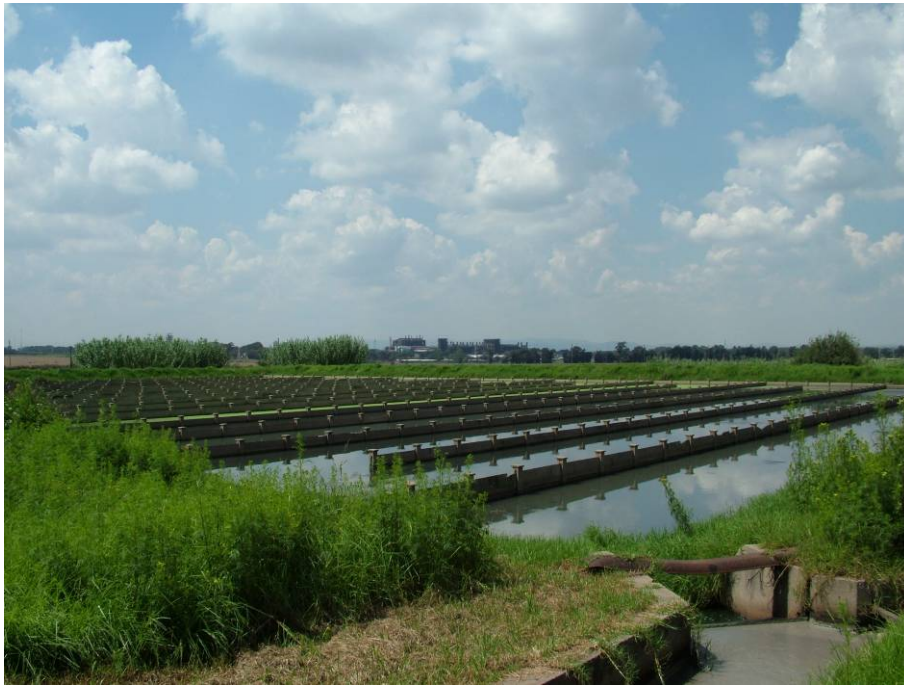
Fig. 77:Lagoon and contact tank, full of sludge and being bypassed.

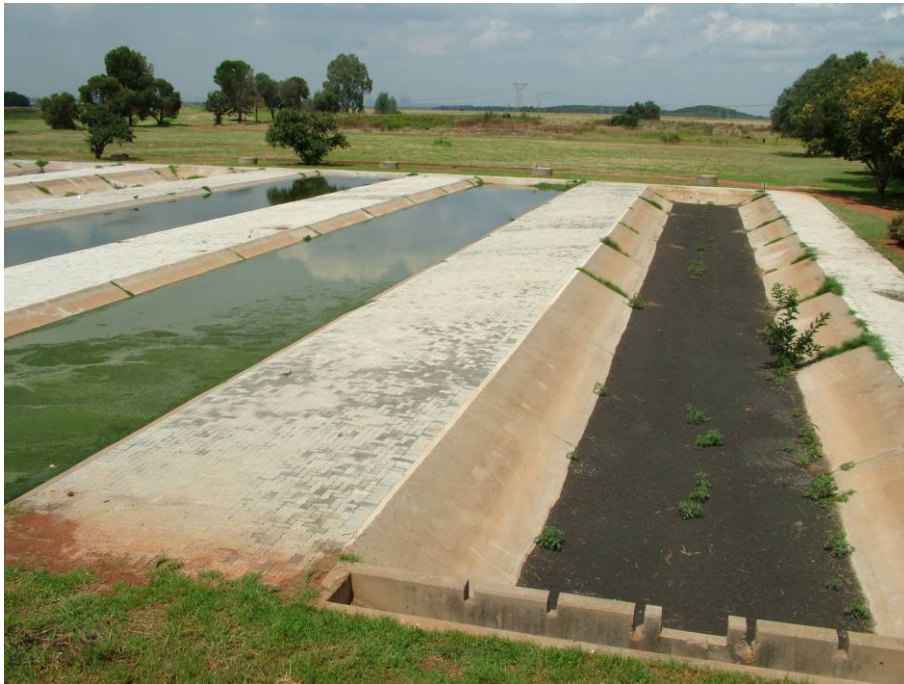
Fig. 79: Sludge drying beds with vegetative growth and algae on surface.

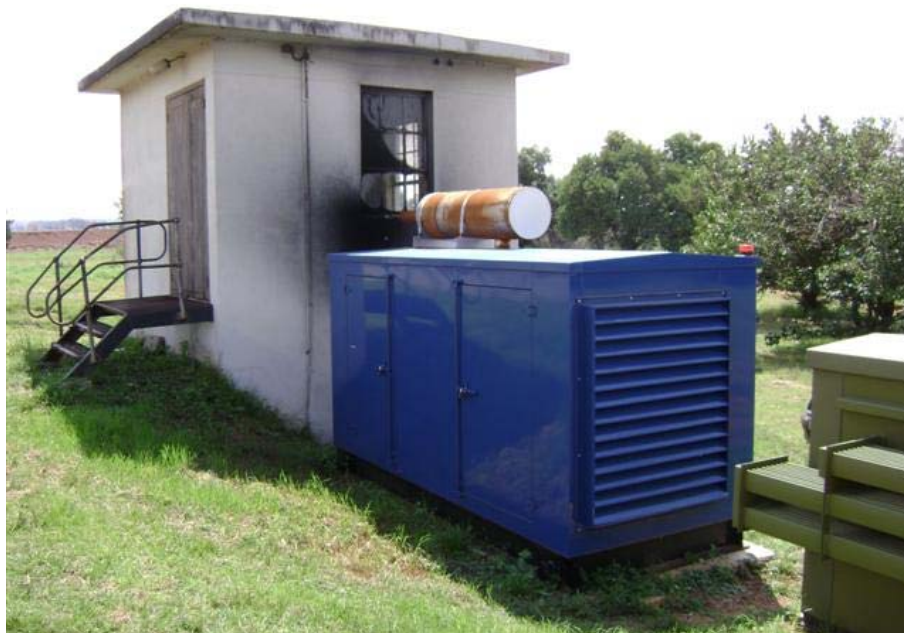
Fig. 82: Standby generator at BNR unit, showing ill thought out placement.

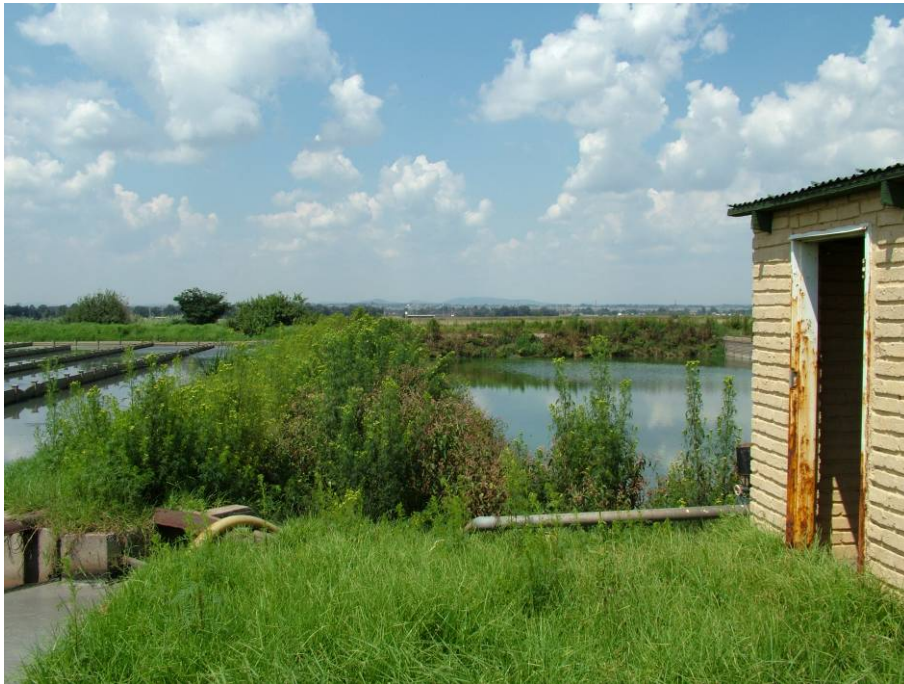
Fig. 83: Dosing building in poor condition and unused.

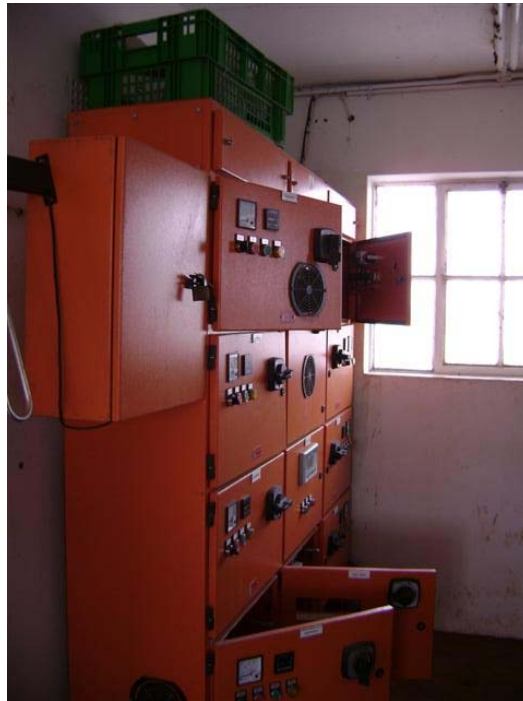
Fig. 85: Transfer ps with panel doors open, posing high risk of electric shock.

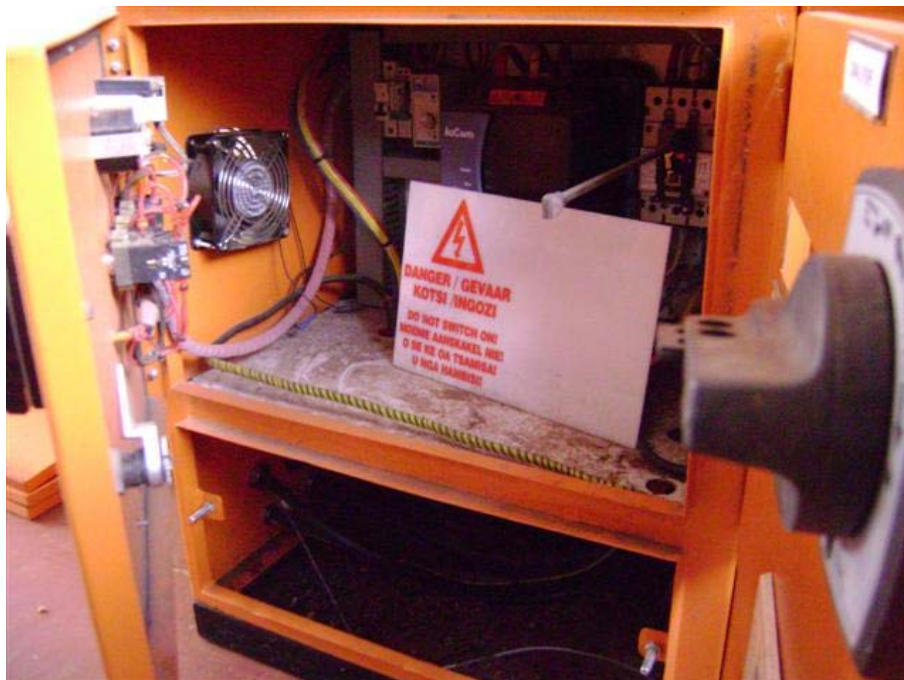
Fig. 86: Inadequate warning or protection against electric shock.

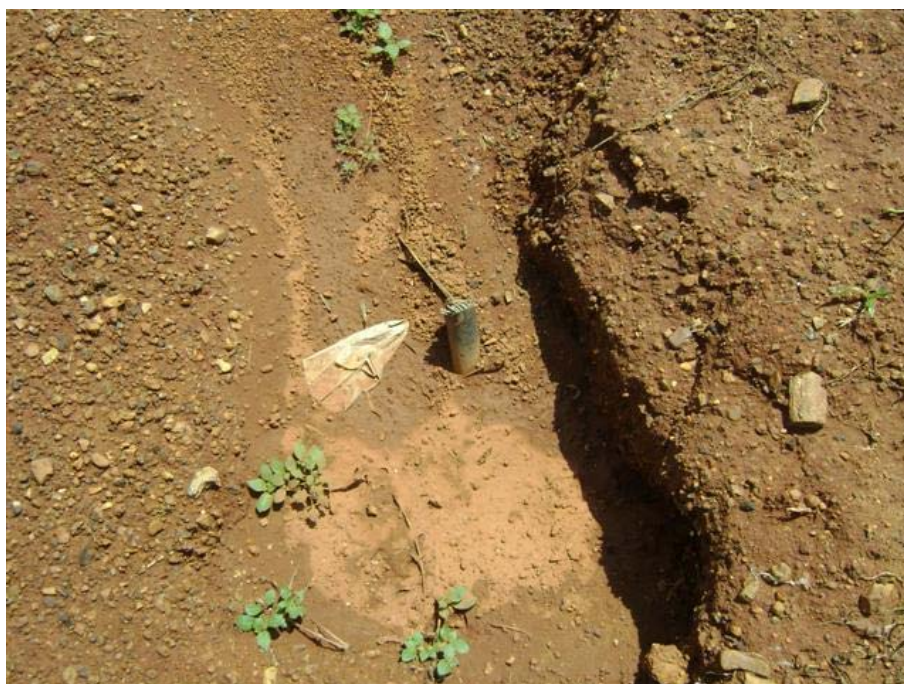
Fig. 87: Electric cable cut off and not protected in any way.
