36th WEDC International Conference, Nakuru, Kenya, 2013

**Piloting ecological sanitation (EcoSan) in the emergency
context of Port-au-Prince, Haiti, after the 2010 earthquake**

BRIEFING PAPER 1800

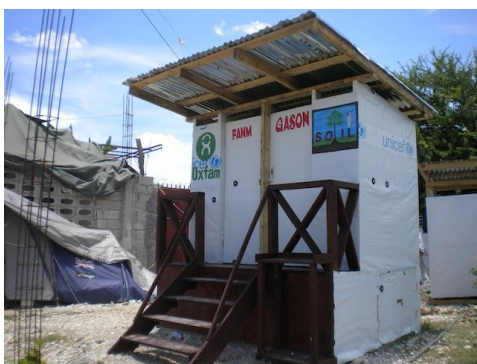
Photograph 1. SOIL UD Toilet, Jan 2011.

The first toilets built in March 2010 were constructed in a camp of approximately 2500 people. The first toilet was identical to the double vault systems in northern Haiti except that a 55-gallon drum was placed beneath the toilet seat in the chambers to allow collection and offsite treatment. The second toilet was similar dimensions but was constructed with wood and plastic sheeting (Photograph 1) in place of cement blocks. Toilet seats were brought in from South Africa. The one-month testing period revealed a number of issues, which were addressed in subsequent models. In response to feedback from the camp residents and SOIL staff all toilets constructed after March 2010 had the following modifications:

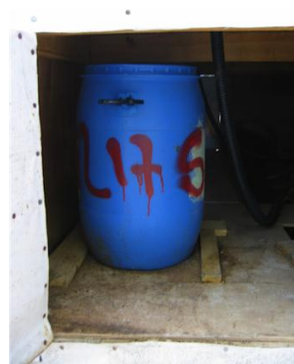
Photograph 2. 15-gallon drum with wooden guides.

- 15-gallon drums in place of 55-gallon drums, to facilitate transport and emptying (Photograph 2).
- Locally produced fibreglass UDT seats (Photograph 3)
- Guides in the chamber below the toilet seat to ensure that the drums are placed directly beneath the seat (Photograph 2).
- Non-separating drum-based toilets for children who had difficulty adapting the UDT seat (Photograph 4).

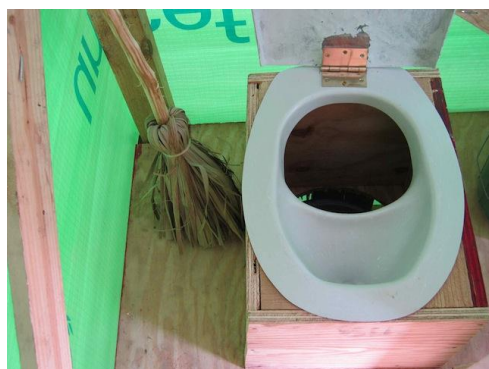
Photograph 3. Fibreglass UD seat made in Port au Prince

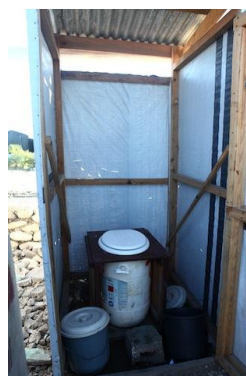
Photograph 4. Non-separating children's compost toilet
