38th WEDC International Conference, Loughborough University, UK, 2015

A hidden crisis: strengthening the evidence base on the current failures of rural groundwater supplies

BRIEFING PAPER 2181

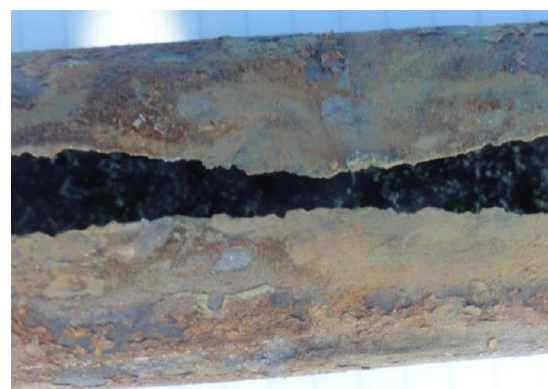
Corrosion of GI handpump components is clearly shown to be a significant causal factor to many of water point failures in the study, with corrosion having led to, or contributed, to mechanical and/or water quality failure symptoms in almost all of the water points examined. Photograph 2 shows an example of corrosion having led to complete perforation of a 0.5 m long section of hand-pump rising main pipe.

Photograph 2. Perforation of a rising main from corrosion

In the absence of a robust evidence base the MWE have been unable to assess the main causes of water point failure in the Amuria and Katawki districts to inform better practice. The results of the pilot study begin to provide this robust evidence base, and the MWE are now working to enforce tighter regulation of hand-pump material quality with the Uganda Bureau of Standards. This should move to find more appropriate hand-pump materials in the region, in which GI material have been advised against for reasons of corrosion in Eastern Uganda since the 1990s.
