Project No: NIG - 72

**Progress Review of Kabong Water Supply
Project
Jos, Plateau State
Nigeria**

TECHNICAL REPORT

March 2007

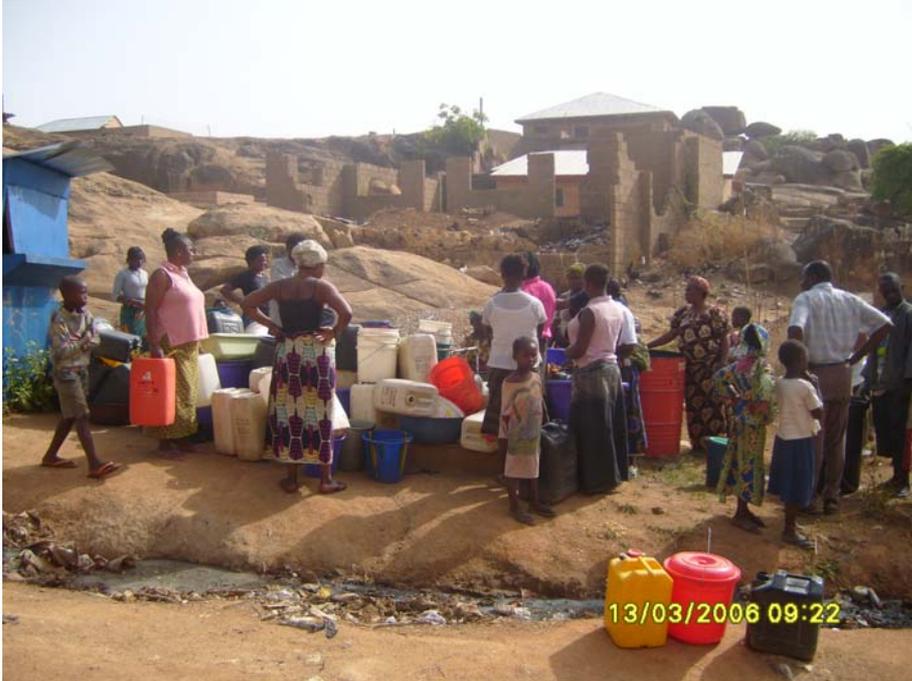
4.2.1 Community standpipe, Kabong

Water reached the first standpipe in Rukuba Road, with local residents commenting that this was only the second time in 4 years that water had been available. The previous occasion being some 4 weeks ago when WaterAid were able to facilitate a similar test.

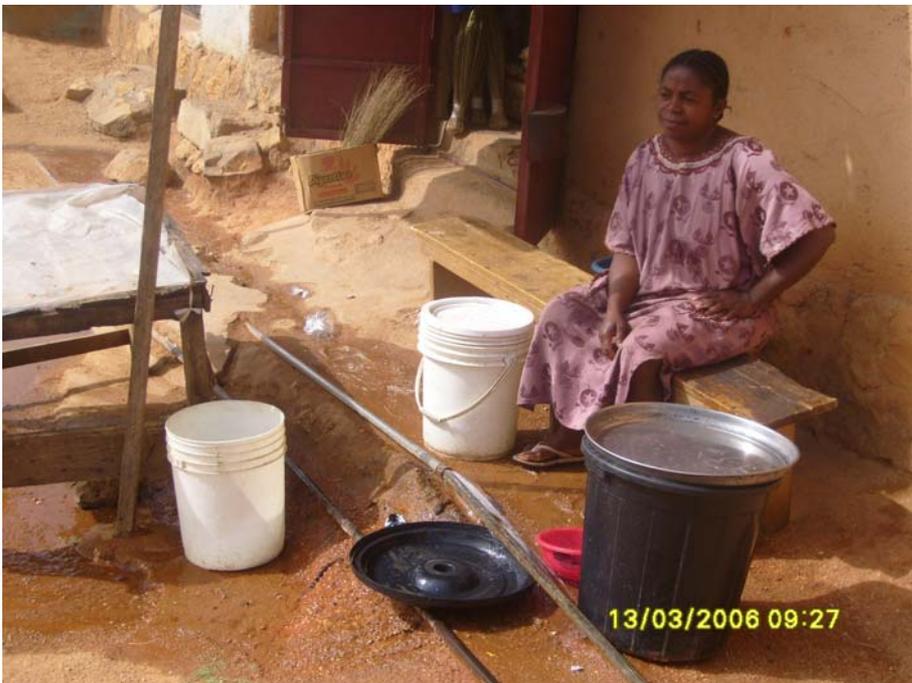
4.2.2 Leak on line supplying standpipe, Kabong

It was noted during the pressure survey that numerous leaks existed on the distribution system, including visible pipework spray at one location, and water showing in road at many locations. These leaks do not normally show as water does reach that far down the distribution system.

Based on the assumption that observable leakage is representative of the buried network, the total amount of water being lost was estimated to be around 30-50% of that available – Between 732 m³/hr and 1220 m³/hr

The water distribution system in Jos suffers from very high leakage, which is not normally apparent due to the lack of a consistent water supply. This leakage should be addressed as part of any strategic refurbishment plan.

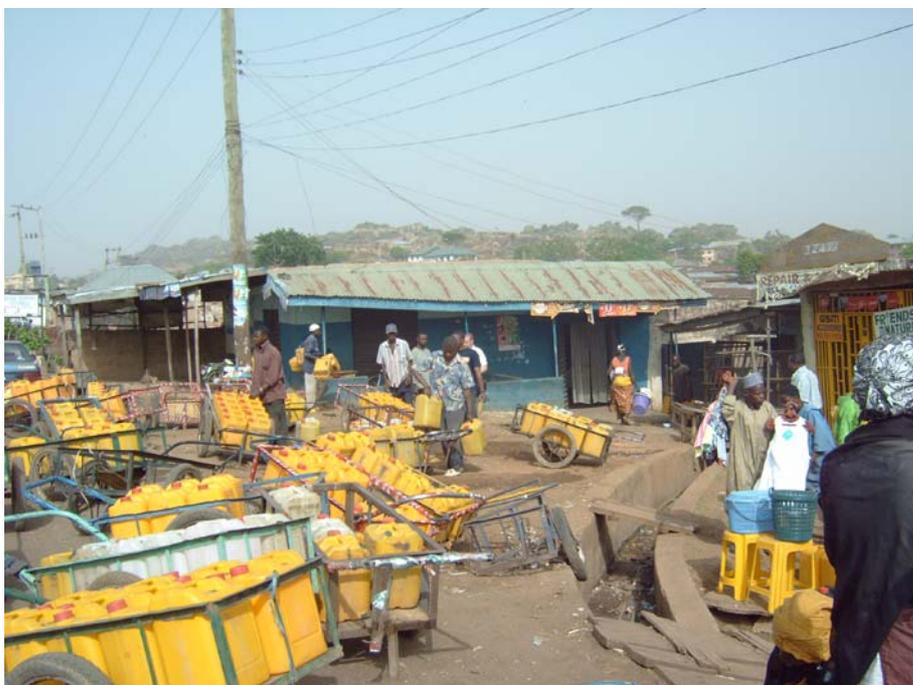
4.2.4 Water seller, Gada Biu bridge, Kabong

The water seller at Gada Biu bridge claimed that water is available every day at his premises although the pressure does vary considerably. He also claimed that a cross connection between the 150 mm Laminga system and the 300 mm Tudun Wada system was present, although was not able to confirm the location of such a connection.

On the first day of our visit the flow at the water seller was estimated to be less than 10 l/min with a minimal pressure of < 1bar.

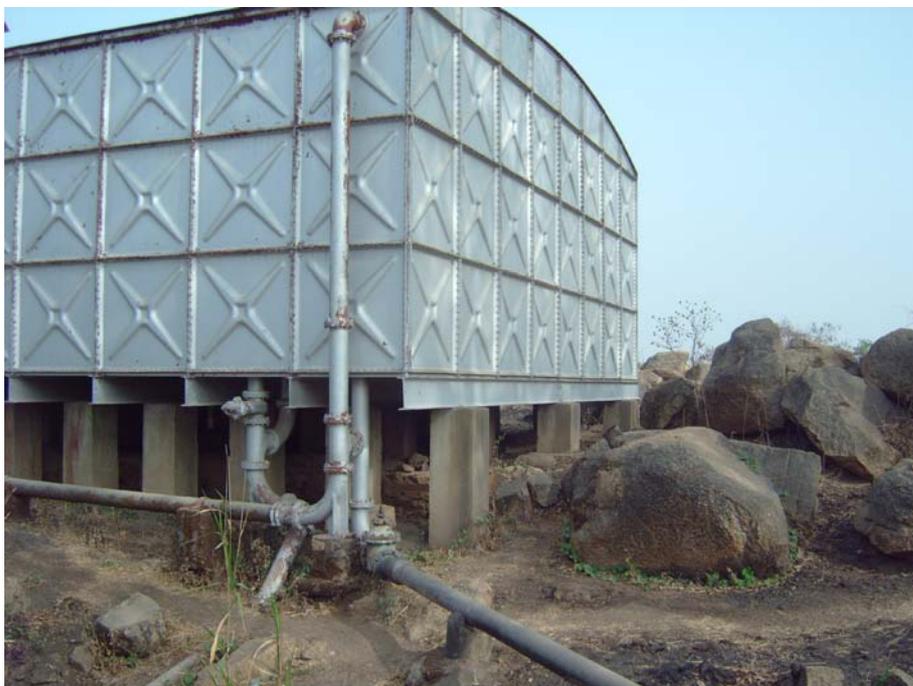
4.2.5 Ministry of Works Reservoir 1

The two tanks on this site are designated MoW 1 size: 24 x 13.2 x 4.8 m (1521 m³) and MoW 2 size: 9.6 x 13.2 x 3.6 m (456 m³).

These tanks effectively break the head of water at this point.

There is a 300 mm AC inlet rising main from Laminga to both tanks with multiple 150 mm outlets from both tanks.

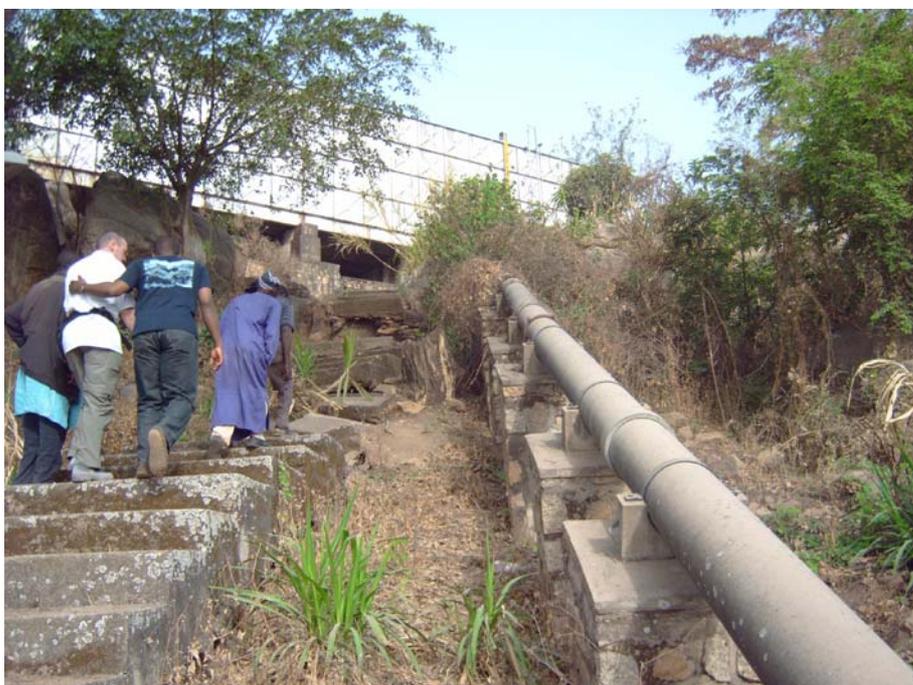
4.2.6 Outlet main from Ministry of Works Reservoir 1

We were informed by PSWB that MoW 1 supplies the Kabong area through a 150 mm diameter main.

Simple modelling shows that flows in excess of 15 l/sec down the 3.8 Km of main to Kabong will not reach the end of the main due to frictional headloss.

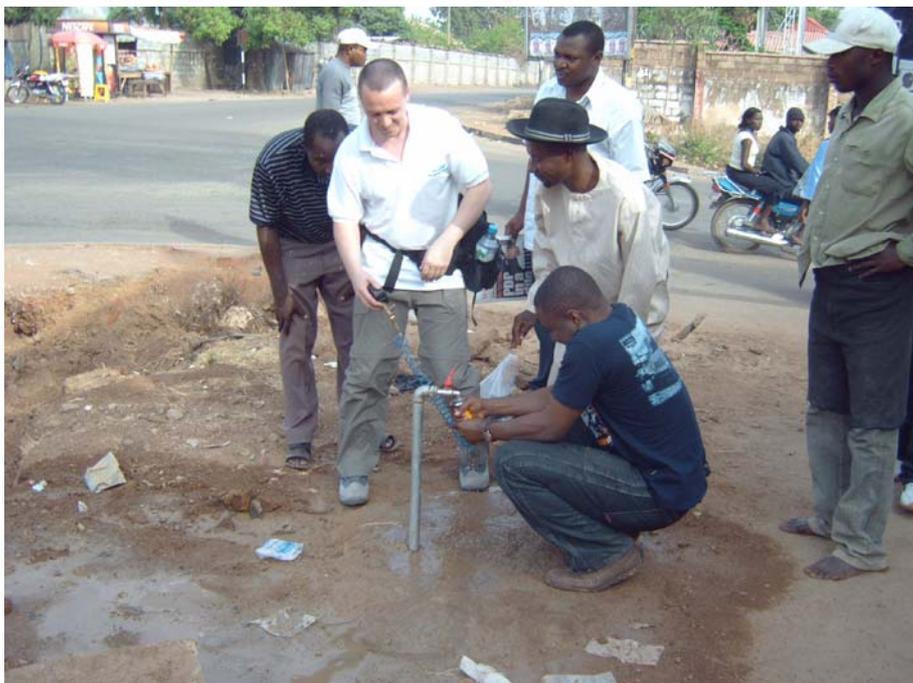
4.2.8 Testing the water pressure in Jos

The pressure was measured at various locations along the 300 mm main and noted as follows:

Brickworks 4.5 bar
Manager's house 1.5 bar
Water seller 1 bar
Booster station showed 2 bar on the inlet gauge
Stand pipe Rukuba road <1 bar – water leaking

New shopping complex (Laminga system) 1 bar
