## **ON-PLOT SANITATION**

IN LOW-INCOME URBAN COMMUNITIES

**Guidelines for Selection**

Andrew Cotton and Darren Saywell

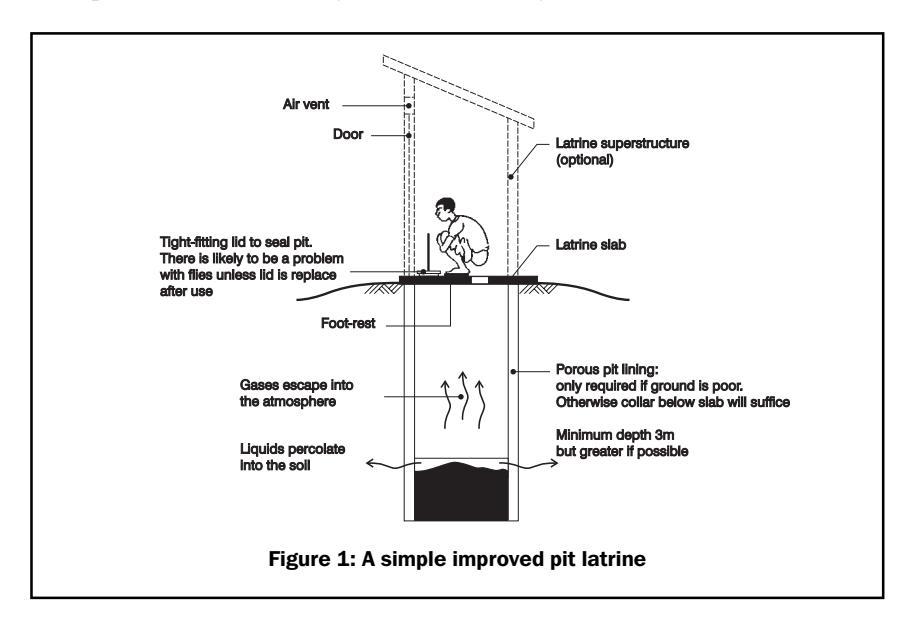
The principle underlying all types of pit latrines is that excreta and anal cleansing material can be deposited in a hole in the ground. Its basic components are a superstructure to provide user privacy, a hole or seat set into a slab which covers the pit, and a pit beneath the slab into which excreta is deposited.

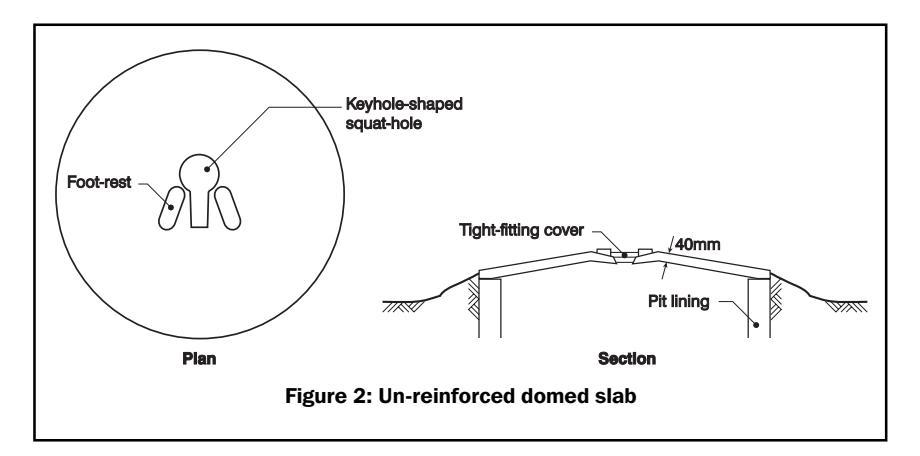
The addition of a lid which fits tightly into the hole in the slab should help to reduce insect and odour nuisance.

The National Low Cost Sanitation Programme in Mozambique is a periurban programme designed to improve the sanitary conditions of low income urban communities through the promotion of an unreinforced domed slab which covers either a lined or unlined pit.

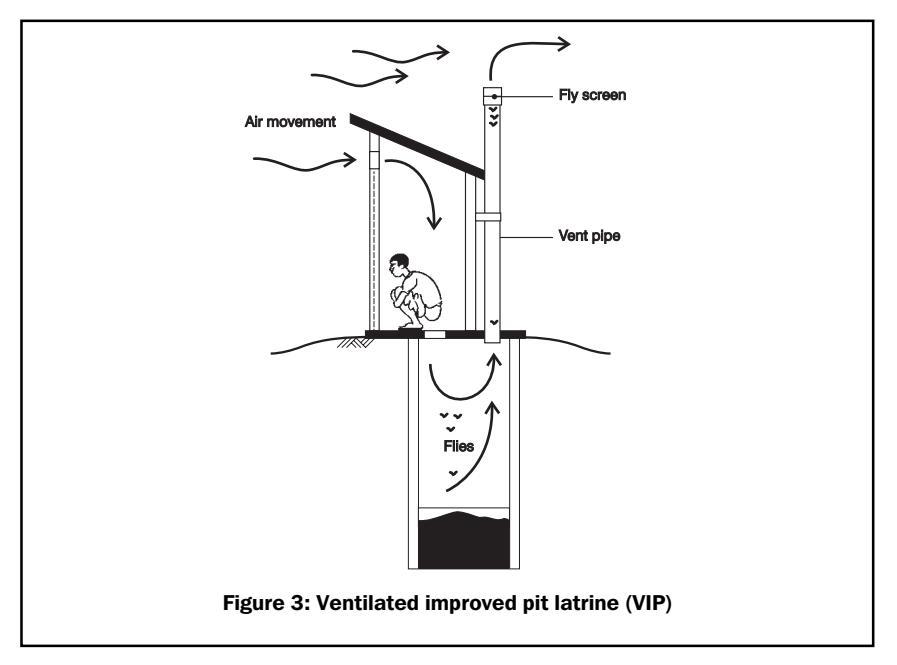
The important feature in the Ventilated Improved Pit Latrine (VIP) is the addition of a vent pipe whose purpose is to reduce the escape of odour and insects through a squat hole by creating a through-flow of air. The vent pipe needs to extend about 300mm above flat or sloping roofs or the apex of conical roofs to benefit from a draught passing across the pipe. Flyproof netting is fixed across the top of the vent.

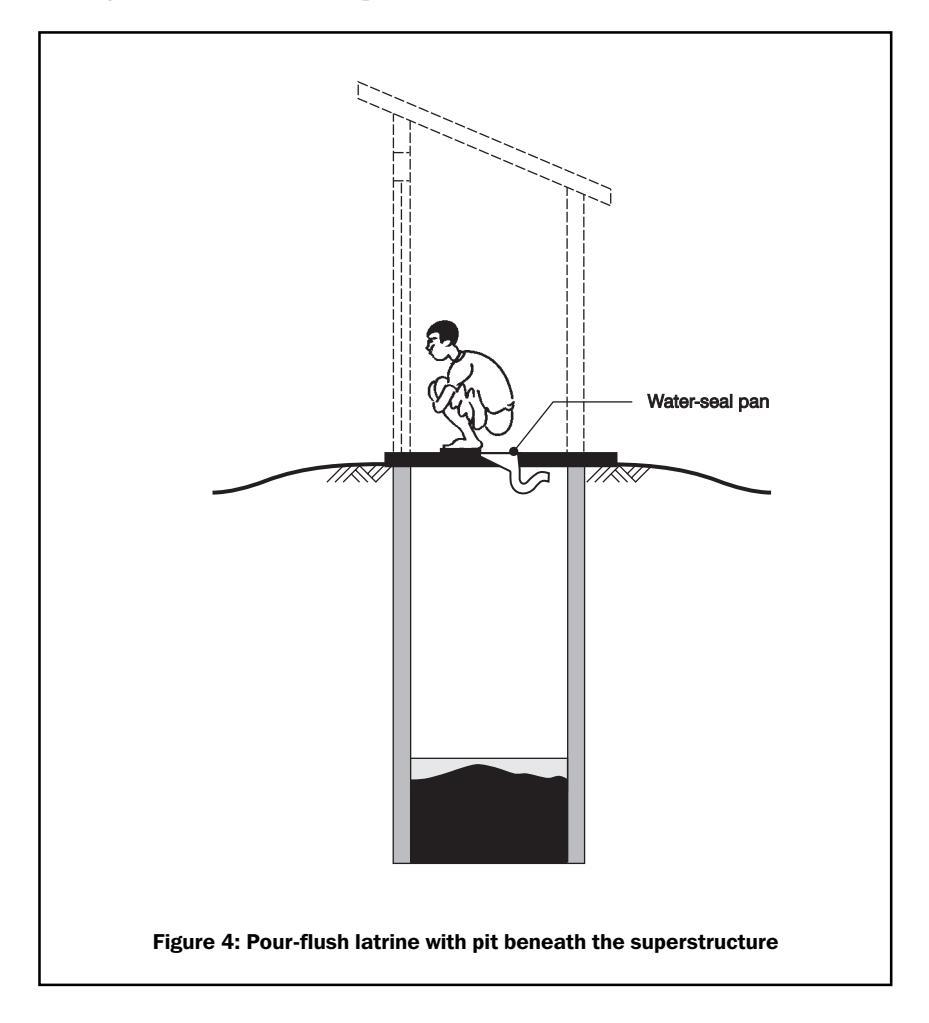
Latrines with water seals are suitable where water is used for anal cleaning. The pour-flush latrine has a bowl inserted into the hole in the slab; when filled with water this creates a seal which isolates the pit from the superstructure and the user, thereby both improving the aesthetics of the latrine and reducing insect and odour nuisance. With a well designed, smooth surface pan only one or two litres of water are required for cleaning. There are several variants of the pour-flush latrine depending on the location and number of pits in relation to the latrine superstructure and pour-flush slab. The pit can either be below the slab, or offset from it and connected via a short length of pipe to a sewer. In the latter case, a further option is to provide two shallow pits which are used/emptied alternately; we refer to this as the double pit pour-flush latrine.

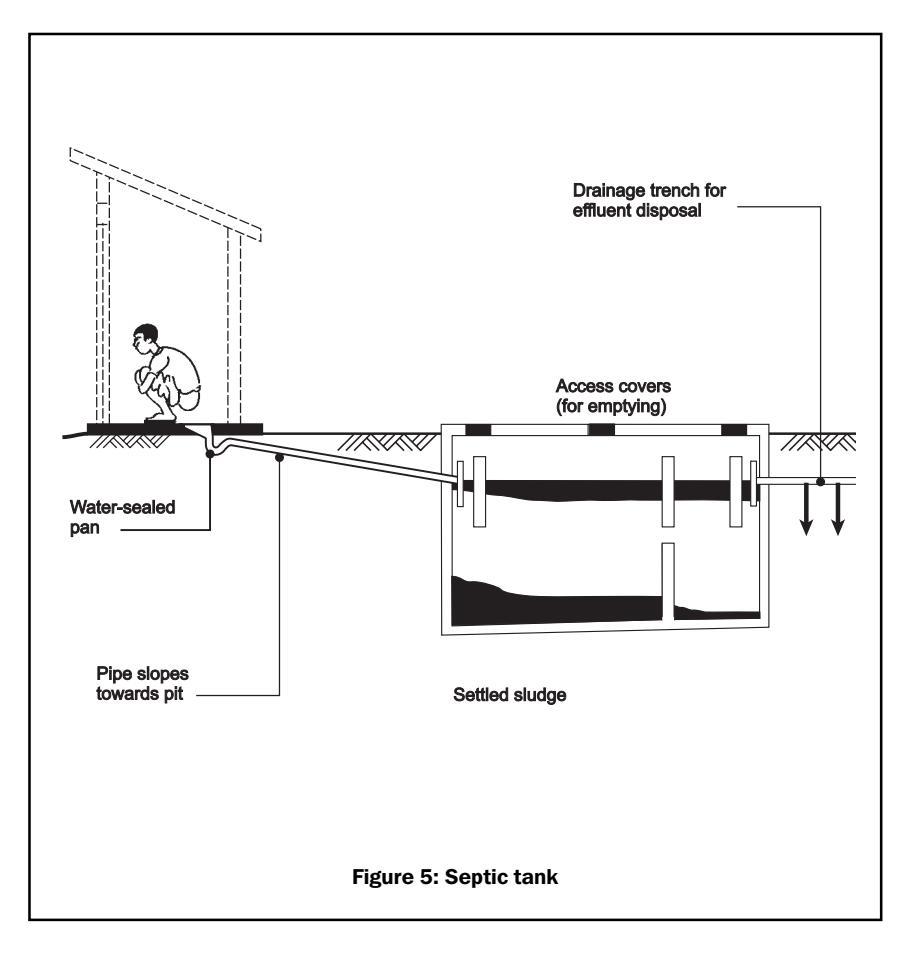
A septic tank is an underground watertight settling chamber into which sewage is delivered through a building sewer connecting a cistern flush toilet to the tank. The sewage receives partial treatment in the tank; effluent infiltrates from the tank into the surrounding ground through soakage pits or trenches.

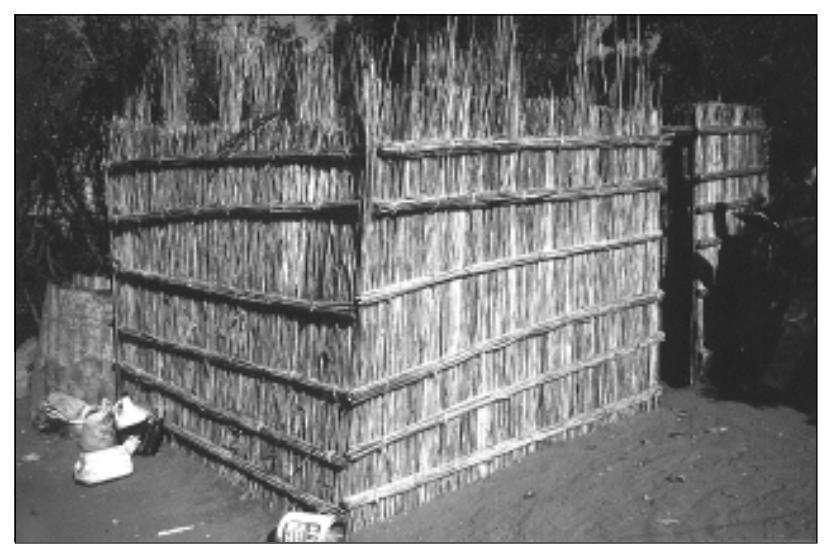
Photograph 1: Typical latrine superstructure (made from reeds) used in Mozambique, where it is customary for latrine shelters to be built without a roof

NB: In Mozambique the convention for latrine superstructures is a privacy screen with no roof. It was observed that this aided reduction of odour and insect nuisance since there was no containment of foul smells or flies within the superstructure.

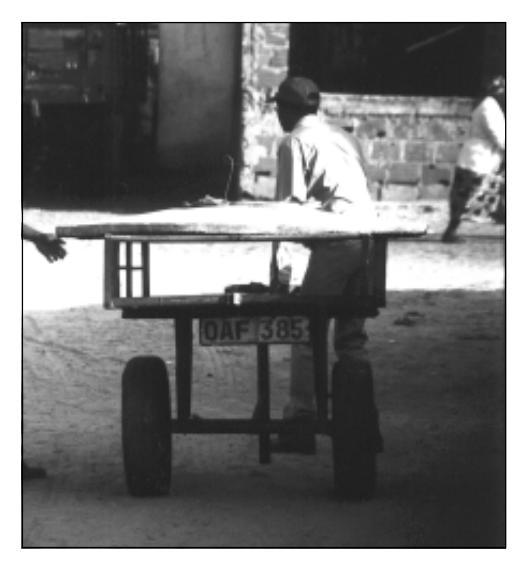
Photograph 2: Transportation of completed slabs from production unit to household plot, Maputo, Mozambique

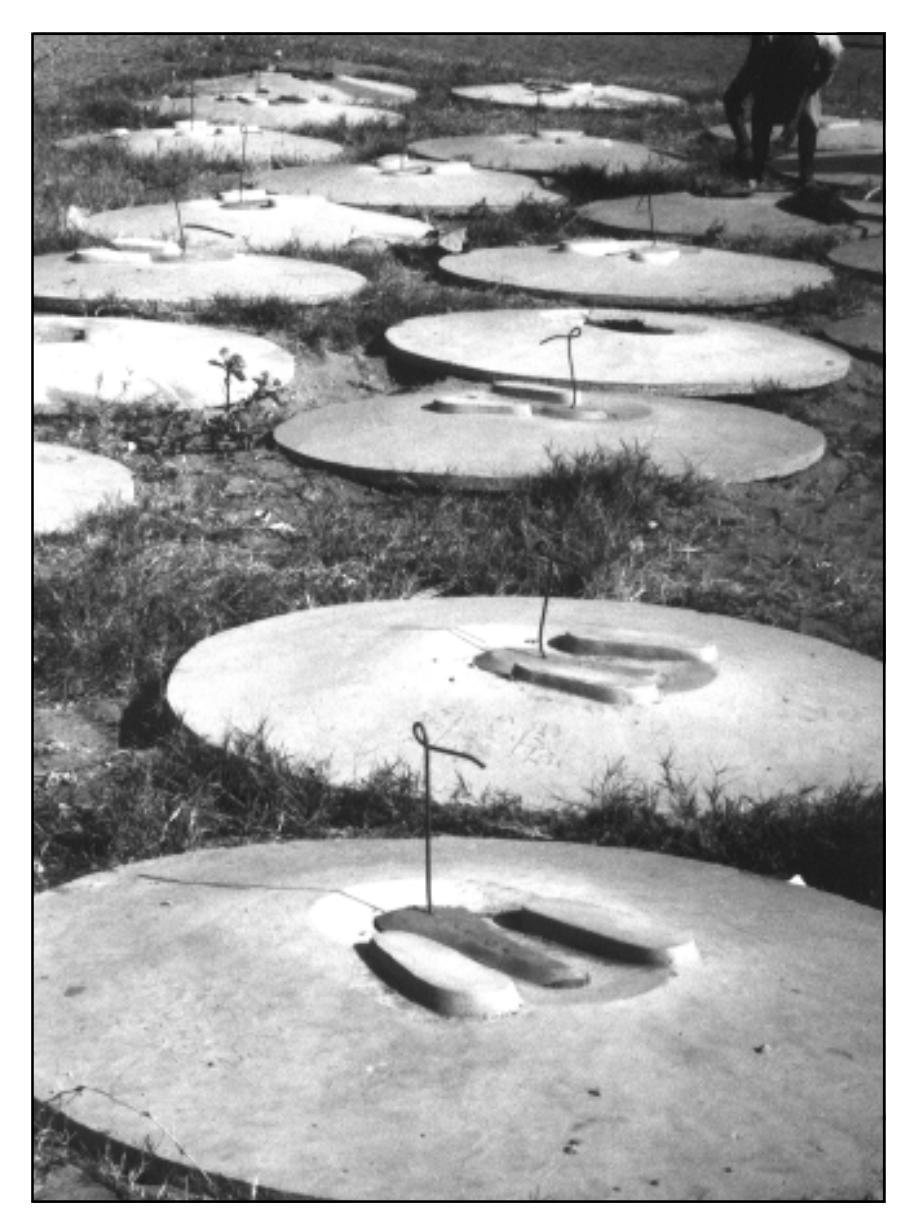
Photograph 3: Production of popular unreinforced domed slabs used for low cost simple pit latrines in peri-urban areas of Mozambique

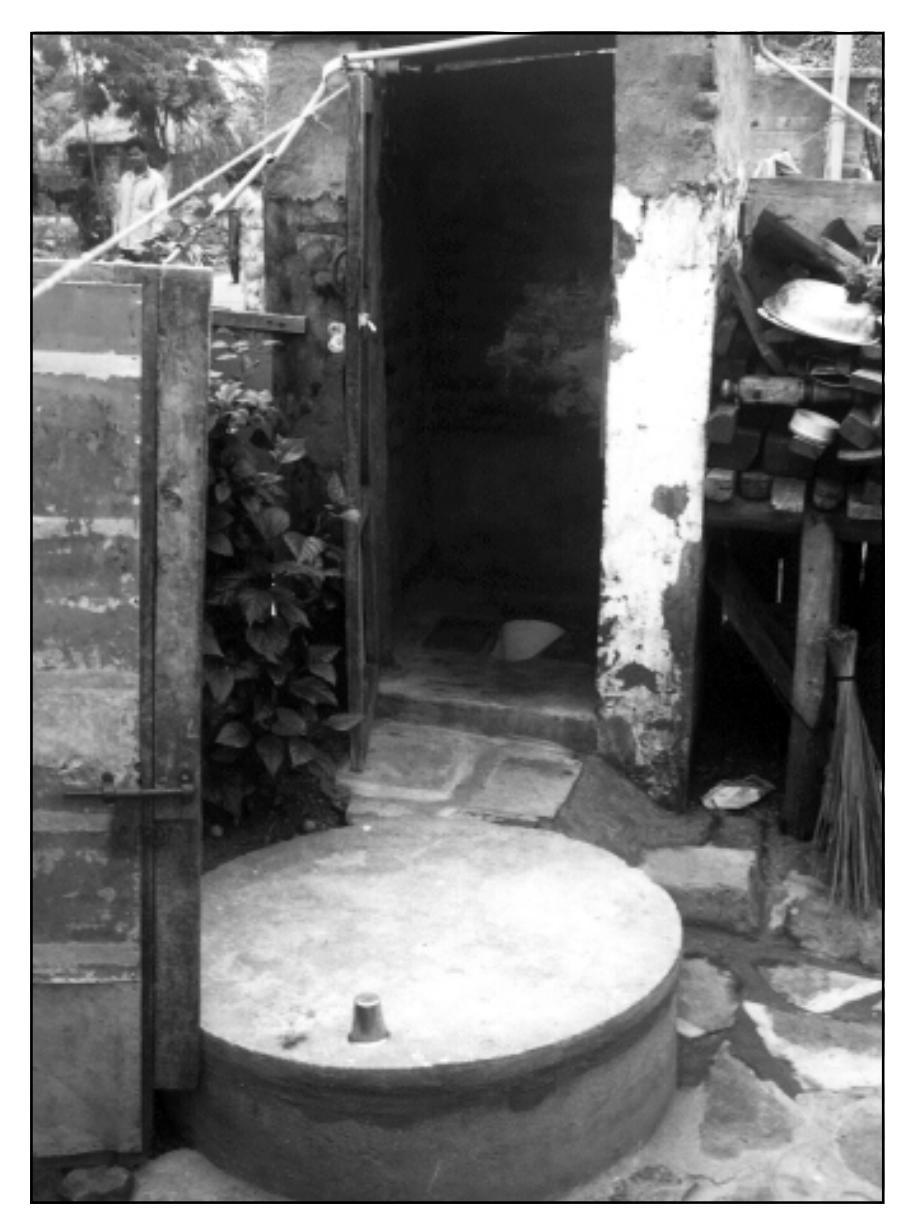
Photograph 4:

Pour flush latrine in improved urban slum, Vijayawada, India. Operational sanitation facilities were found to be commonplace on the smallest of plot sizes (as small as 14m<sup>2</sup>)

- Pour flush latrines have been constructed on plots as small as 14m<sup>2</sup>
- Just under two-thirds of all households using pour-flush latrines had used them for more than five years
- Two-thirds of all latrines had not been emptied, and half of these had been in use for between 6-10 years
- For 60% of all latrines the period between being emptied exceeded three years. In just over a quarter latrines, this period lasted for five years or more
- User satisfaction levels are most significantly affected by smell, blockage and frequent repairs
