## Borehole Sustainability in Rural Africa: An analysis of routine field data

P.A. Harvey, UK

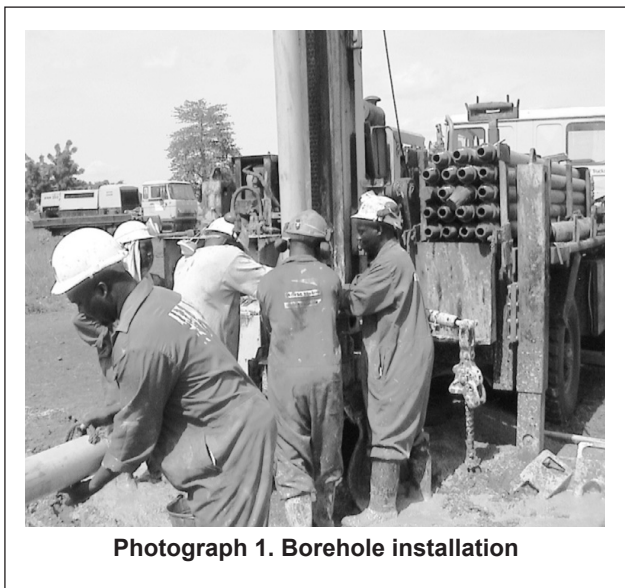
**Photograph 1. Borehole installation**

The quality of borehole installation (Photograph 1) was not considered as a variable since all boreholes were drilled, developed and constructed following consistent practice by GRWP drilling teams, consisting exclusively of World Vision employees. Random assessments indicated that the quality of workmanship was of a consistently high standard. Also, the study aimed to analyse routine or commonly available field data using a replicable process, and since borehole cameras are not widely available in rural Africa, their use was precluded in the study.

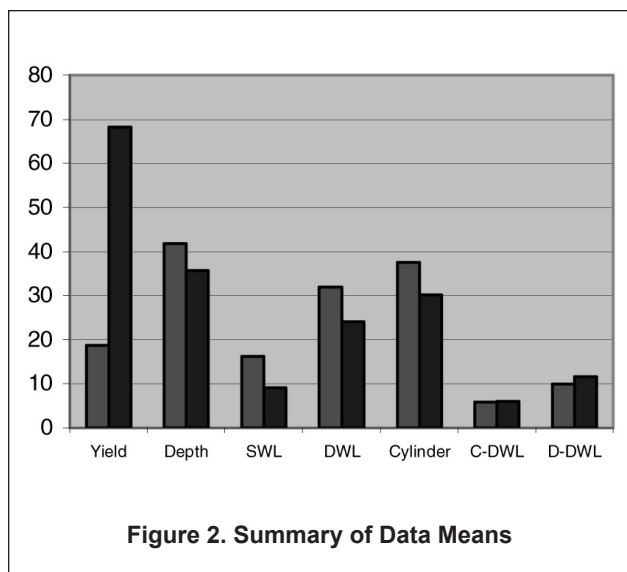
**Figure 2. Summary of Data Means**

Figure 2 presents a summary of the main variables assessed for each borehole, whether failed or operational. The respective mean values are provided for initial recorded yield (Y) in l/min; depth of borehole (D); static (or rest) water level (SWL); dynamic water level (DWL) measured during pumping test; cylinder depth (C); depth of cylinder below dynamic water level (C-DWL); and depth between dynamic water level and the bottom of the borehole (D-DWL), all in metres.

As can be seen from the graph, the most apparent contrast between operational and failed boreholes was the difference between the mean values for initial yield. The mean yield for operational boreholes was 68.2 l/min, while that for failed boreholes was only 18.7 l/min. The variations in depths are less significant, but the mean values for failed boreholes are consistently greater than those for operational boreholes. Means for total depth, static and dynamic water levels are 6-8 metres greater for failed than operational boreholes. The mean value for cylinder depth below dynamic water level (C-DWL) is almost identical for both datasets at 6m, indicating consistent practice among installation teams. Similarly, the mean total depths of borehole in relation to dynamic water level (D-DWL) are very similar. These findings are examined in more detail below.

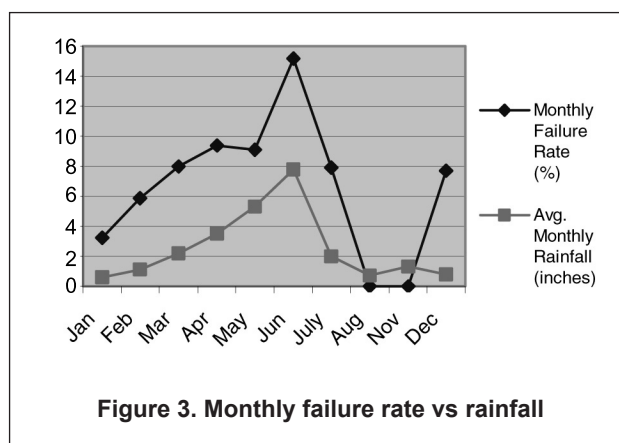
**Figure 3. Monthly failure rate vs rainfall**

Figure 3 shows the pattern of average monthly rainfall figures in relation to the proportion of failed boreholes as a percentage of all boreholes drilled for each month of the year. The months of September and October were excluded due to an inadequate sample size for each month, with only 2 and 6 boreholes respectively. The precipitation figures used are average monthly totals, rather than actual totals for precise months when drilling took place.

The graph demonstrates a clear relationship between the wettest months and highest failure rates, and the correlation coefficient for this relationship is strongly positive ( $r = 0.865$ ,  $df = 9$ ,  $p < 0.01$ ). This reinforces the finding that wet season drilling is considerably more likely to lead to borehole failure than drilling during the dry season, and suggests that drillers were not making sufficient steps to take seasonal fluctuations in water levels into account during operations. The consistent depth of cylinder installation with respect to DWL, regardless of time of year, supports this assumption. Wurzel (2001) suggests a systematic approach whereby drillers drill an additional 10 metres after sufficient yield is attained to allow for seasonal variation. It is not clear, however, how effective this measure is in countering seasonal water table fluctuations, since the approach was not adopted by the GRWP drillers.

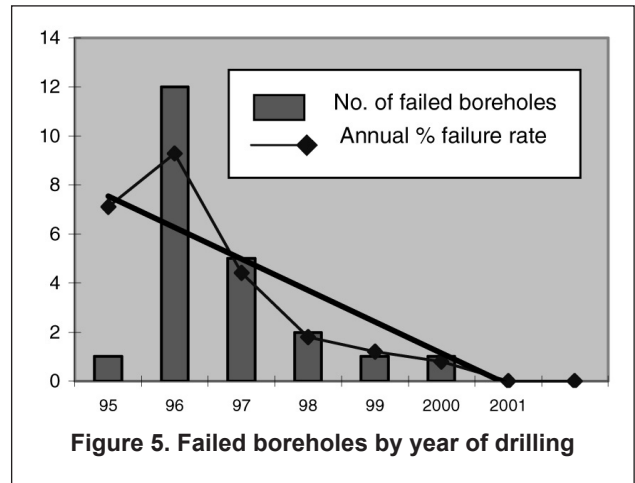
**Figure 5. Failed boreholes by year of drilling**

It is a logical expectation that the number of failed boreholes will increase with age, and this can be seen in Figure 5. The annual failure rate reduces with decreasing age, so that no failed boreholes were drilled in 2001 and 2002, while there was a maximum number drilled in 1996 (only a very small number of boreholes were drilled in 1995). This suggests that boreholes take at least one or two years before they ‘fail’, and failure rates increase considerably from five years. It should be noted, however, that the survey of water points was conducted during March when the wet season had already started, so it is possible that some ephemeral boreholes contained water that had not done so during the recently ended dry season. This means that the actual total of failed boreholes may be even higher than indicated.
