**Situation analysis and recommendations for an improved
wastewater disposal system at Saint Francis Hospital in Zambia**

A dissertation submitted in partial fulfilment
of the requirements for the award of the degree of
Master of Science
of Loughborough University

AUGUST 2012

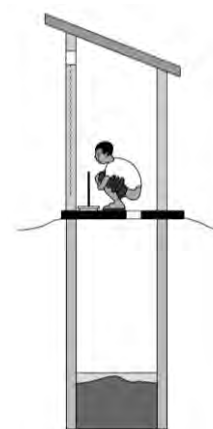
Figure 2.2 – Simple pit latrine (image courtesy of WEDC. © Ken Chatterton)

A simple pit latrine (see Figure 2.2 for an illustration) consists of a slab over a pit which may be two metres or more in depth, a squat hole in the slab or a seat is provided so that the excreta fall directly into the pit (Franceys et al., 1992). It is simple and cheap to build and needs no water for operation, but it can cause considerable fly nuisance and smell (Franceys et al., 1992). The slab and the shelter can be re-used after a pit is filled up (Jantsch & Vest, 1999).

Once the contents in a pit reach 0.5 m below the top, it should either be excavated or filled with earth and a new pit should be dug (Jantsch & Vest, 1999). If the latrine is not excavated once it is full, it can also be used to dispose of infectious material or used needles and sharps, since there is no danger of access to the excreta (Jantsch & Vest, 1999). If the ground consists of hard rock, if the water table is very close to the surface or if the area is prone to flooding, it may be advantageous to raise the pit above the ground (MSF, 2010; Scott, 2012). The raised pit lining can be surrounded with a mound of soil. Part of the lining can be left porous so that liquids can percolate into the mound and then into the top soil (Scott, 2012).

Construction: The top 0.5 m of a pit must always be lined; depending on local soil conditions and emptying practices, the rest might also need to be lined. The cover slab is commonly flat with a hole near the centre and it is placed directly on top of the pit lining about 15 cm above the surrounding ground level. The cover slab is surrounded by a mound of soil to seal the space between the lining, the slab and the surrounding soil. The superstructure provides privacy for the users and the design of it can be adapted to suit the requirements of the users. Specially designed children's pit latrines should be implemented, especially in health structures where lots of children are present (MSF, 2010).

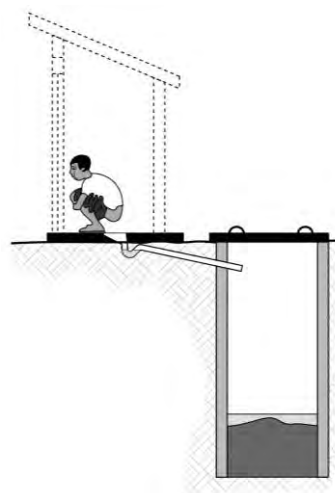
Figure 2.3 – Offset pour-flush latrine (Image courtesy of WEDC. © Ken Chatterton)

Offset pour-flush latrine: The pit is separated from the toilet building; a short length of typically 100-150 mm diameter pipe leads from the toilet pan to the seepage pit (see Figure 2.3 for an illustration). Once the pit is full, a second pit could be dug and the discharge pipe diverted to it; in the meantime, the first pit can be safely emptied and reused. They are more expensive to build and require more water to flush than simple pour-flush latrines.

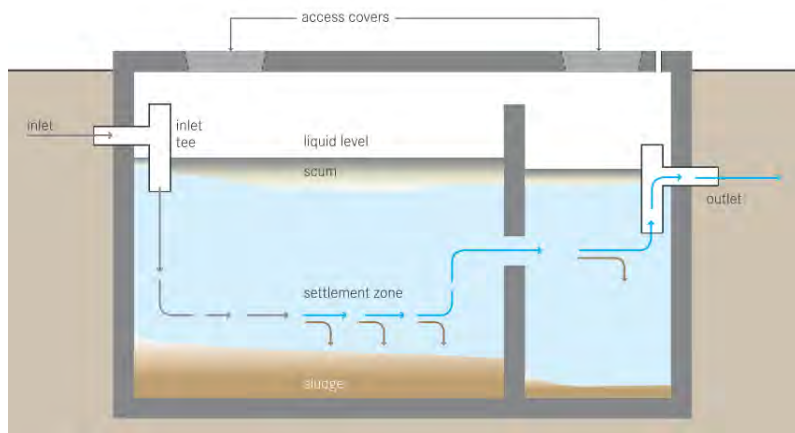
Figure 2.5 – Treatment processes in a septic tank (Tilley et al., 2008)

Compartmentalization: It is best to build a septic tank with two compartments (see Figure 2.5), the first one being twice as big as the second (Jantsch & Vest, 1999; Scott, 2012). Compartmentalized tanks or tanks placed in series provide better suspended solids removal than single-compartment tanks alone (USEPA, 2002).

Dimensions (Scott, 2012): The depth of liquid from the tank floor to the bottom of the outlet pipe should be at least 1.2m and preferably 1.5m or more. The width of the tank should be at least 0.6m. The width of the tank should be half the length of the first compartment and the width of the second compartment should be equal to its length. In larger tanks the base often slopes towards the inlet end of the tank.

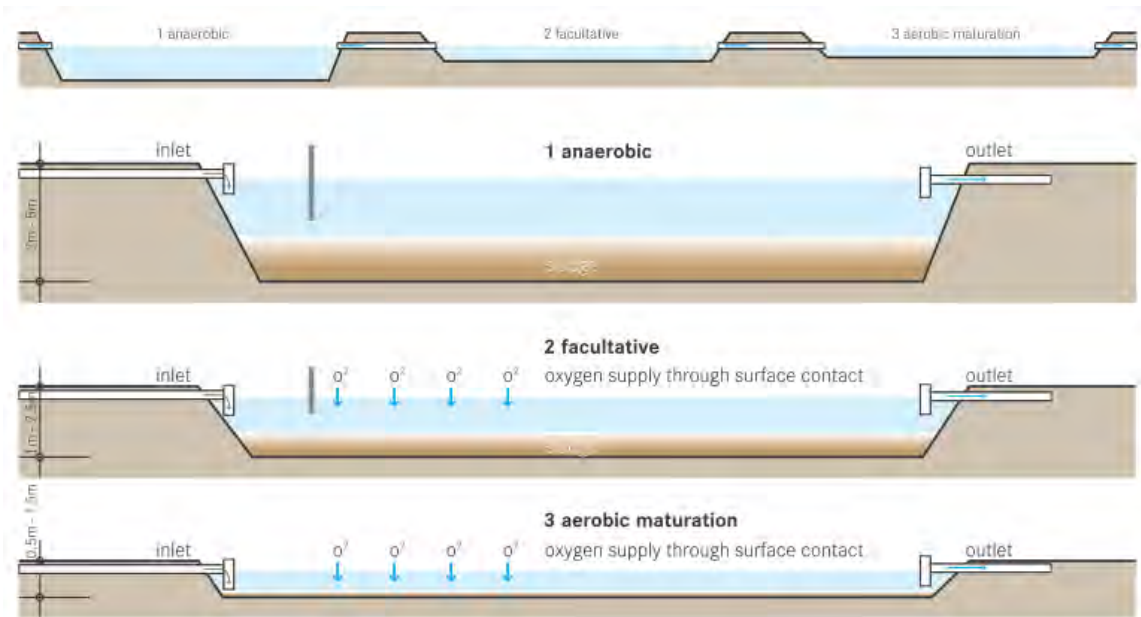
Figure 2.6 – Illustration of Waste Stabilization Ponds (Tilley et al., 2008)

Figure 2.6 shows the order and arrangement of WSPs, the sludge accumulation as well as the importance of oxygen supply.

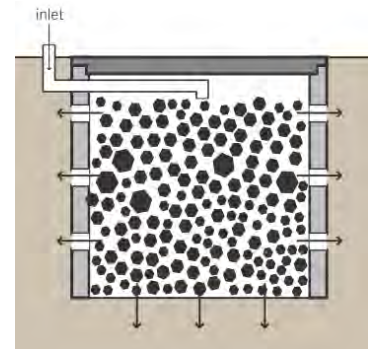
Figure 2.7 – Soak pit filled with stones (Tilley et al., 2008)

Basic design considerations: Soak pits are commonly 2 to 5 m in depth and 1 to 2.5 m in diameter; their volume should be larger than the tanks they are connected to (Scott, 2012). The pit can either be lined (porous lining) or filled with large stones (see Figure 2.7), blocks or bricks to support the pit walls and cover (Scott, 2012). The soak pit should be separated from the septic tank by at least 3 m, downhill from the health facility, and at a safe distance of 30m from any drinking water source (Jantsch & Vest, 1999). For calculating the volume of the pit, only the wall surface area below the inlet pipe should be considered (Scott, 2012).

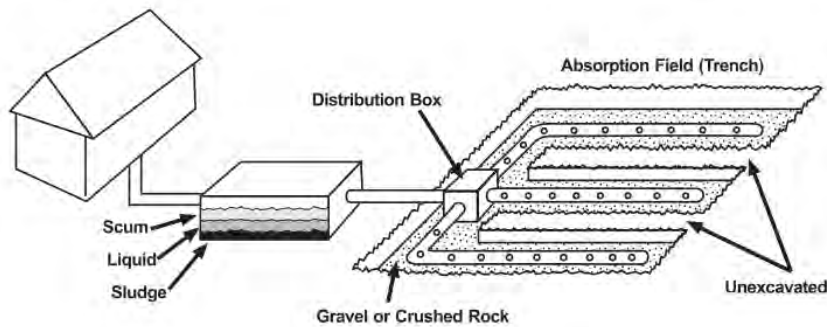
Figure 2.8 – System with infiltration trenches (USEPA, 2002)

Basic design considerations: The trenches should be orientated parallel to the surface contours (see Figure 2.8) in order to reduce linear contour hydraulic loadings and groundwater mounding potential (USEPA, 2002). They are normally between 300 and 600 mm wide and

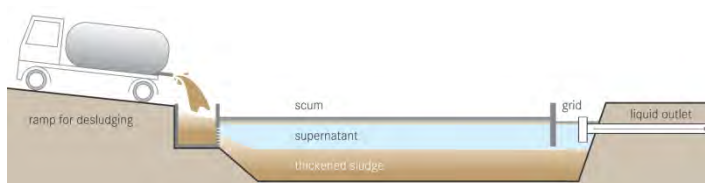
Figure 2.9 – Sludge settling ponds (Tilley et al., 2008)

Settling ponds (primary treatment): These are sedimentation or thickening ponds (see Figure 2.9) that create calm conditions in which suspended solids can settle to the bottom; they are usually operated in pairs using a batch system (Scott, 2012).

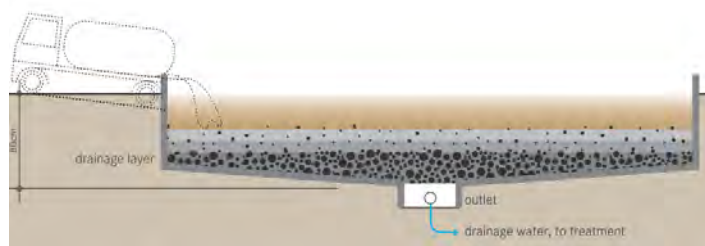
Figure 2.10 – Sludge drying beds (Tilley et al., 2008)

Sludge drying beds (primary or secondary treatment): Sludge can be deposited onto a shallow tank, which allows drainage and is covered with a layer of sand to form a bed (see Figure 2.10). In favourable conditions, the solids content increases within one week so that it can be lifted by hand or a mechanical shovel (Pickford & Shaw, 1997).

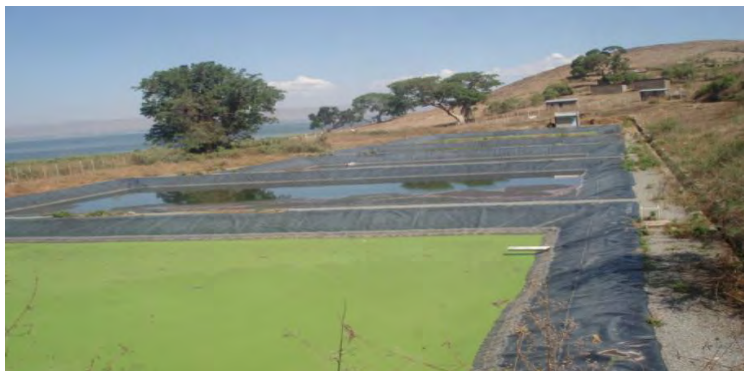
Figure 2.11 – WSPs at Hawassa Referral Hospital (Dires, 2008)

bacterial activity and therefore reduce the removal effectiveness. Another factor for the insufficient removal rate may be the design of the ponds, especially the depth: All the ponds are between 5 and 7 metres deep which means that none of them serve as facultative or polishing ponds. Furthermore, the ambient air temperature around the ponds might reduce the removal efficiency of the stabilization ponds.

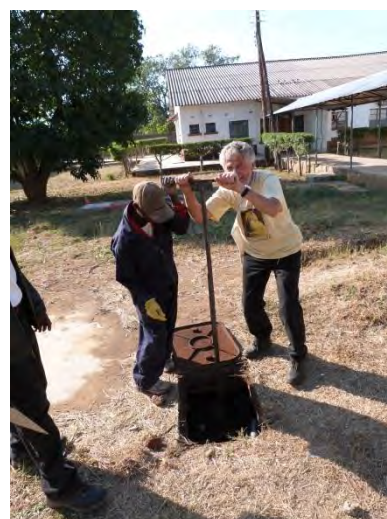
Figure 3.1 – Inspection of ST5 with metal pole. © Mirco Keller.

Survey of septic tanks: The existing septic tanks on the hospital site were first observed from the outside (structural status, cracks etc.) and the size measured. The inspection covers were then removed and the interior was first visually examined (level of sewage, type of floating materials etc.). Subsequently, a metal pole (3 m long, with handle, made at the SFH workshop) was used to determine the solidity and viscosity of the septic tank contents (see Figure 3.1 for a photograph of the inspection

process). The percentage of sludge and scum within each septic tank could be roughly estimated in this way.

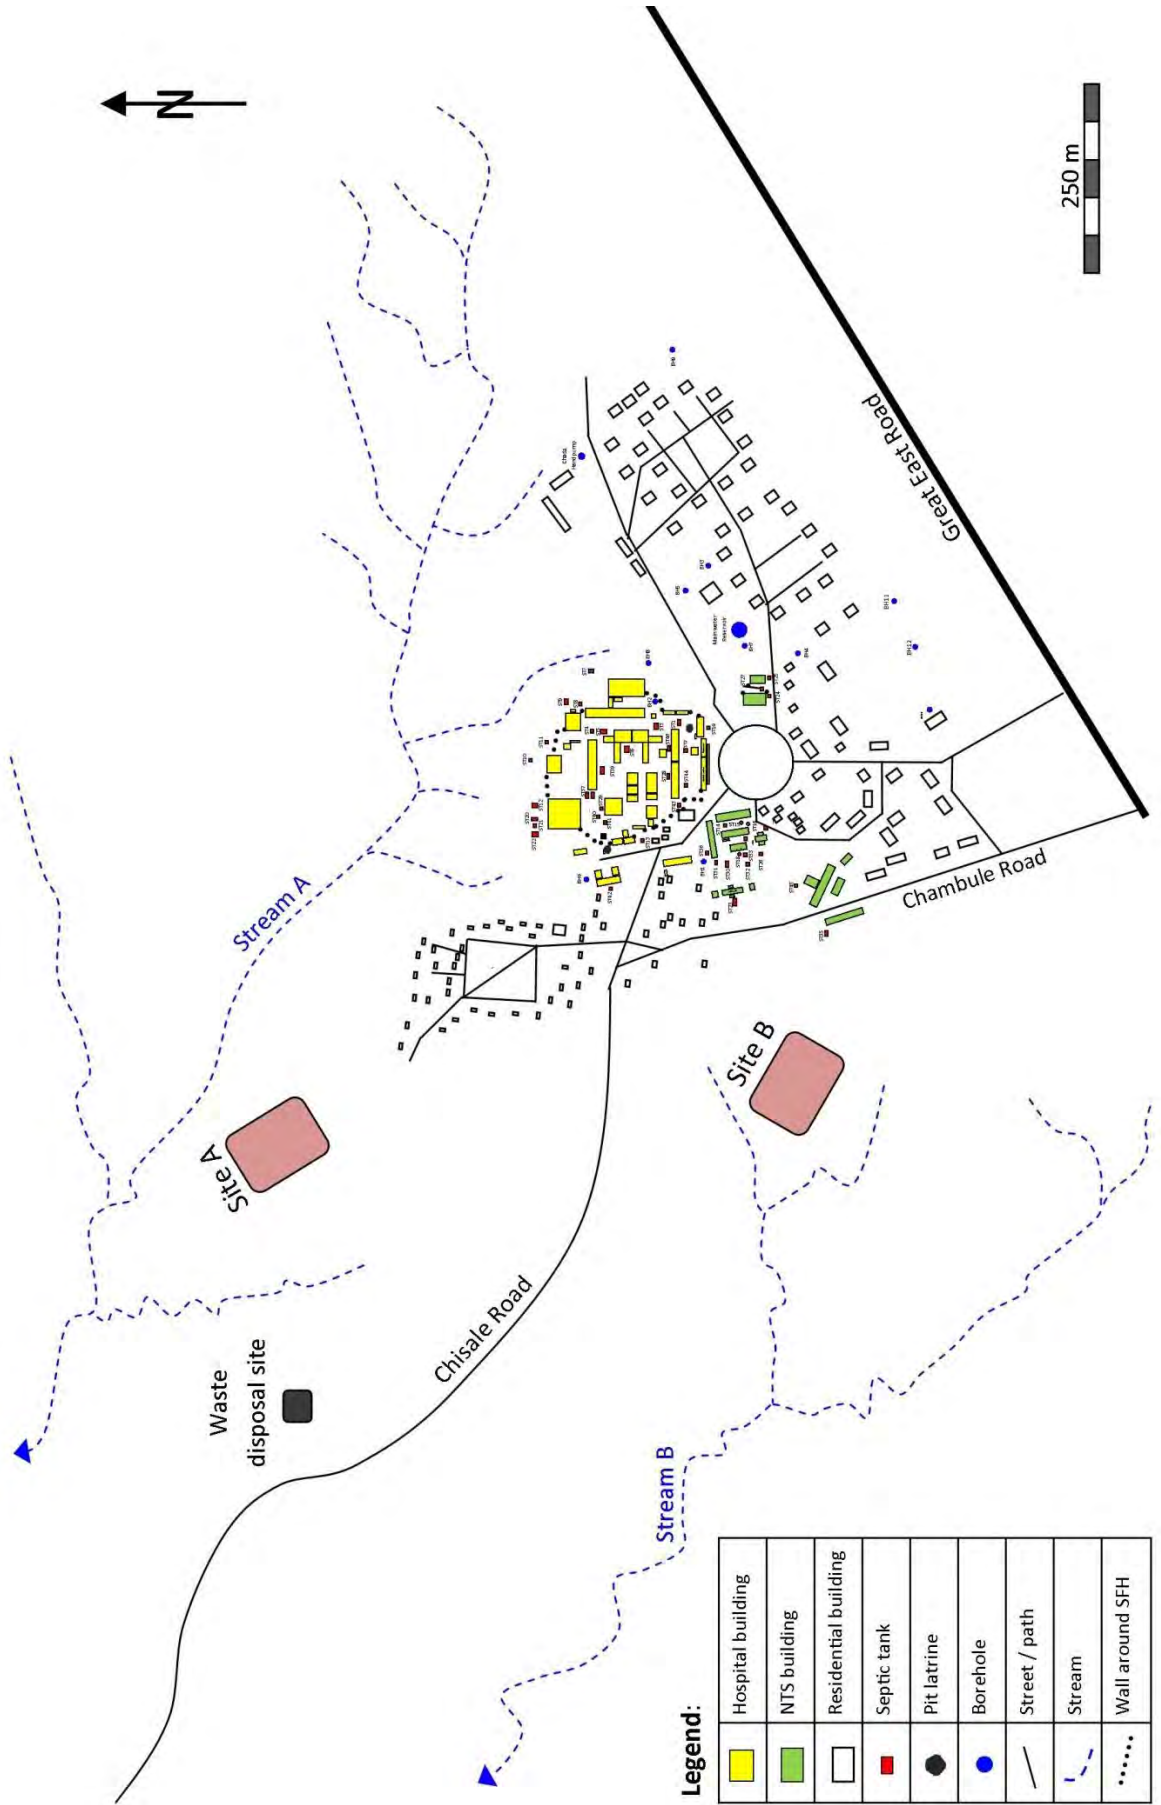
Figure 4.1 – Map of SFH with surroundings © Mirco Keller

Site A (see Figure 4.1): Site A is located in proximity to the Stream A, but sufficiently far away not to be affected by any floods. It is on a fairly flat ridge (with a small hill in the middle) which slopes towards the north-west with about 2° to 3° incline. It is used for agriculture and is about 150 m away from the closest building. The measured level difference between the hospital level and Site A is between 7 and 10 m; According to Google Earth it is about 15 m. The measured distance along the walking path between the closest point on the roundabout and the closest point of Site A is 753 m. A straight line (measured on the map) between the two same points would be about 660 m.

Site B (see Figure 4.1): Site B is situated in a fairly flat area (1° to 2° incline towards the north-west) that starts to slope steeper in the north-western end of the site (3° to 4° incline towards the north-west). It is close to a number of springs that form small streams during the rainy season. The site is not used for agriculture and is also about 150 m away from the closest building. The measured level difference between the hospital level and Site B is between 6 and 9 m (8 m with Google Earth). The measured distance along a walking path between the main entrance of the hospital and the closest point of Site B is 439 m. A straight line (measured on the map) between the two same points would be about 390 m.

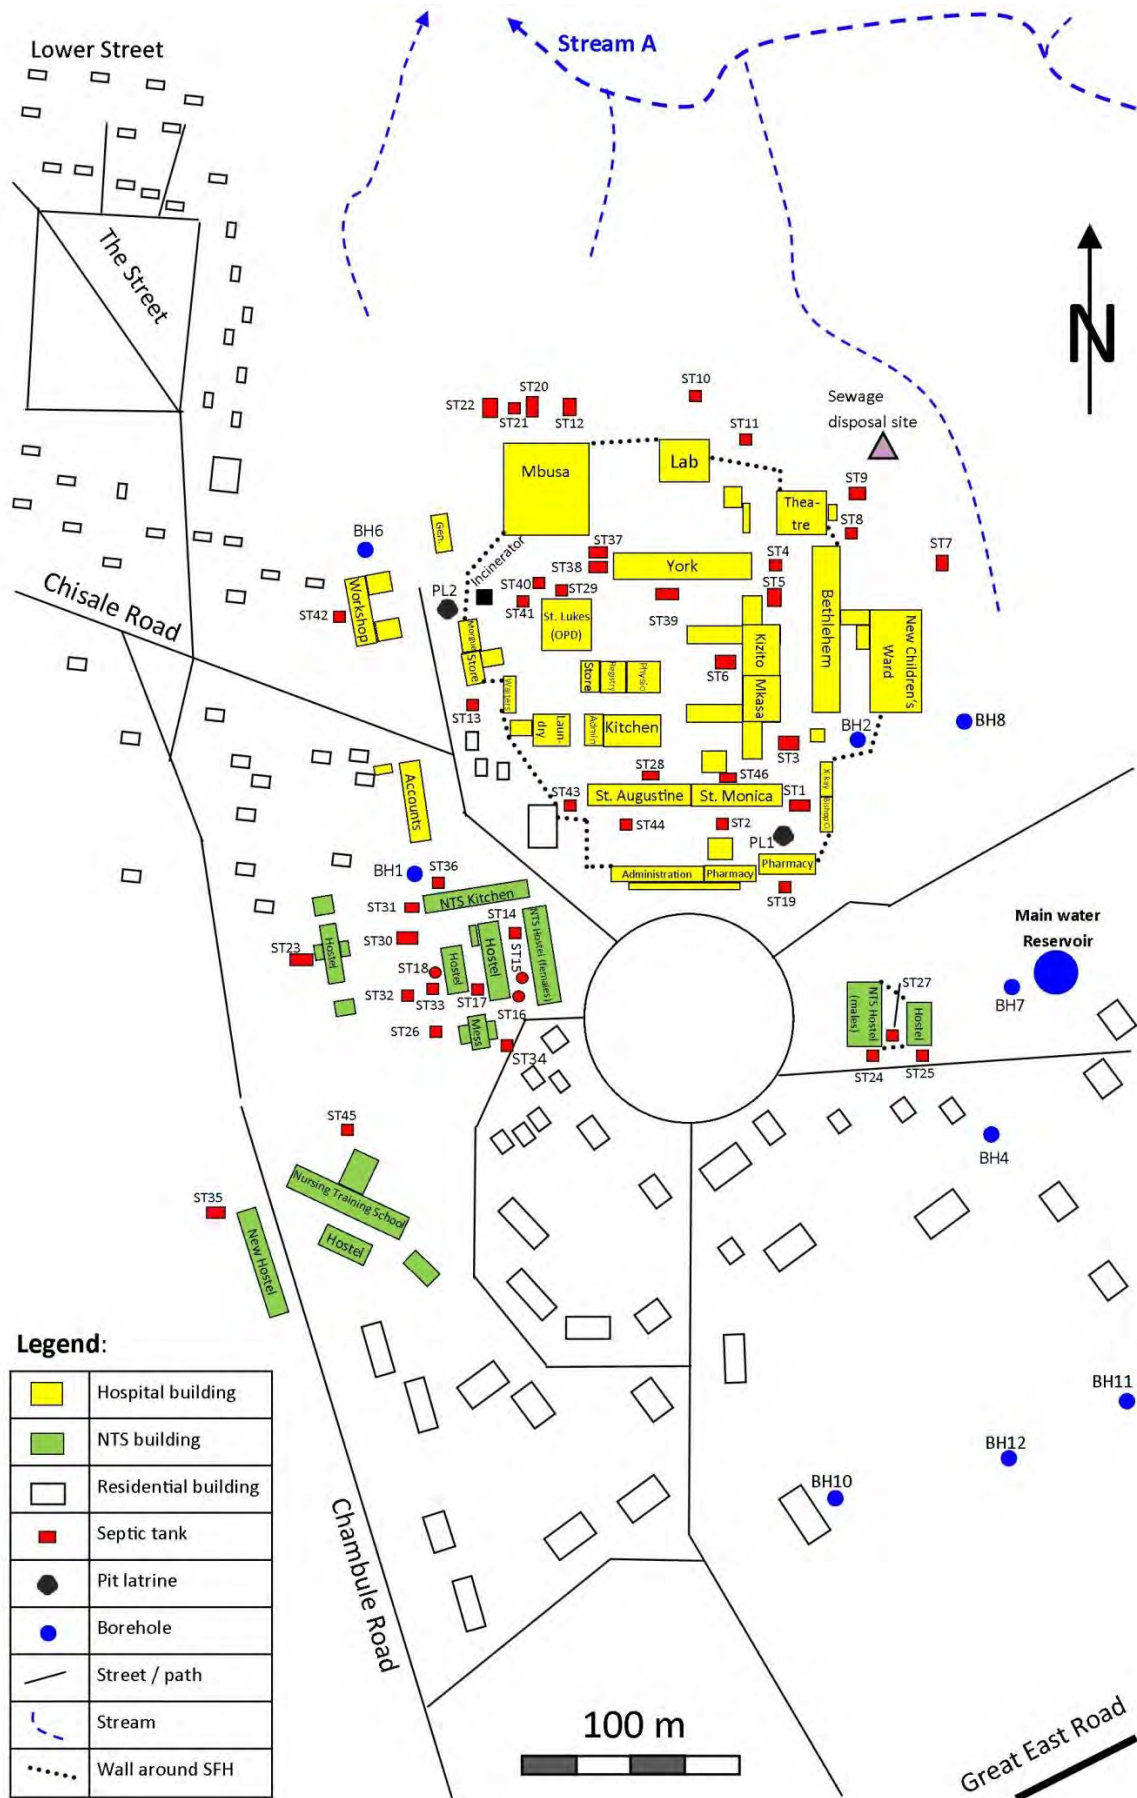
Figure 4.2 – Map of SFH with the location of all septic tanks. © Mirco Keller.

There are 46 septic tanks that serve all hospital and NTS buildings (see Figure 4.2 for the exact location of all septic tanks). A small number of these septic tanks could actually be soak pits or some kind of collection pits which are connected to another pit. Due to insufficient knowledge about the current system and difficulties to inspect certain septic tanks, it was not always possible to decide what should be considered as a proper septic tank and what not (See Appendix E for a more detailed list of all septic tanks).

Dimensions: 28 of the 46 septic tanks have been measured in size; the average volume of a septic tank turned out to be 13.8 m³. The total volume of all measured septic tanks comes to 401 m³. If all the septic tanks that were not measured in size had average dimensions, the total volume of all 46 septic tanks would be 635 m³.

The wastewater from the toilets, sinks and showers are disposed of in about 46 septic tanks on-site (see 4.5.2 and Figure 4.2 for locations), the average volume of a tank is 13.8 m³ (see 4.5.2). Most of the septic tanks have an adjoining soak pit (see Figure 5.2 for a photograph of ST6), which receives the effluent from the septic tanks as well as (in some cases) grey water directly from sinks and showers. About 9 septic tanks do not have any soak pit, but discharge their effluent directly into the environment.

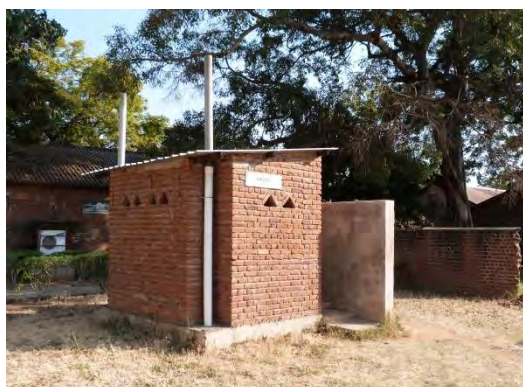
Figure 5.1 – PL1. © Mirco Keller.

There are 4 pit latrines on site (see Figure 4.2 for location). The two pit latrines which are inside the hospital premises (PL1, see Figure 5.1) are frequently used. Staff from certain wards (especially from St. Monica) has reported that some patients and relatives prefer to use these pit latrines instead of the flush toilet inside the ward (see 4.4.4). The other two pit latrines (PL2, next to the mortuary) are not used by many people.

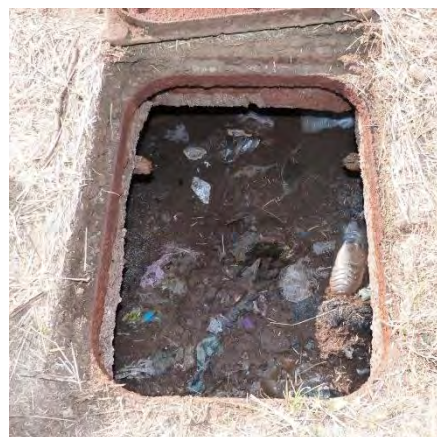
Figure 5.3 – Solidified sludge of ST5.
© Mirco Keller.

Out of 18 septic tanks that were inspected thoroughly (see 4.5.2), nine were found to be impossible to empty with a vacuum tanker (3 of which were not in use), while the 9 others were found to be feasible to empty (1 of which was not in use). These decisions were based on inspections of the nature and solidity of the contents, conducted with an inspection pole. See Figure 5.3 for a photograph of the solidified sludge of ST5. A selection of photographs of several septic tanks can be found in Appendix D.

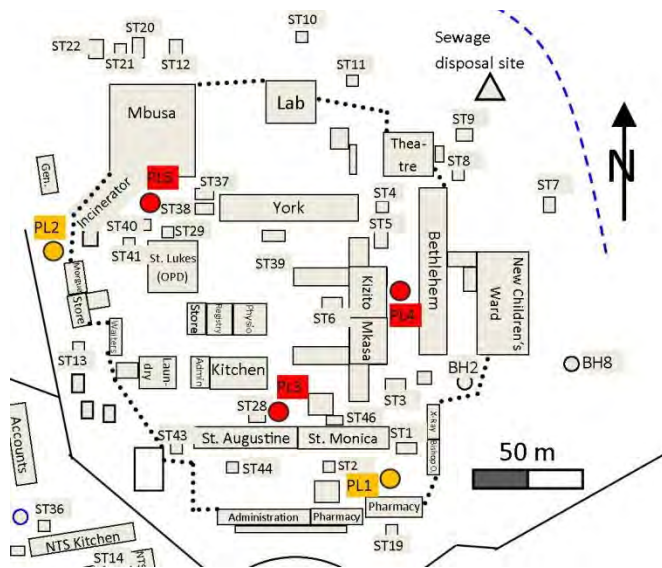
Figure 5.5 – Suggested location of new pit latrines

Due to the large number of disadvantages (which cannot outweigh the advantages), pit latrines are not considered being feasible on a large scale for SFH. Nevertheless, it is recommended to continue with the operation of the existing 4 pit latrines (PL1 and PL2) and to build a few more. It is suggested to build 6 more pit latrines at 3 locations (PL3, PL4 and PL5, see Figure 5.5), each with one cubicle for males and one for females. This will enable all patients and relatives who prefer to use pit latrines instead of flush toilets to do so. Furthermore, it will allow these people to dispose any solid materials into the pit (assuming the pit is not excavated once it is full). Eventually this will reduce the occurrence of blockages in the flush toilets and sewers.

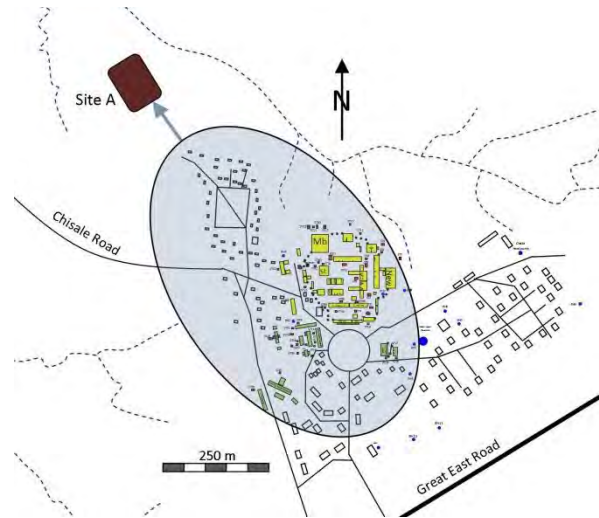
Figure 5.6 – Site A: Location of ponds and approximate coverage area of sewerage system

One option for a possible location of the WSPs would be at Site A (see Figure 5.6 and 5.7), which is to the north-west of the hospital, about 150 m towards the north-west from the last house at Lower Street. The whole hospital compound, all NTS buildings and about 70% (estimated) of the residential buildings could be connected to the sewerage system (see Figure 5.6). This means that about 30% of the residential areas remain unconnected and have to continue using septic tank systems.

The length of the main sewer would need to be at least 750 m (from the roundabout to Site A). The level difference between the two points has been measured to be between 7 and 10 m, but could be slightly higher (up to 15 m according to Google Earth).

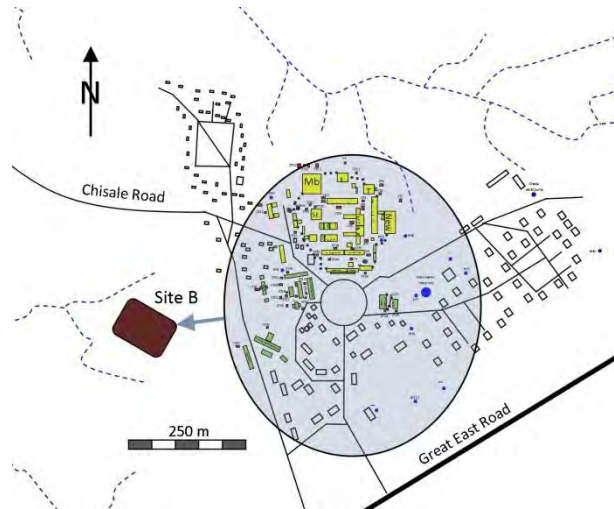
Figure 5.8 – Site B: Location of ponds and approximate coverage area of sewerage system

A second option for locating the ponds would be at Site B (see Figure 5.8 and 5.9), which is to the west of Chambule Road and the NTS buildings, about 150 m to the west of the new NTS hostel. The whole hospital compound, all NTS buildings as well as about 50% (estimated) of the residential buildings could be connected to the sewerage system (see Figure 5.8). This means that around 50 % of the residential buildings remain unconnected and have to continue using septic tank system.

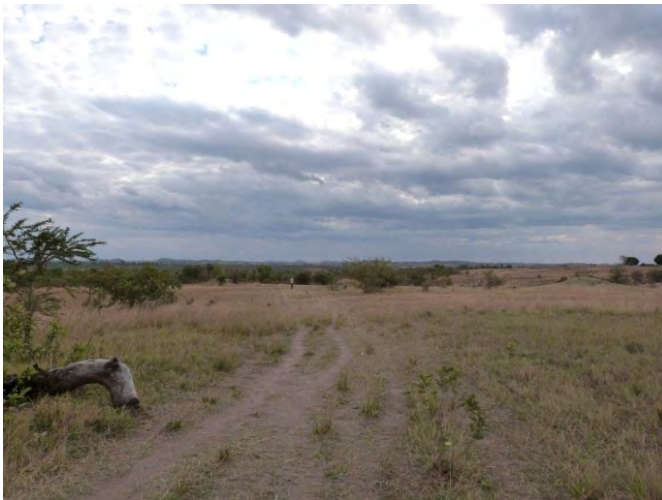
Figure 5.9 – View of Site B towards north-west. © Mirco Keller.

springs and streams and the area is not used for agricultural purposes. There is no vegetation to speak of and access to the site is ideal (via Chambule Road). The area is prone to being water-logged during the rainy season (it can get swampy at times), but with an appropriate construction of the WSPs, this should not prove to be a problem, once the construction is finished. It is recommended to carry out all excavations and constructions during the dry season.

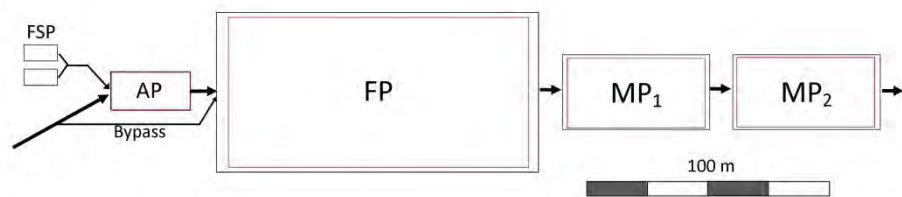
Figure 5.10 – Design and size of WSPs (black: Site A, red: Site B)

for Site A are shown in black, the ponds for Site B are shown in red colour.
