**Partners for Water and Sanitation (PAWS)
Wastewater Treatment Works Assessments
Gauteng Province, South Africa**

March 2009

Report prepared by Tom Wayling and Rob Smith of Anglian Water (UK), in collaboration with Department of Water and Environmental Affairs (SA) and Partners for Water and Sanitation.

Executive Summary

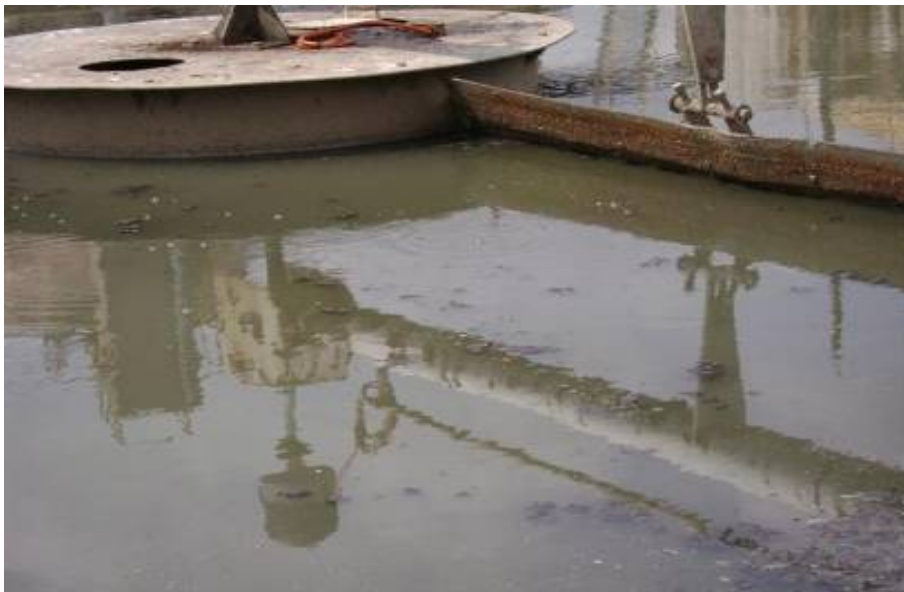
Fig.3: East works PST short-circuiting

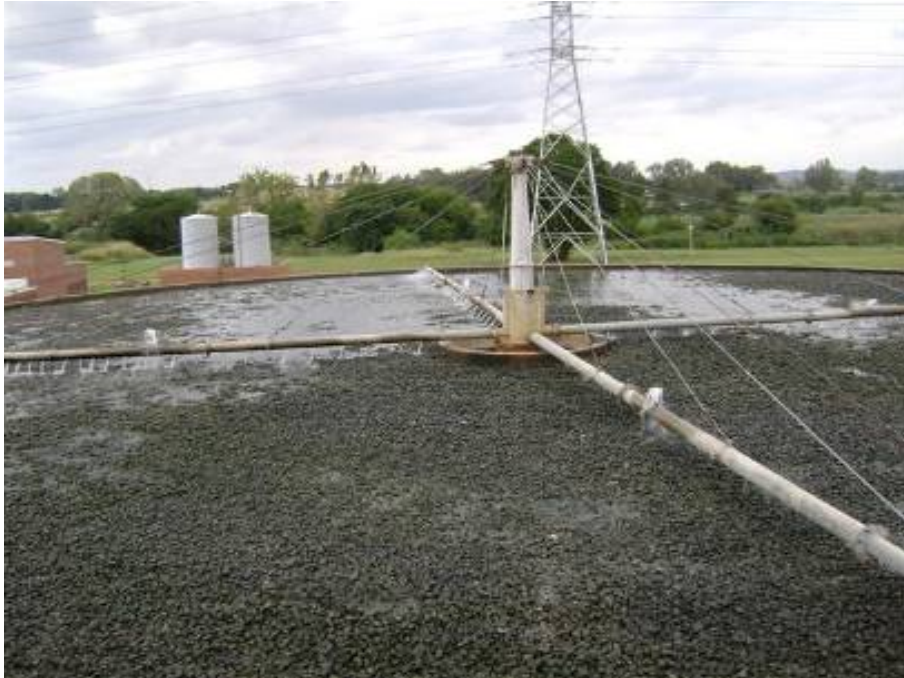
Fig. 4: East works biofilters ponding due to overloading

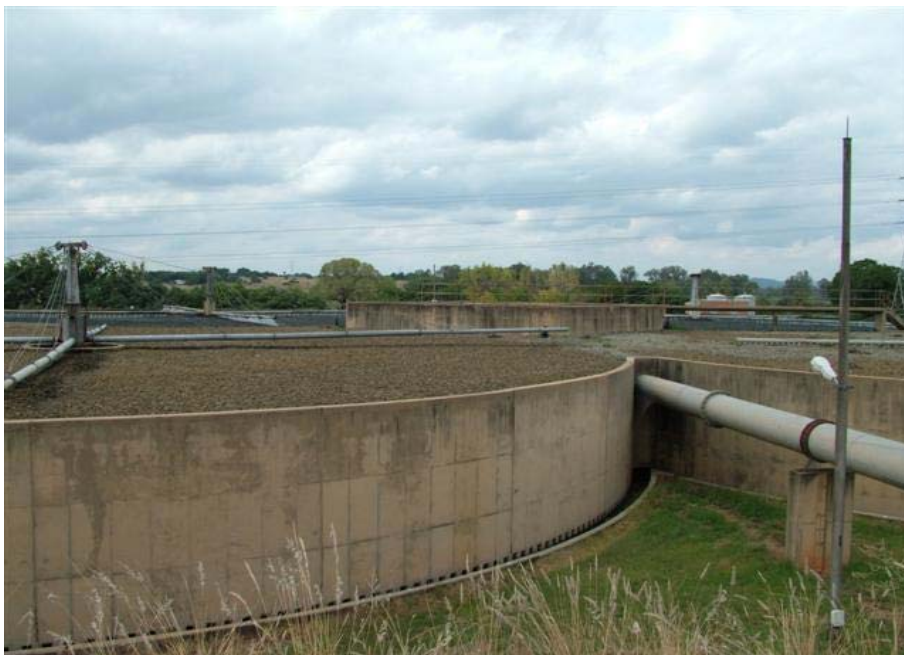
Fig 5: East works filters out of use due to mechanical issues.

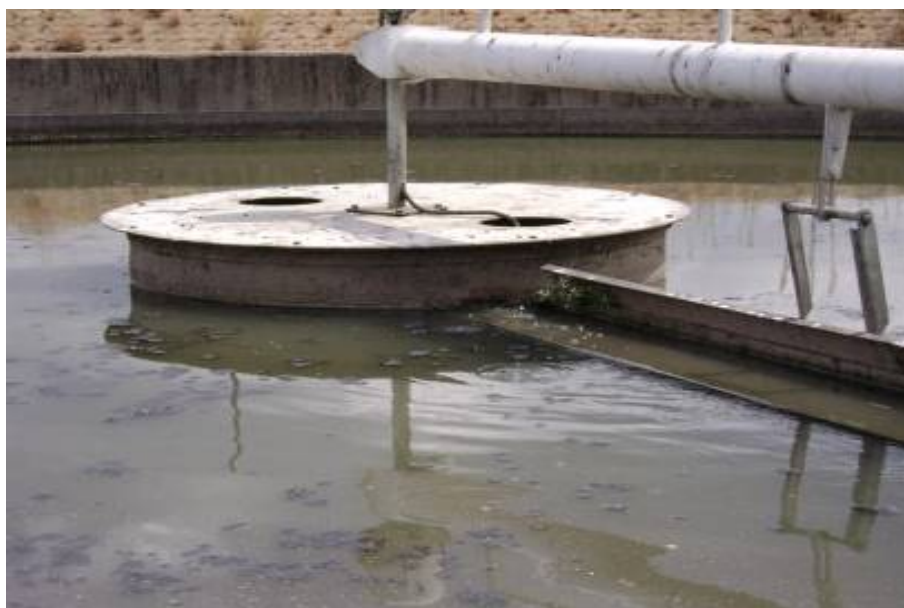
Fig. 6 Humus tanks overloaded

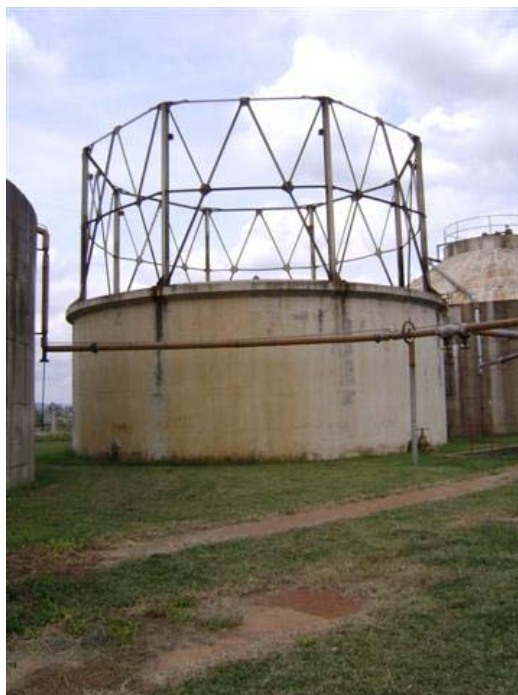
All of these were seen to be in a relatively poor condition, and some showing signs of leaking sludge (fig 8). The methane gas generated should be collected in a nearby gas holder, but this was seen to be empty (fig 9). There was also a boiler (fig.10) intended for burning the gas to provide steam injection heating and mixing of the digesters. This too, was out of action, due to the lack of gas. Site staff informed us that the digesters were not separately heated, and so the digestion was being carried-out at ambient temperatures. Air temperature on the day was approximately 25°C. This temperature is below a more ideal 37°C required for effective mesophilic digestion (and assumes that no heat loss occurred through the concrete walls of the structures). No information was available as to the feed rates of the digesters. The nearby psts were also only desludged manually, so digester feed would have been erratic, irrespective of actual volumes and rates.

Fig. 9: Empty gas holder east works

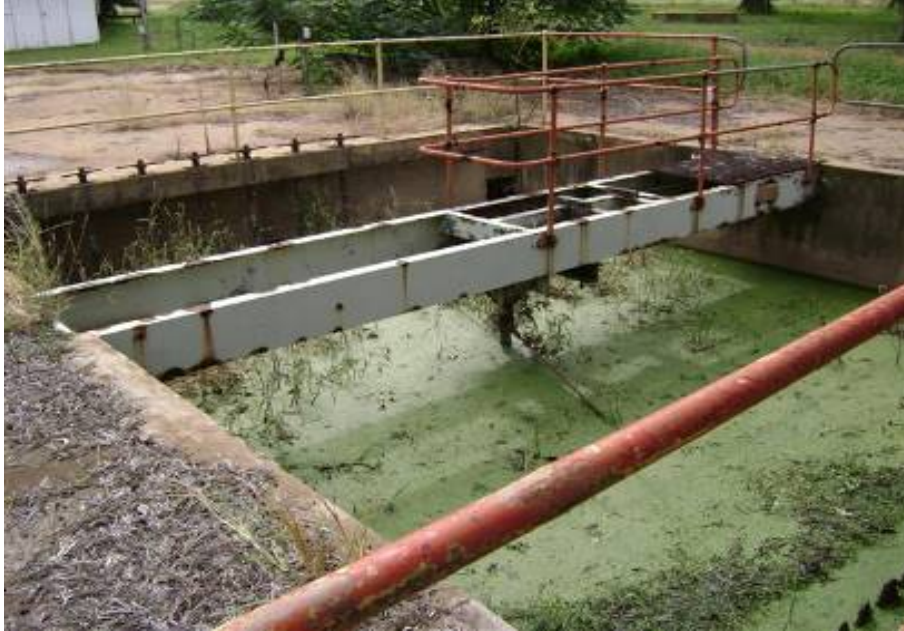
Fig. 11: Inlet works abandoned and unused.

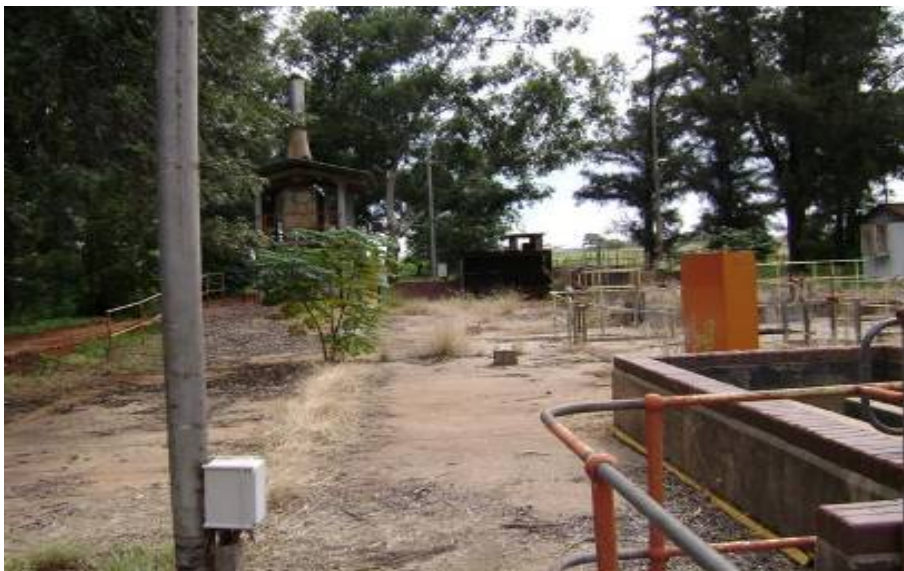
Fig.12: Inlet works abandoned

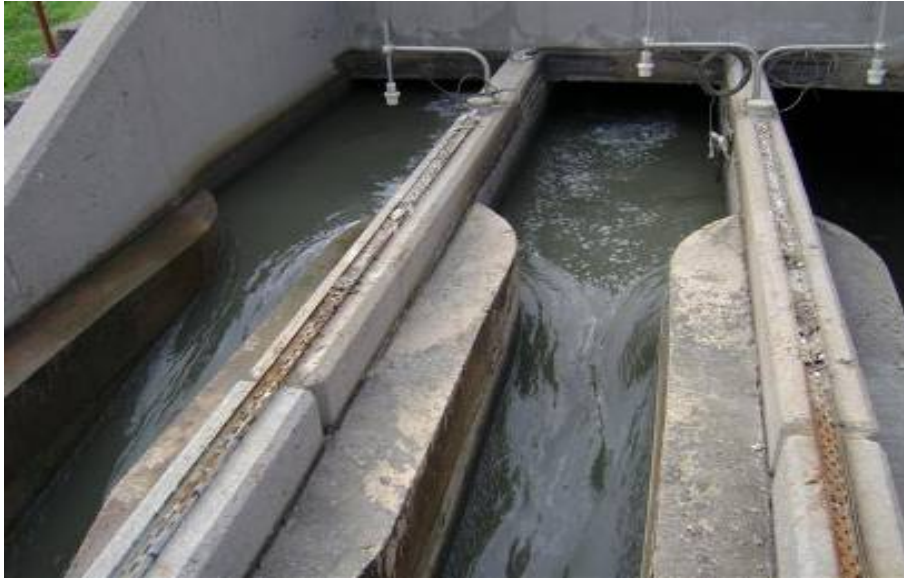
Fig. 18: Flooded inlet flumes

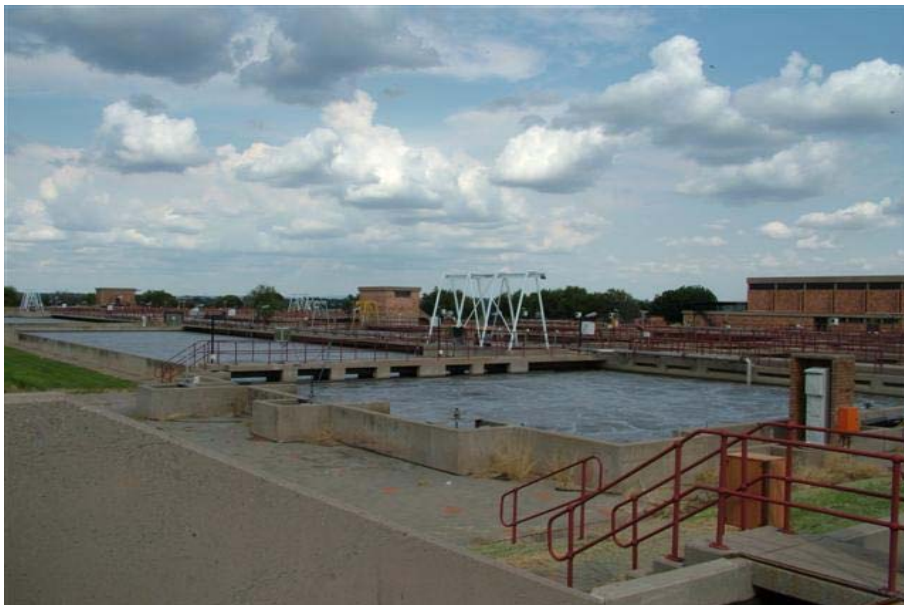
The North works consists of 6 BNR reactors, set in pairs (1.1 & 1.2; 2.1&2.2; 3.1& 3.2) (see Fig 19). These units were said to be designed as 3 Stage Phoredox units for biological removal of both phosphorus (P) and nitrogen (N). The diagram below (Jansen et al) indicates the flow patterns and configuration of this system.

Fig. 19: BNR Reactors

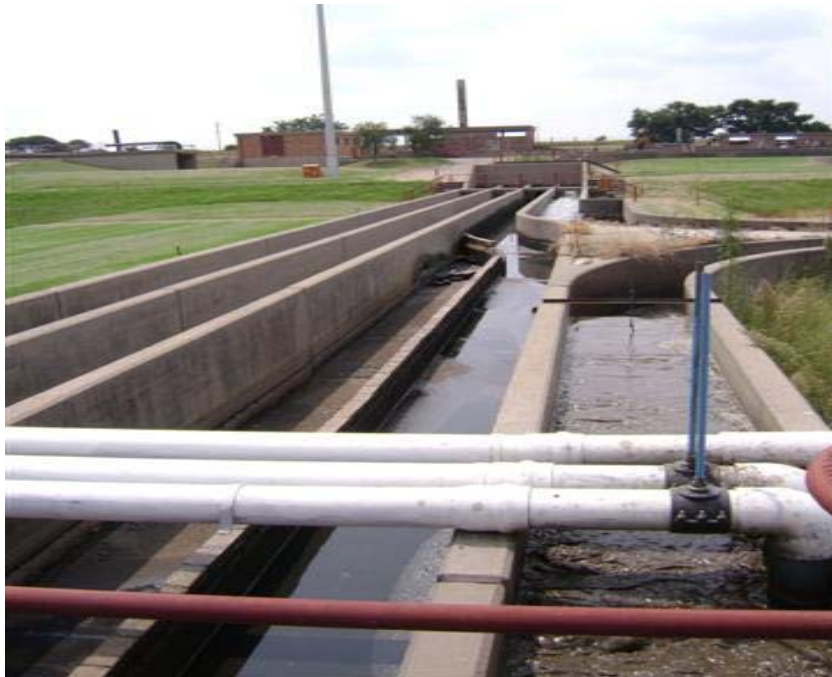
Closer inspection found that the original pipe and channel construction actually fed these flows into the front of the anoxic zones. However, the RAS screws had been taken out of action (fig 22) and replaced by pumps closer to the FSTs. These pumps passed the RAS flows along long, above ground pipelines (fig 23), depositing it into a channel close to the incoming settled sewage flows and thus directly into the front end of the anaerobic zones. Site staff were not able to confirm when or why this action was taken. The net result of this action was to provide a feed of nitrate bearing RAS into the anaerobic zone, thus hindering the P removal process. This is of course, assuming that the aerobic process was converting the ammonia to nitrates in the main bulk of the reactor.

Fig.23: Above ground RAS pipelines feeding back to BNRs

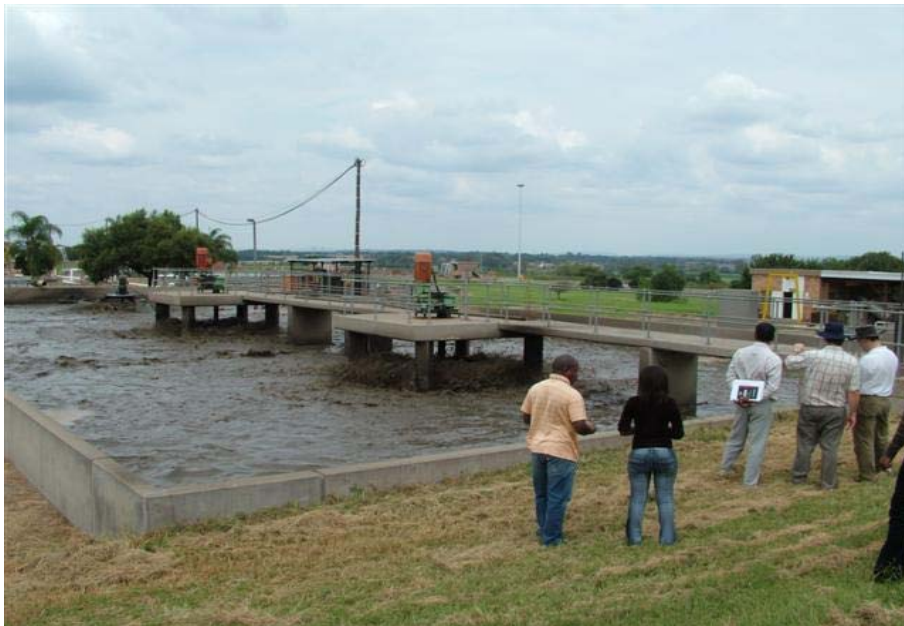
Waste activated sludge (WAS or SAS) was being pumped from the BNR reactors and FSTs into the dissolved air flotation (DAF) plant and the aerobic digester (fig 25). The intention of this process was to perform some degree of thickening prior to pumping to the holding dam (and therefore reduce pumped volumes). However, little evidence as the effectiveness of this process was available. There were also two drum thickeners present (fig.26), but these were not being used. The reason given for this was that it was not possible or practical to pump sludge over 2% dry solids. This is regarded as an odd comment, as it is common practice in the UK to pump sludge between 3-6% dry-solids. Site management also made some comments to the effect of the control PLCs (Programmable Logic Controls) being too complex for available site skills to operate.

Fig. 25: General view of aerobic digester

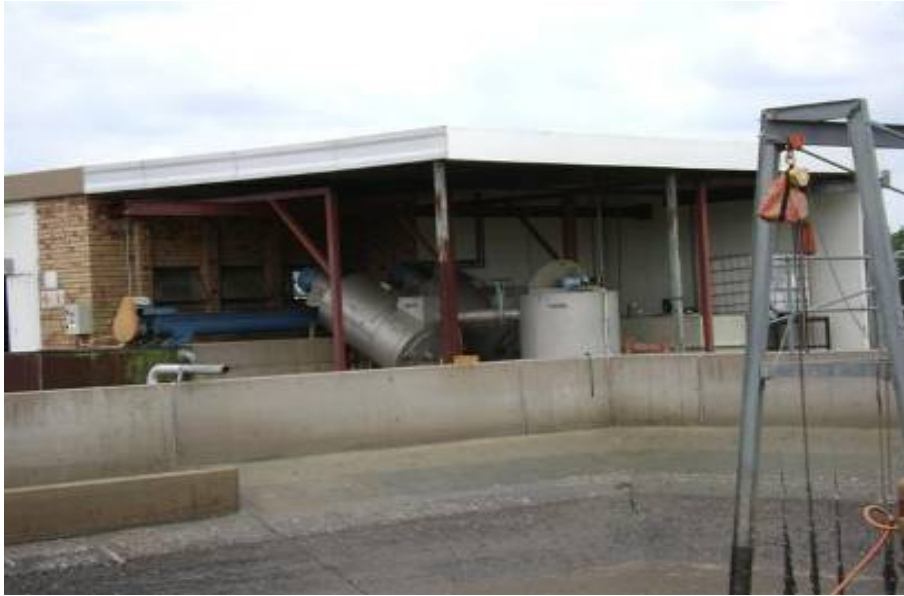
Fig. 26: Drum thickeners not being used.

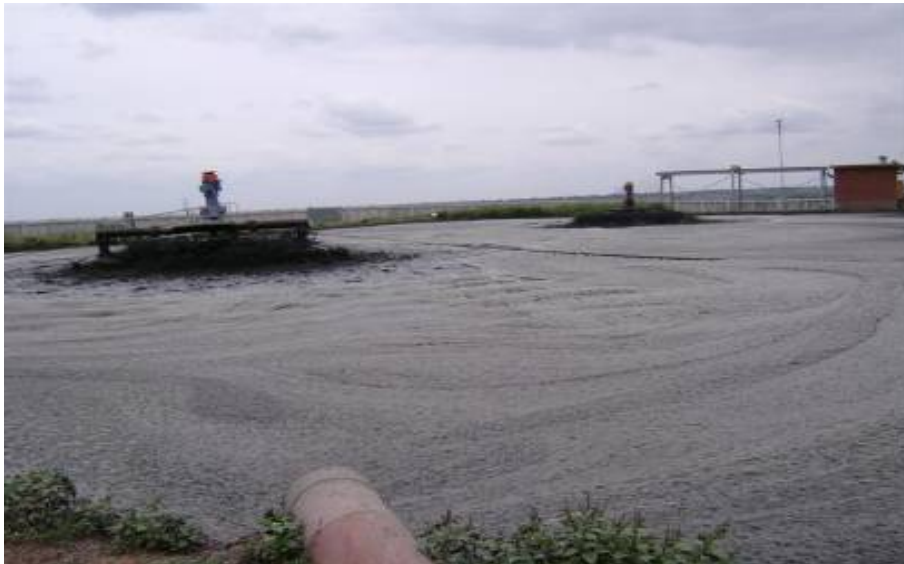
All of the sludge produced ultimately ends up in the sludge dewatering facility, located to the north of the treatment sites (fig.27).

Fig. 27: Sludge holding dam, with floating aerators.

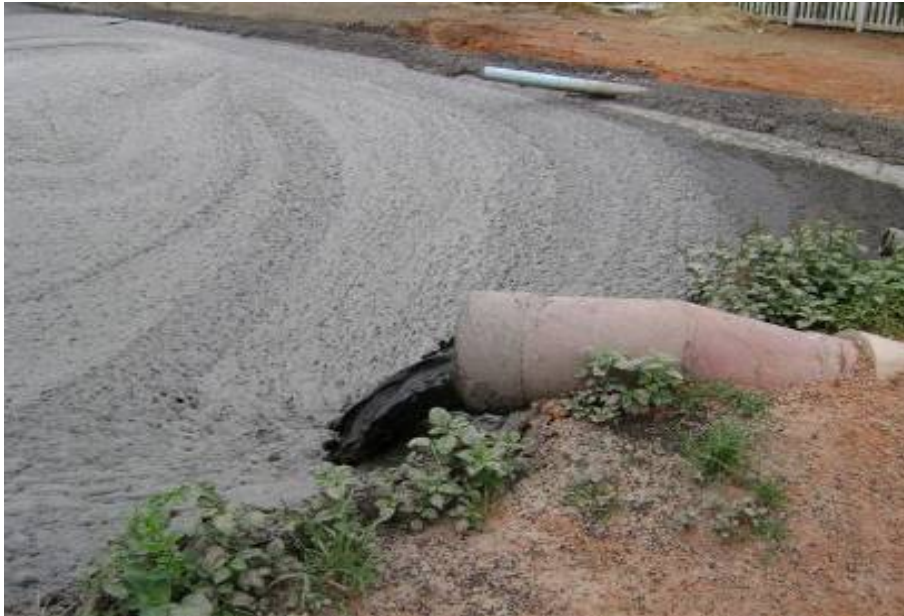
The sludge arrives through one of three pumping mains, which deposit their flows very close to the bank area (fig 28). Sludge is initially aerated to liberate gases before being pumped into the dewatering building. The condition of the pumps and the general area was seen to be poor, with several mechanical tasks apparently started but not finished (fig.29). There was considerable evidence of the dam overflowing (fig.30), lack of maintenance (fig.31), and security (fig.32).

Fig. 28: Sludge dam inlet flows, shows close proximity of inlet pipes to banking.

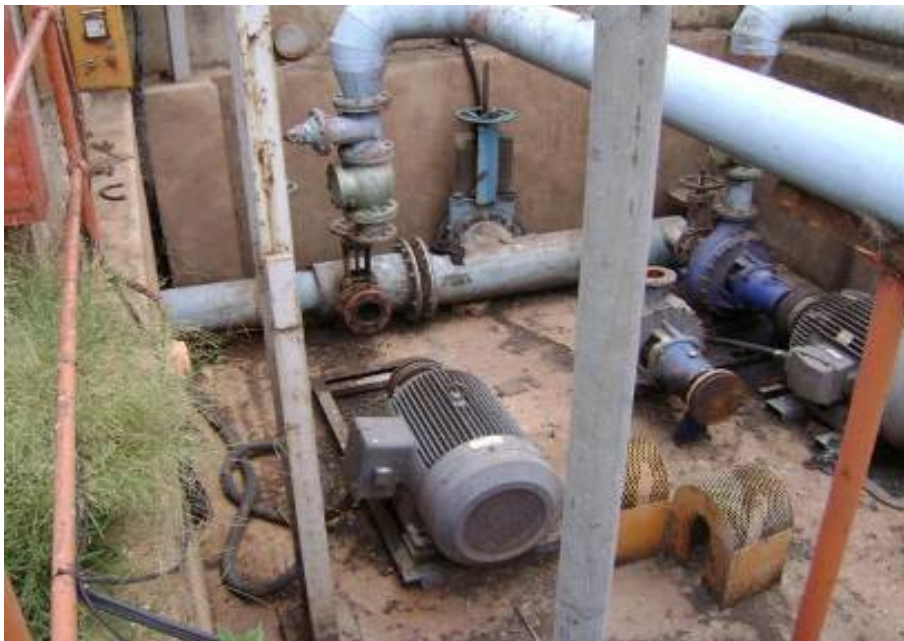
Fig. 29: Unfinished maintenance around sludge dam.

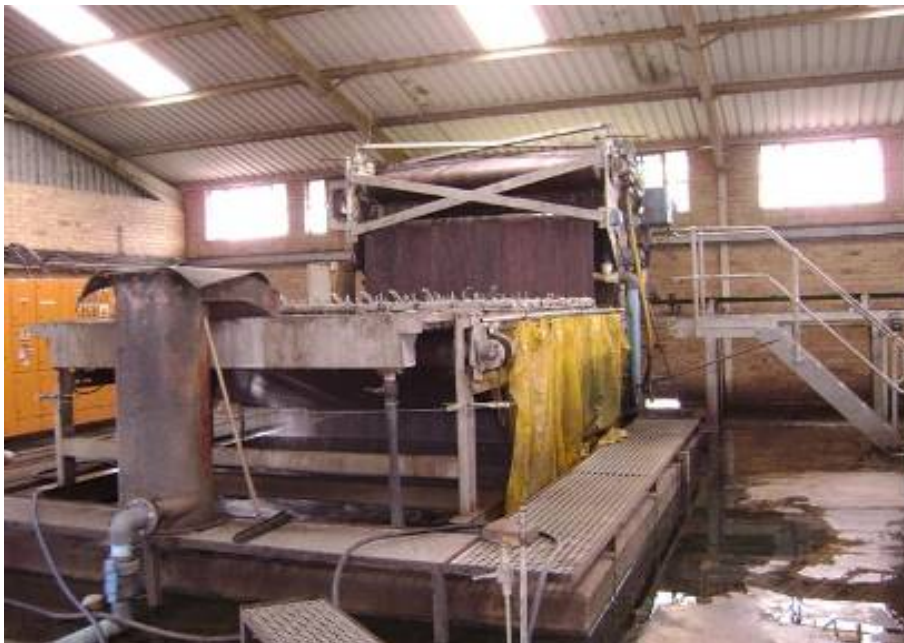
Inside the building there were three sludge gravity belt thickeners, all of which were in use (figs 33). Whilst the equipment appeared rather old and rather worn, the product did appear to be reasonable for this process. Figure 34 shows the cake product, which was estimated at approximately 15 – 20% dry solids. There was a small lab and some limited analytical equipment present, but staff were not able to provide any specific detail as to sludge characteristics.

Fig. 33: Sludge dewatering press belts inside building

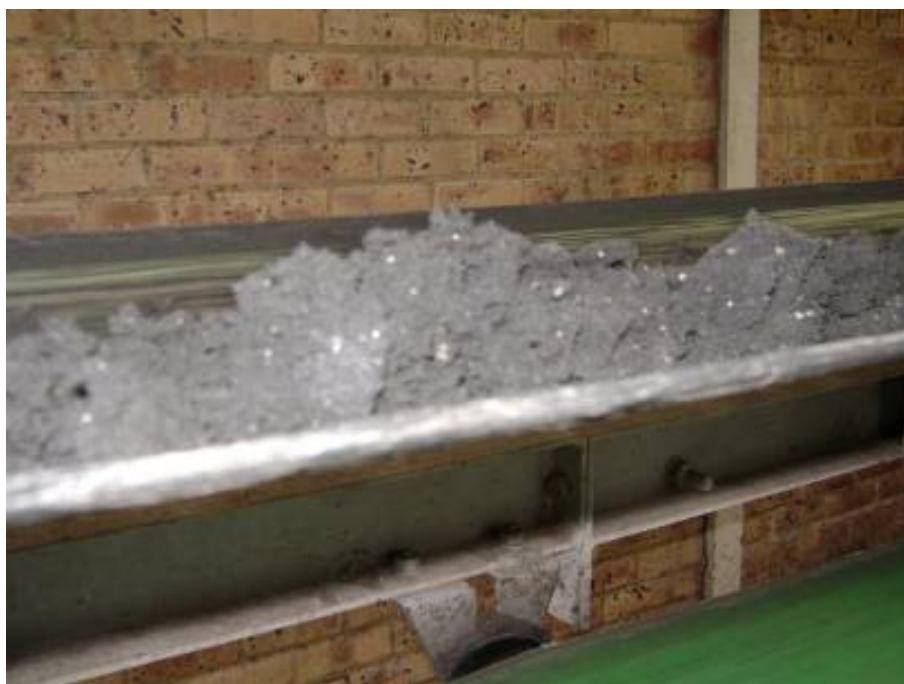
Fig. 34: Finished dewatered cake product on conveyor belt.

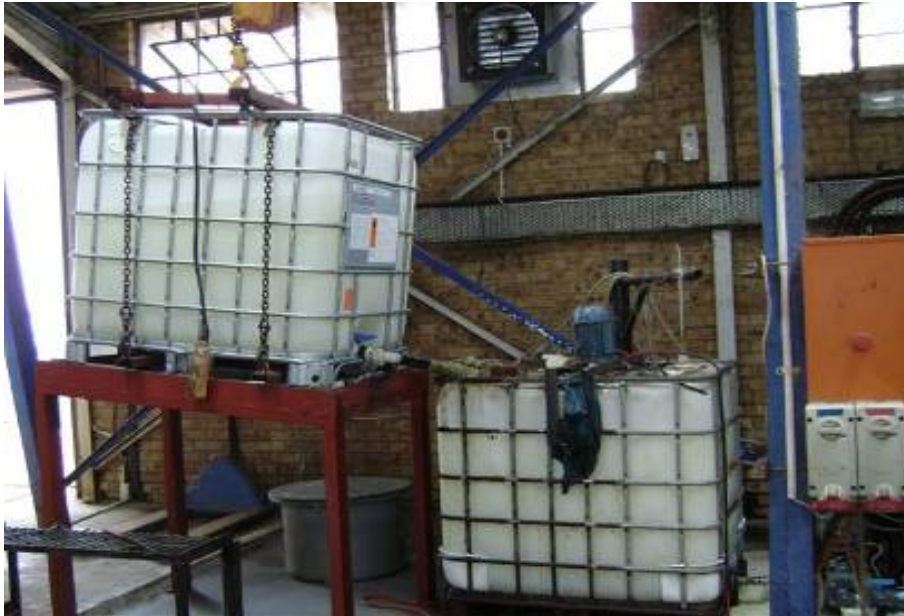
As is commonplace with this type of equipment, a cationic polymer was being dosed to encourage separation of solids and water. The dosing system appears to have been changed around several times in recent years, resulting in a large quantity of redundant or unused equipment (fig.35). Polymer is purchased in 1000 litre IBCs (Intermediate Bulk Containers), and the dosing system although working, seen to be a little unorthodox. (fig 36). Discussion with site staff also implied that this chemical was expensive, but this may have been due to the fact it was being imported from Switzerland. It is possible that bulk delivery, if available, may be more cost effective.

Fig. 36: Polymer dosing plant in use.

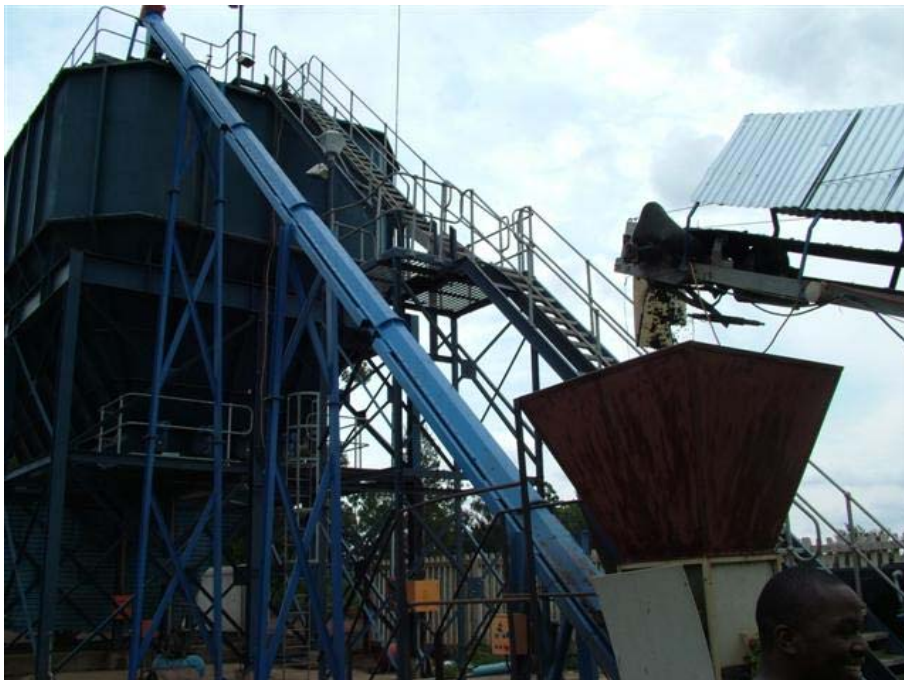
Dewatered cake drops onto a belt conveyor and is passed to a further inclined conveyor outside the building (fig.37). This second unit then elevates it up into the raised 400m³ capacity holding hopper (fig 37). The condition of these conveyors was old, but they were functioning.

Fig. 37: Inclined cake conveyor transporting cake into elevated hopper.

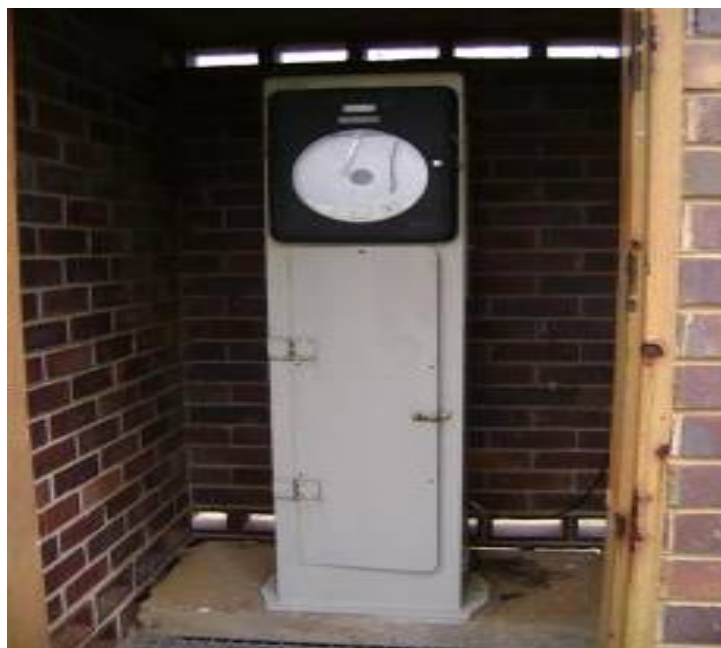
Fig. 39: Redundant flow measuring devices at west works

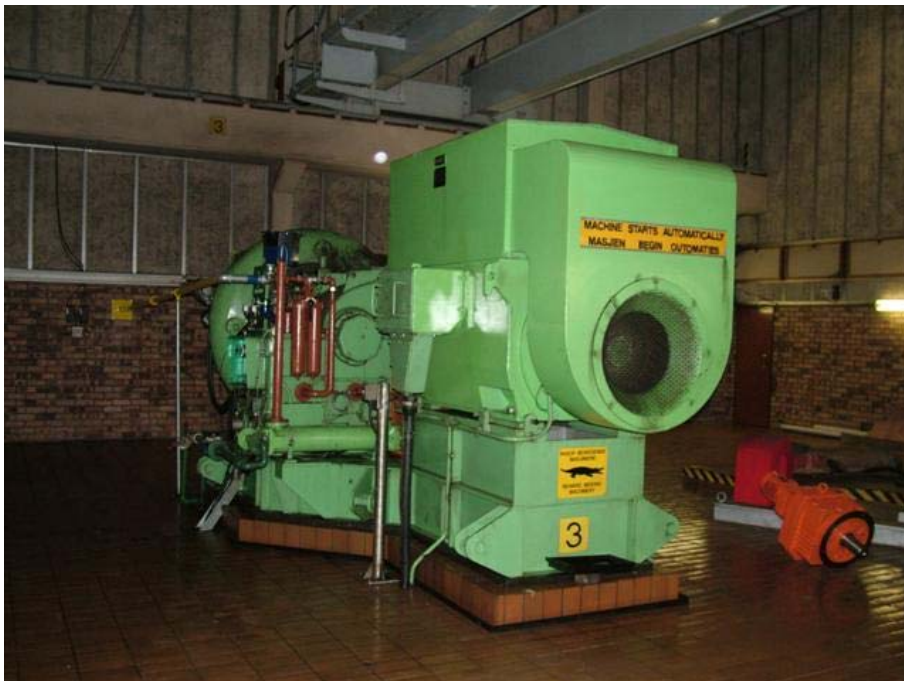
Fig. 41: Safety warning on blowers on north works.

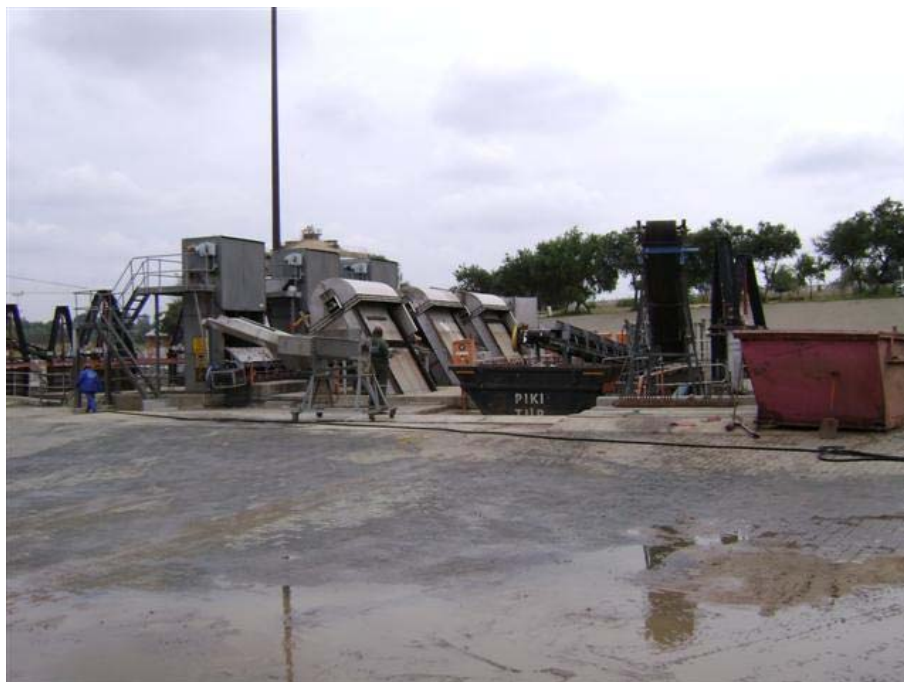
As this diagram shows, all flows are subjected to screening and degritting before being passed to treatment. In addition, flows are split off to balancing dams prior to any of the primary treatment stages. (Albeit there are further flow balancing tanks later in the process). All grit and screenings removed are collected and stored in skips (fig.43), for subsequent removal from site to landfill by a separate department of the City Council.

Fig. 43: Grit and screenings properly collected in skips prior to off site disposal.

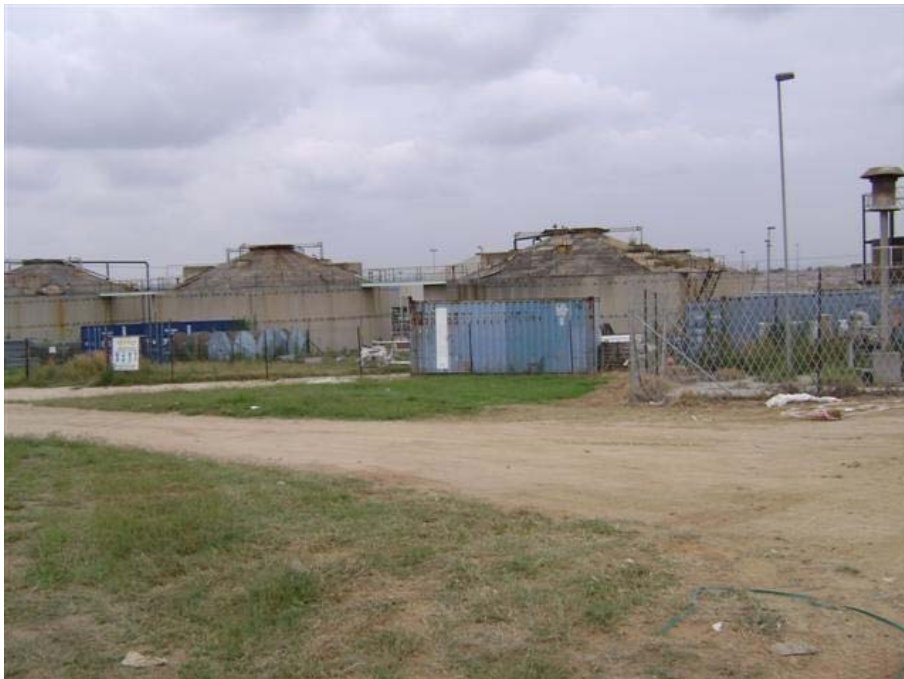
Fig. 46: Bank of 6 digesters, some in need of refurbishment.

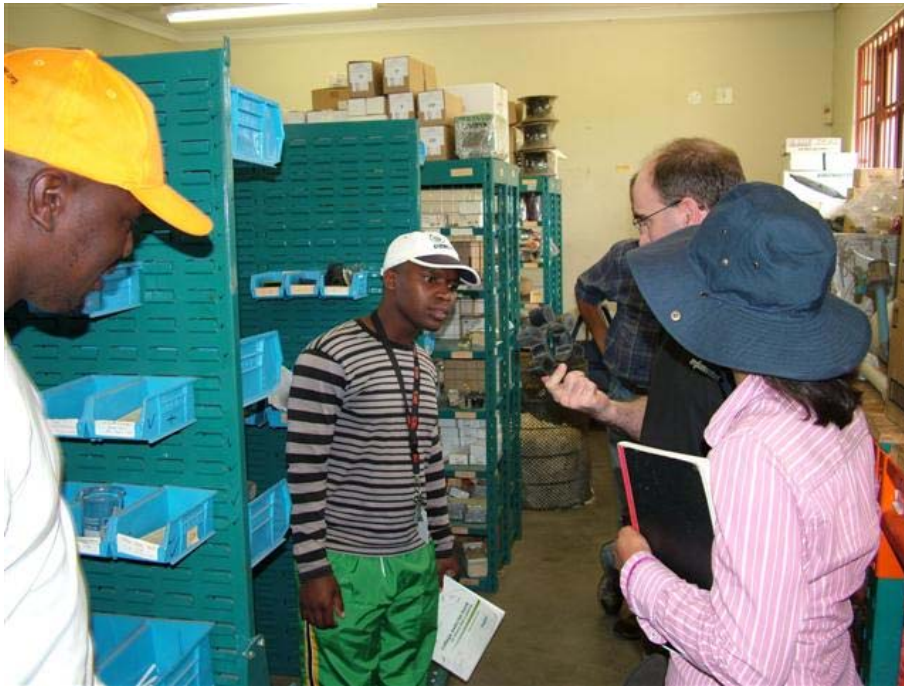
Fig. 56: Small maintenance workshops and spares.

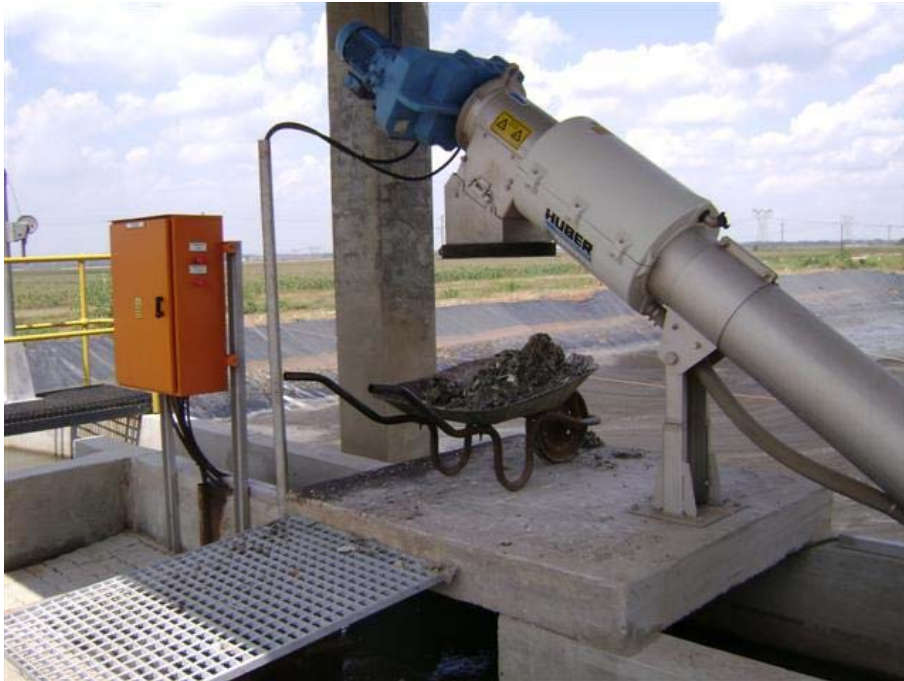
No barriers existed around the balance pond, or around the inlet screen and degritter units. Any staff taking grit or screenings away to the skip would have to risk balancing on small ledges (fig 62). The ramp to the skip, whilst rather ingenious, did put the user at some risk (fig 64).

Fig. 64: Unsafe access to skip for rag and grit disposal.
